# Aviation Investigation Final Report

| <b>Location:</b> | Porterville, California | <b>Accident Number:</b> | WPR22FA216 |
| <b>Date &amp; Time:</b> | June 18, 2022, 14:54 Local | <b>Registration:</b> | N3835U |
| <b>Aircraft:</b> | Cessna 336 | <b>Aircraft Damage:</b> | Destroyed |

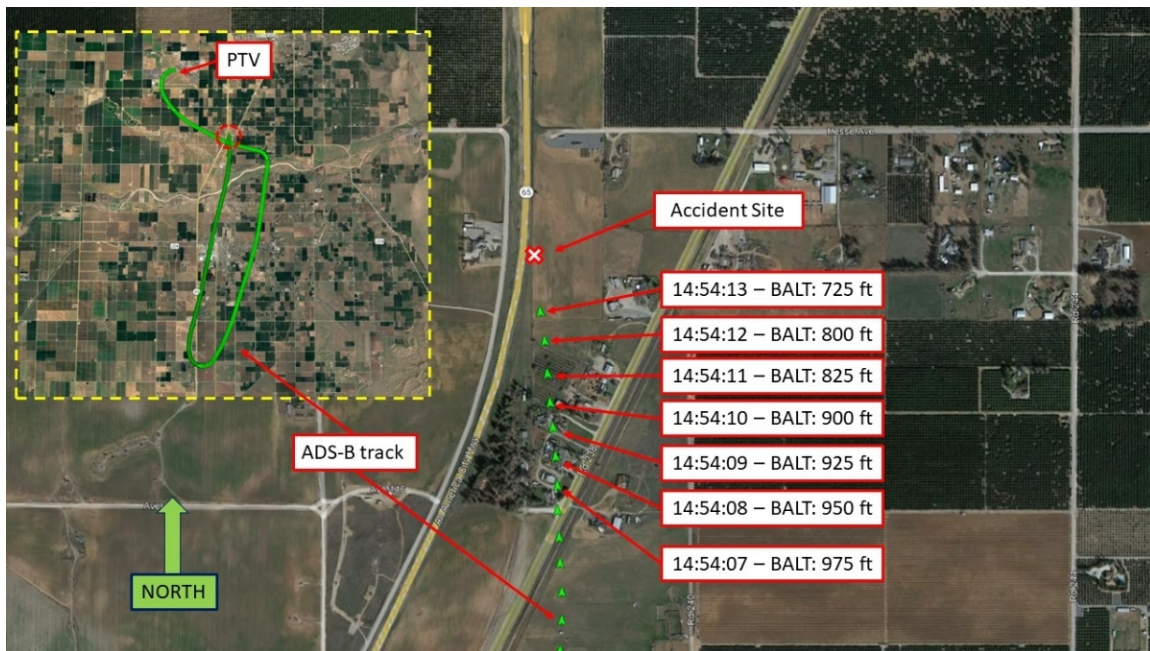
Figure 1: Recorded ADS-B Data plots.

Recorded ADS-B data, depicted in figure 1, showed the airplane in a left climbing turn shortly after takeoff from runway 30 at Porterville Municipal Airport (PTV). The airplane climbed to about 825 ft msl on a southeasterly heading. About 1 minute and 7 seconds later, the airplane entered a right turn to a southerly heading. The airplane continued a south-southwesterly heading for about 2 minutes, 46 seconds, and climbed to about 1,550 ft msl before entering a descending right turn to a northerly heading. About 37 seconds later, the airplane leveled off about 1,000 ft msl and continued north for about 1 minute, 41 seconds. The last 6 seconds of recorded data showed the airplane in a descent from 975 ft to 725 ft near the last recorded ADS-B target, about 435 ft south of the accident site.
