Aviation Investigation Final Report

Location:	Stillwater, Oklahoma	Accident Number:	CEN22LA255
Date & Time:	June 18, 2022, 09:45 Local	Registration:	N5895Q
Aircraft:	Mooney M20E	Aircraft Damage:	Substantial
Defining Event:	Loss of engine power (partial)	Injuries:	2 None
Flight Conducted Under:	Part 91: General aviation - Personal

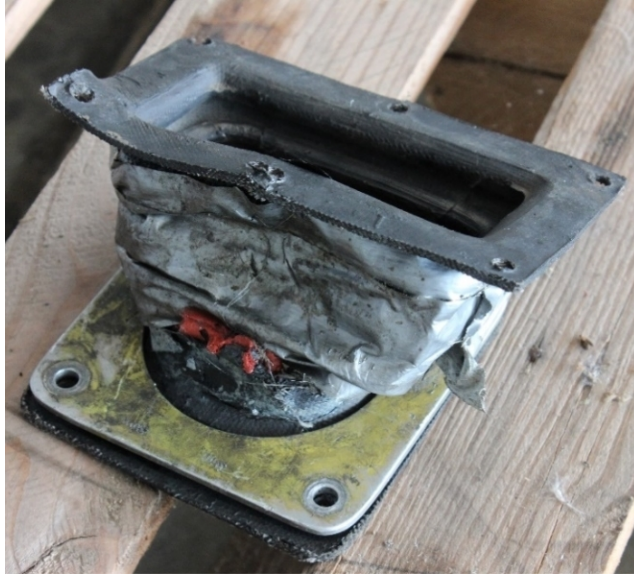
During a postaccident examination, the induction air coupling was found wrapped in gray tape. When the tape was removed, separations were visible on the top and bottom at the flange on the inboard side. The top and bottom separations likely reduced the rigidity of the coupling when the engine was operating. Examination of the inside of the coupling showed that the lower portion appeared to be permanently deformed in a manner similar to compression. Therefore, because of the reduction in the coupling's rigidity, the coupling had likely closed due to suction from the engine, which impeded airflow.

A postaccident examination revealed no anomalies with the engine control system, and throttle control continuity was established from the cockpit controls to the engine. The engine cowling was removed, and the induction air coupling was found wrapped in gray tape (see figure 1). When the tape was removed, separations were visible on the top and bottom at the flange on the inboard side. The inside of the coupling was examined, and the lower portion appeared to be permanently deformed in a manner consistent with compression (see figure 2).

Figure 1. Induction coupling with gray tape.

Tape should not have been applied as a fix for the induction coupling separations. The investigation could not determine when the coupling separations appeared or the tape was applied, but those events had likely caused the permanent deformation to the coupling. The airframe and powerplant mechanic, who performed annual inspections for the airplane during the 3 years before the accident. should not have allowed the airplane to return to service with the tape applied and the coupling deformed.

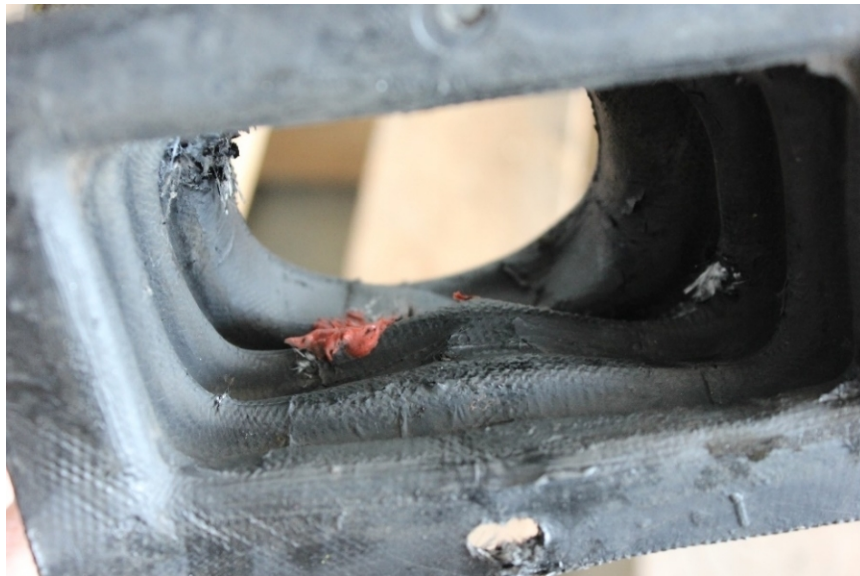
Figure 2. View from inside the induction coupling
