Aviation Investigation Final Report

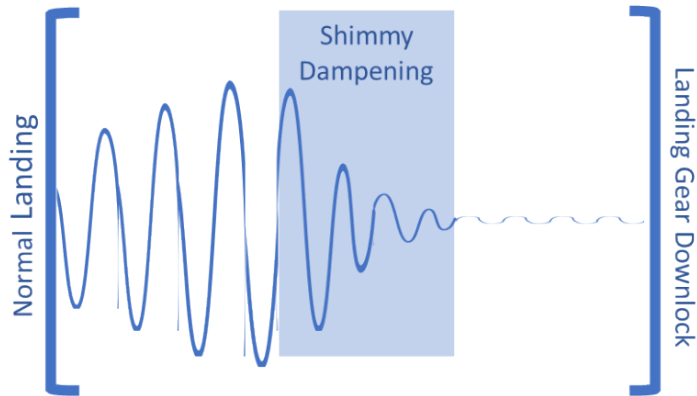
Figure 1. The blue line is a representation of vibrations from a normal landing dampened by normally operating shimmy dampers when both main landing gear are down and locked. Note: Figure is not to scale nor depicting actual data.

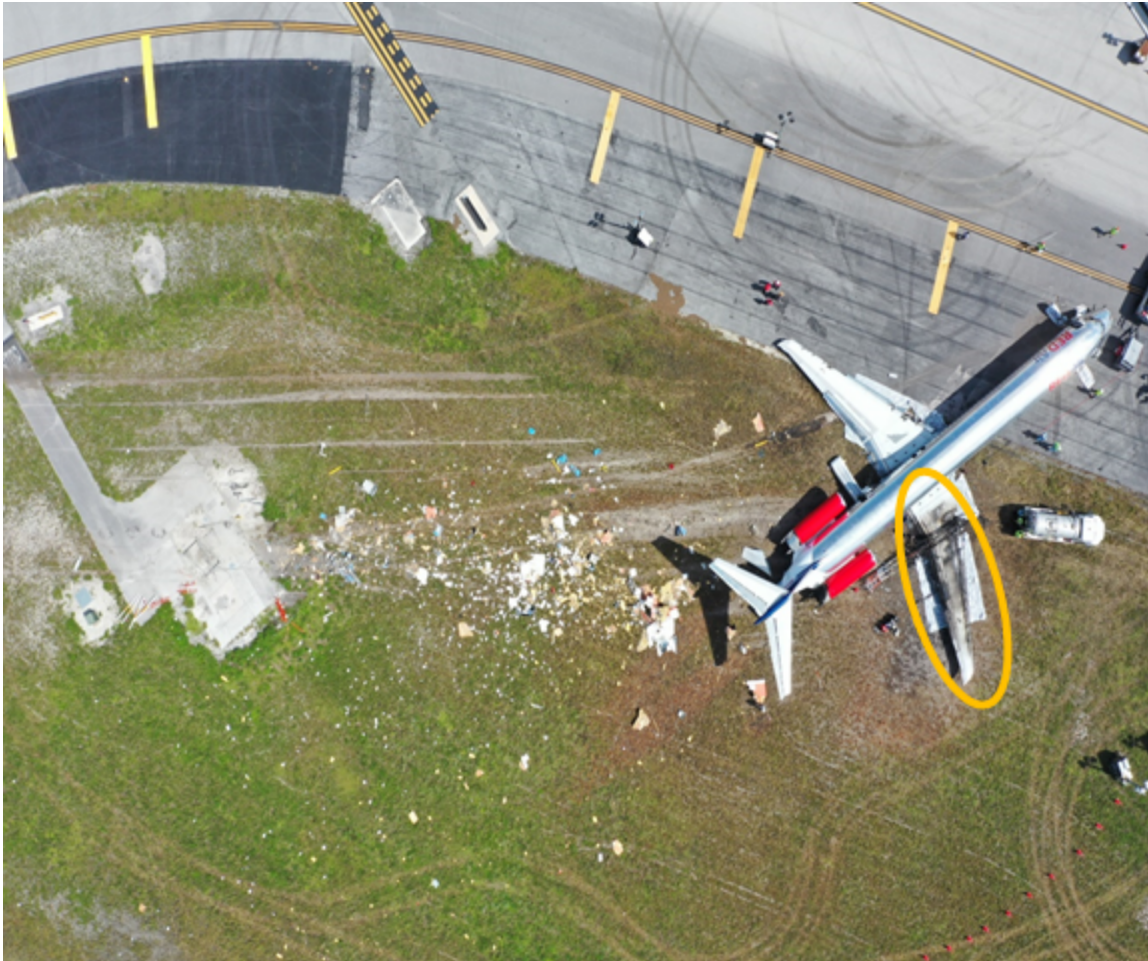
Figure 12. Overhead image of the wreckage captured by NTSB’s small UAS. The fire damage to the right wing is indicated by the yellow circle.
