Aviation Investigation Final Report

Location:	Miami, Florida	Accident Number:	DCA22FA132
Date & Time:	June 21, 2022, 21:38 UTC	Registration:	HI-1064
Aircraft:	McDonnell Douglas MD80	Aircraft Damage:	Substantial
Defining Event:	Landing gear collapse	Injuries:	4 Minor, 136 None
Flight Conducted Under:	Part 129: Foreign

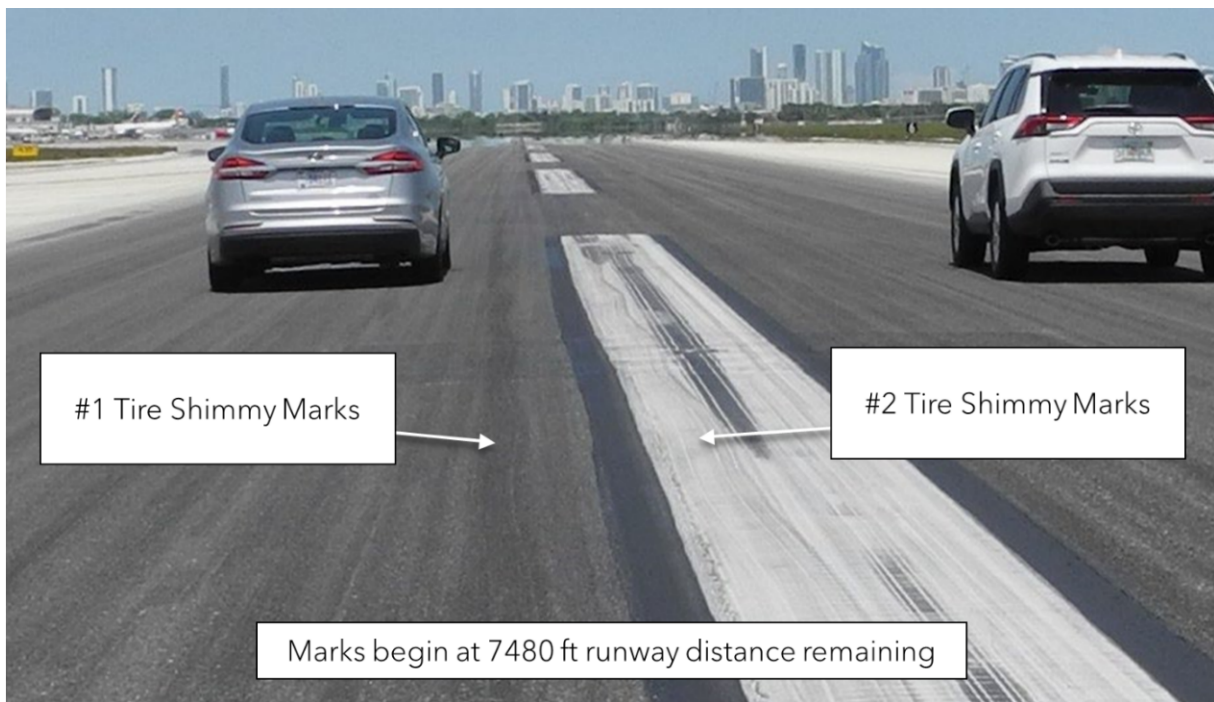
Rubber deposits from the left MLG tires were found on the runway (see figure 9). These deposits grew in amplitude, indicating an increasing shimmy. The initial markings were continuous and were consistent with side-to-side oscillations. The markings became more arched and noncontinuous, consistent with the axle/wheels turning about the vertical axis. The markings then changed from a two-tire pattern to a single-tire pattern and were located on the opposite side of the runway centerline, consistent with the tire sidewall contacting the runway after the left MLG collapsed (see figure 2). The first debris located on the runway (about 1,840 ft from the touchdown point and with 7,060 ft of runway remaining) was a small piece of rubber that was later determined to be from the outboard side of the No. 2 tire.

Figure 9. Start of the left main landing gear shimmy marks. The distance noted is distance to the end of the runway.

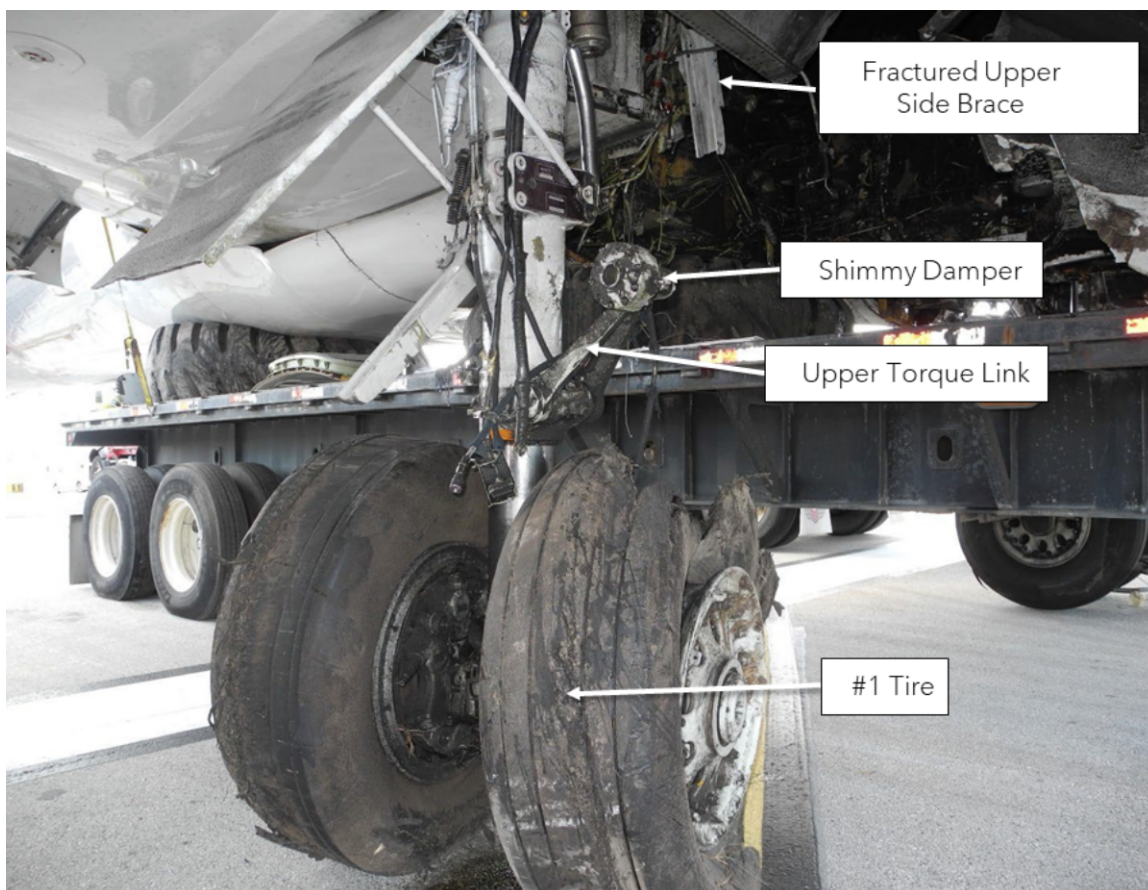
Facing severe undampened axial vibration on rollout, the left main gear lower torque link (downlock) failed due to overload. When the downlock failed, the side braces were free to, and did, fold in the opposite direction from normal as the gear folded inboard and collapsed.

When the airplane was lifted during recovery, the left MLG dropped down to the extended position, and the axle was found to be rotated 90° outboard (with the No. 2 tire forward). The left MLG lower side brace fractured just below the joint of the upper and lower braces. The

lower end of the lower side brace remained attached to the outer cylinder. The upper side brace fractured into upper, middle, and lower pieces. The largest of the three pieces was the upper piece, which remained attached to the airplane (see figure 10). The middle and lower pieces were recovered in the debris field just past the glideslope building. The middle piece showed evidence of impact damage on its forward face. The lower piece had a small piece of black rubber, consistent with tire material, wedged in the joint.

Figure 10. Photo of the left main landing gear after the accident looking inboard and slightly forward. Note that the landing gear assembly is facing outboard in the photo.

Further examination of the left MLG found that all the fractures in the side braces and torque links occurred due to ductile separation consistent with overload; no evidence indicated fatigue failure. The damage on the forward side of the side brace aligned with damage on the outer cylinder near the gland nut, consistent with the side braces moving in the opposite direction of normal. The lower lock link was bent in the aft direction and was sheared. A small segment of the lower lock link, measuring about 3/16 inch, was missing. The upper lock link was bent in the forward direction with corresponding contact marks on the upper lock link and outer cylinder.
