Aviation Investigation Final Report

Location:	Mendon, Utah	Accident Number:	WPR22FA227
Date & Time:	June 24, 2022, 09:03 Local	Registration:	N934JH
Aircraft:	Cessna 152	Aircraft Damage:	Substantial
Defining Event:	Aerodynamic stall/spin	Injuries:	2 Fatal
Flight Conducted Under:	Part 91: General aviation - Instructional

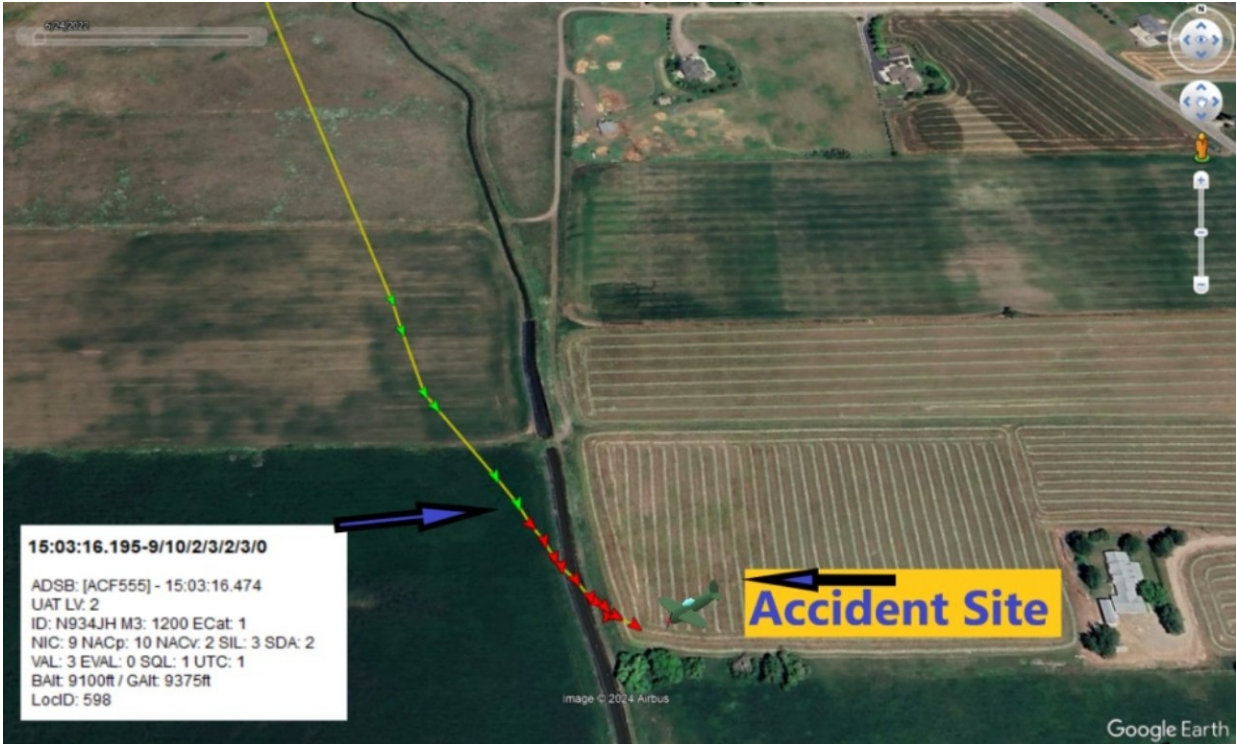
Figure

Three maneuvers were performed with directional changes greater than 180° or rapid descents in altitude, consistent with spin training. ADS-B data indicated that the accident maneuver was entered about 9,100 ft msl (~4,510 ft agl). The elevation at the wreckage site was 4,590 ft. A review of surveillance footage showed the airplane in a fully developed left spin. When the airplane entered the surveillance video's field of view, the airplane subsequently completed three rotations to the left, in a nose-down attitude, within a time span of about seven seconds, before disappearing from the camera view and impacting terrain.

1: N934JH spin maneuver initiated
