Aviation Investigation Final Report

Location:	Kerrville, Texas	Accident Number:	WPR22FA229
Date & Time:	June 25, 2022, 18:23 Local	Registration:	N4267H
Aircraft:	Mooney M20J	Aircraft Damage:	Destroyed
Defining Event:	Sys/Comp malf/fail (non-power)	Injuries:	2 Fatal
Flight Conducted Under:	Part 91: General aviation - Personal

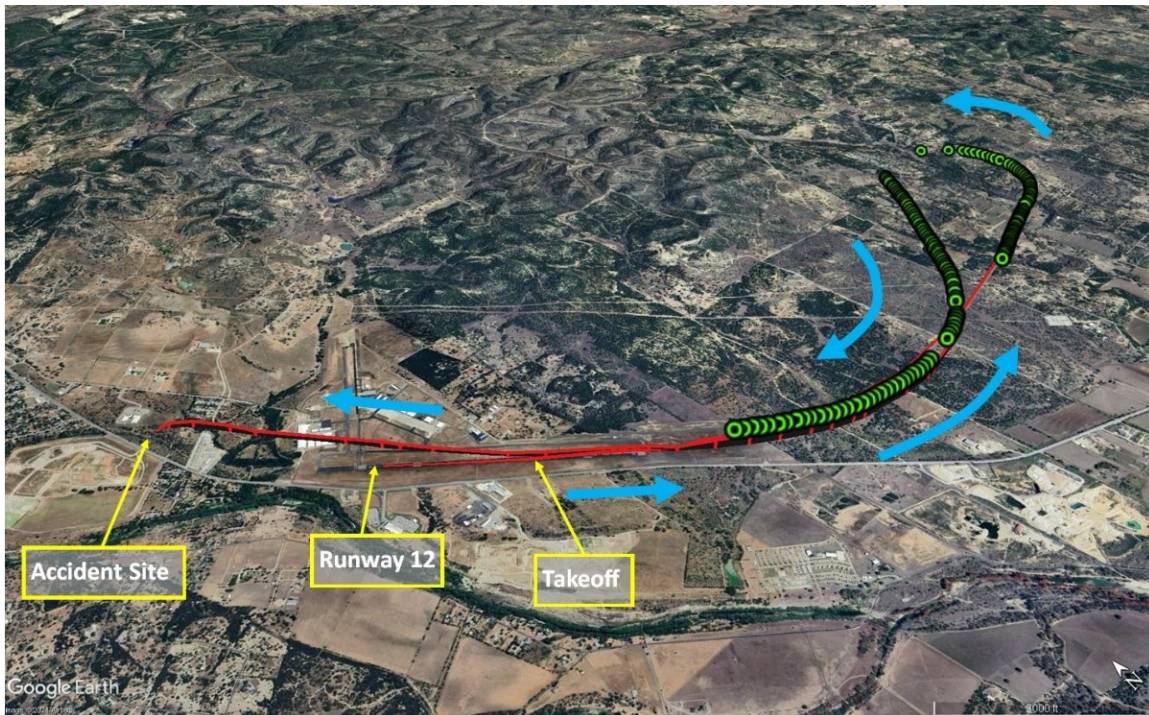
Another witness traveling along the same highway observed a Mooney airplane flying over runway 30, but not climbing. He assumed it had just taken off and was concerned because the wind favored the opposite runway, and the weather was hot. He watched as the airplane continued traveling in a northwest direction, in a manner that he described as “mushing.” It was very close to the treetops when it appeared to make a turn to the left. The witness thought this was a left base turn for runway 12, but the bank angle became very steep, and the airplane disappeared behind trees (see Figure 1).

ADS-B data provided by a publicly available collection service (ADS-B Exchange) recorded position data during the return leg to the airport. The data appeared to match the witness observations and showed that the airplane flew directly over the takeoff runway at an altitude of about 100 ft agl before making a 10° turn to the right. The airplane continued at the same altitude for the next 1.25 miles before beginning a left turn almost 800 ft southeast of the accident site.

Figure 1 – Composite flight track. Green: FAA ADS-B. Red: ADS-B Exchange.

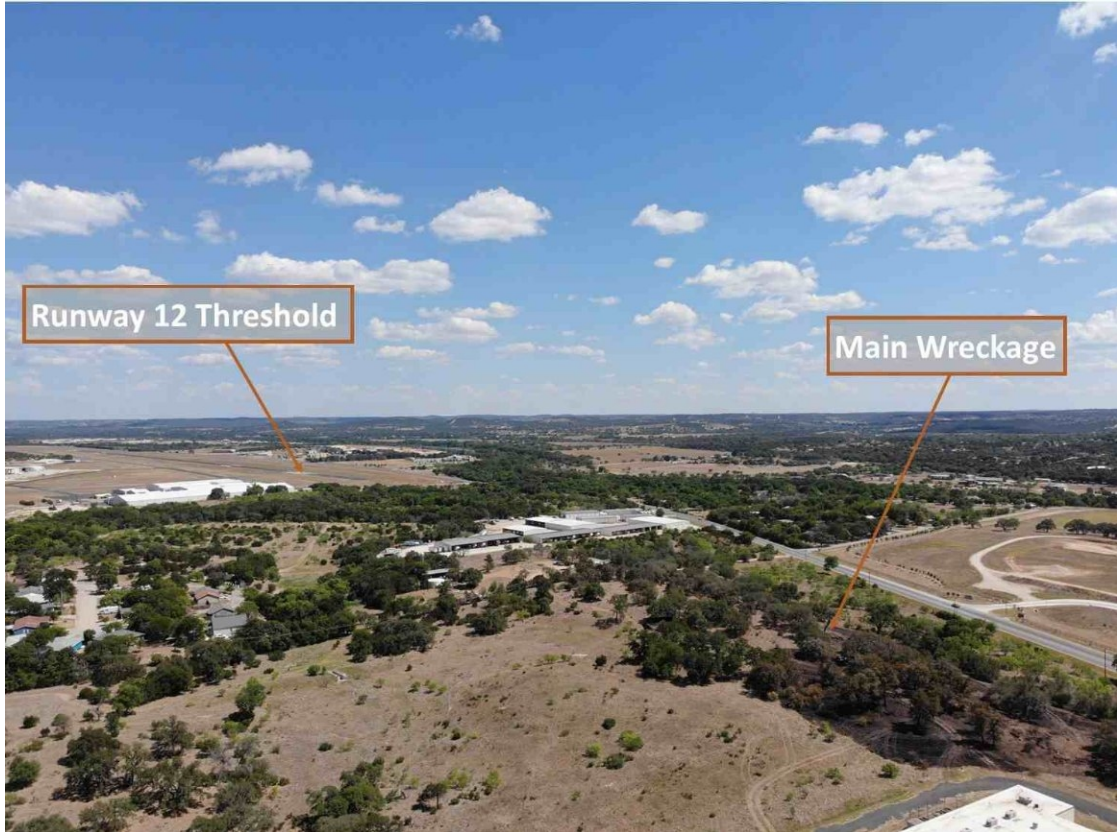
The airplane came to rest at an elevation of about 1,600 ft on the slope of a hill about 4,200 ft beyond the runway 12 threshold and 20° offset from the runway centerline (see Figure 2). The first identified point of impact was a cleanly cut swath of tree branches and limbs at an angle of 60° relative to the horizon (Figure 3). The airplane was located about 30 ft southwest of the swath at the base of a felled 50-ft tall oak tree. The tree exhibited impact damage along its north face.

Figure 2 – Wreckage location and runway threshold.

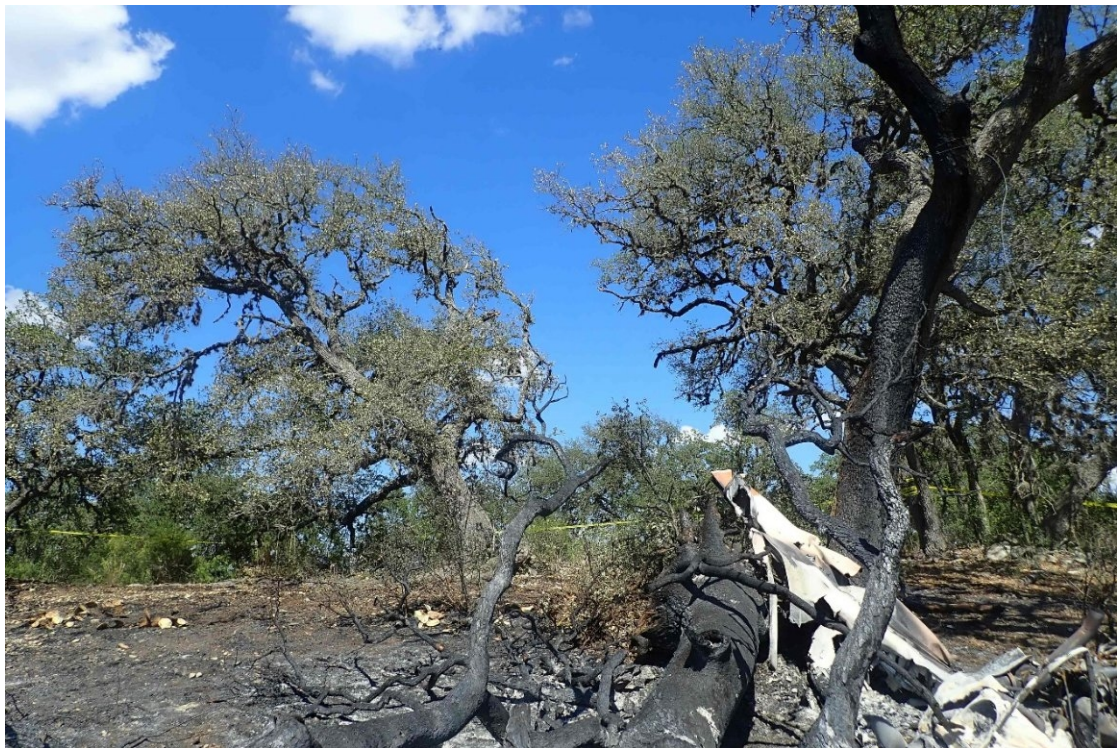
Figure 3 – Facing north, a 60° swath of cut tree limbs and branches, with the main wreckage in the foreground.
