Aviation Investigation Final Report

| Location: | Vancouver, Washington | Accident Number: | WPR22FA235 |
| Date & Time: | June 28, 2022, 07:40 Local | Registration: | N444PM |
| Aircraft: | Beech V35B | Aircraft Damage: | Destroyed |

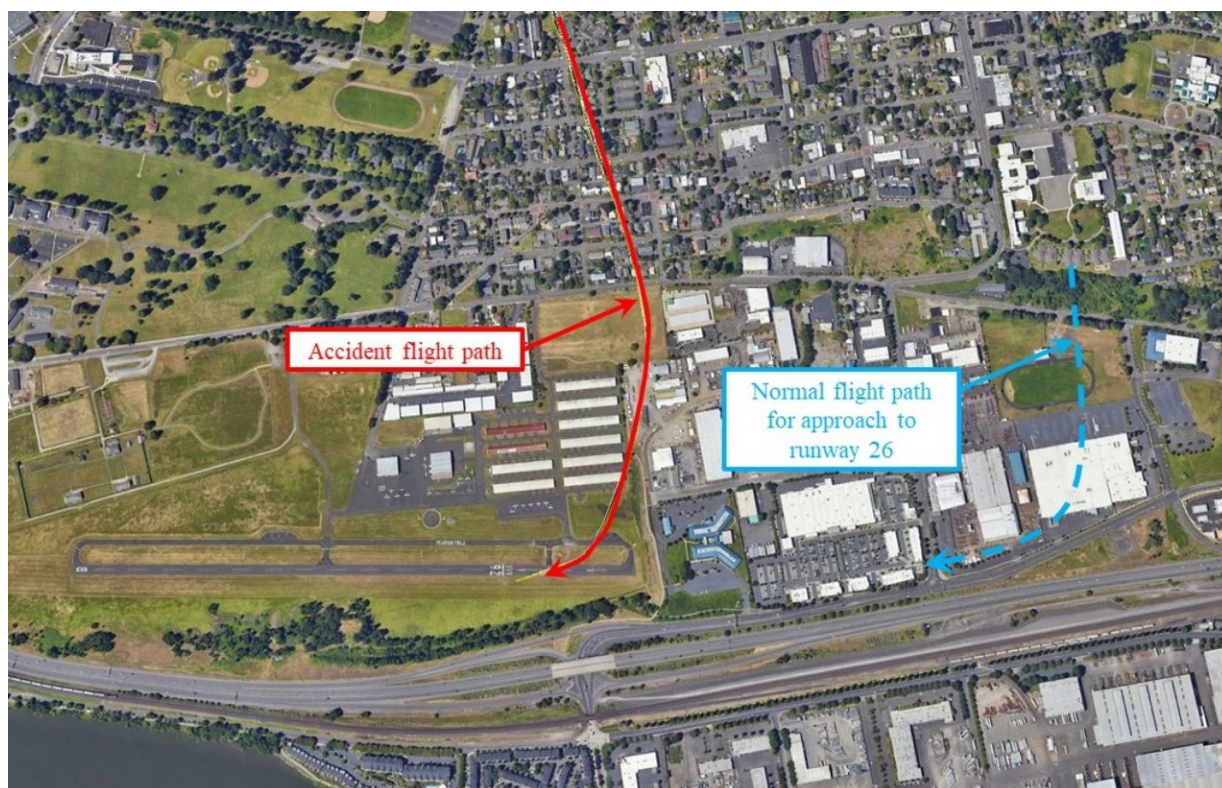
As the pilot turned onto final approach, he commanded a steep turn to align the airplane with the runway, which likely resulted in an exceedance of the airplane's critical angle of attack, an accelerated stall, and impact with terrain. The pilot had an opportunity to go-around after the improper base leg entry, thus his decision to continue the approach following the base leg turn contributed to the accident.

The pilot's flight logbooks could not be located. A friend who had flown at least 30 hours with the pilot in the accident airplane reported that he had helped the pilot purchase the airplane and had given him his most recent flight review. He stated that they normally turned onto the final approach leg of the traffic pattern over a large white building (about a 0.5 nm distance from the runway). He further remarked that he had previously taught the pilot normal and accelerated stalls in the accident airplane.

Figure 1: Accident flight path versus pilot's usual flight path to runway 26

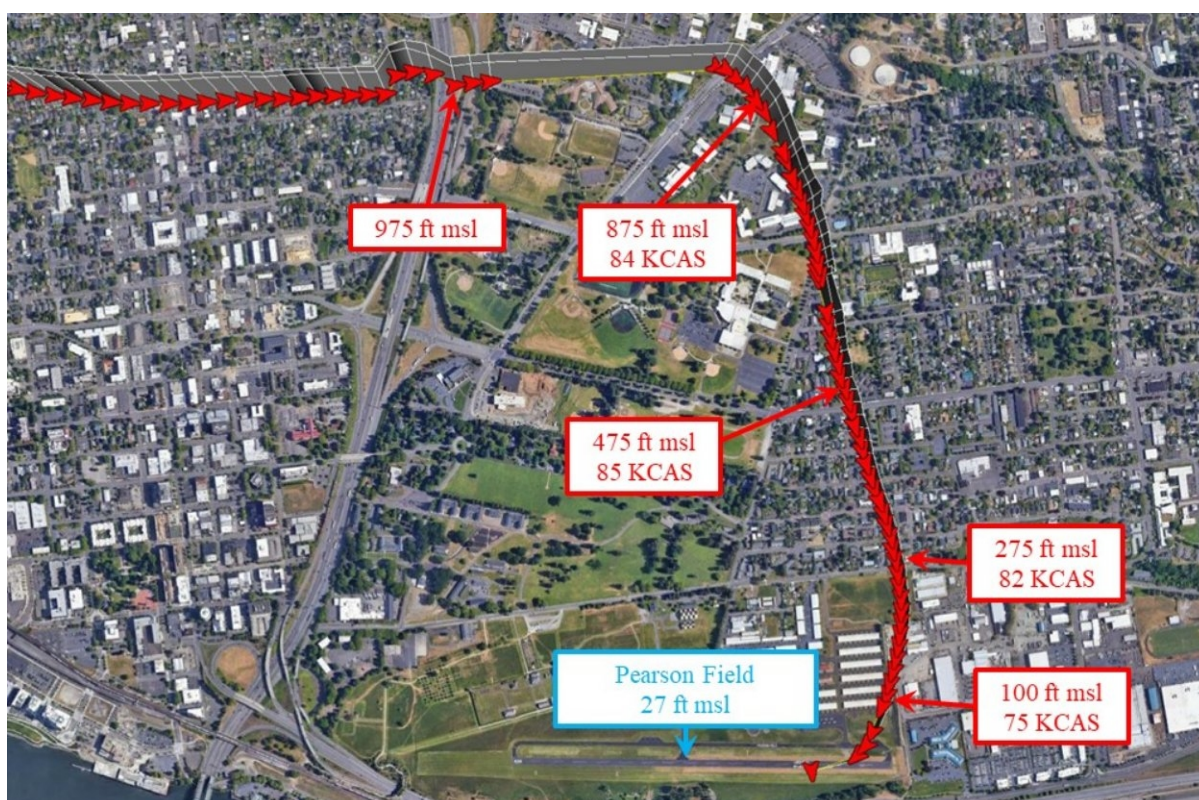
An analysis of the ADS-B data from 0736 to the time of the accident combined with winds aloft data showed that the airplane had an average descent rate of about 1,000 fpm, an average airspeed of about 80 knots calibrated airspeed, bank angles of about 7°, and an average angle of attack of about 5° on the base leg of the traffic pattern.

Figure 2: Airplane's flight path with altitude and airspeeds

The airplane's stall speed was computed using the stall chart from the airplane POH. The stall chart incorporates a maximum bank angle of 60°, which the airplane exceeded during its turn to final approach. According to the stall chart, the airplane's stall speed as it turned to final approach would have been exceeded 80 kts. An analysis of the ADS-B data showed that the airplane's airspeed at this time would have been about 73 KCAS.
