# Aviation Investigation Final Report

<b>Location:</b>	Vancouver, Washington	<b>Accident Number:</b>	WPR22FA235
<b>Date &amp; Time:</b>	June 28, 2022, 07:40 Local	<b>Registration:</b>	N444PM
<b>Aircraft:</b>	Beech V35B	<b>Aircraft Damage:</b>	Destroyed
<b>Defining Event:</b>	Aerodynamic stall/spin	<b>Injuries:</b>	1 Fatal
<b>Flight Conducted Under:</b>	Part 91: General aviation - Personal

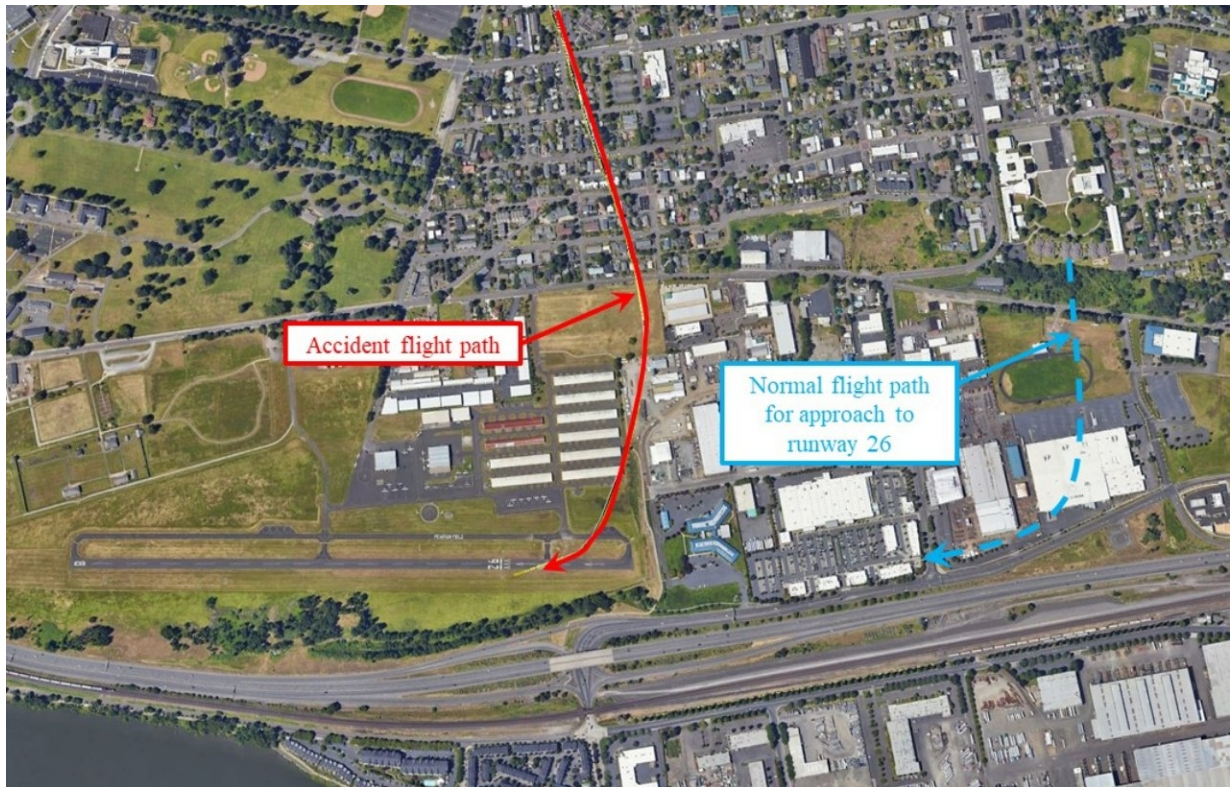
The pilot’s flight logbooks could not be located. A friend who had flown at least 30 hours with the pilot in the accident airplane reported that he had helped the pilot purchase the airplane and had given him his most recent flight review. He stated that they normally turned onto the final approach leg of the traffic pattern over a large white building (about a 0.5 nm distance from the runway). He further remarked that he had previously taught the pilot normal and accelerated stalls in the accident airplane.

Figure 1: Accident flight path versus pilot's usual flight path to runway 26

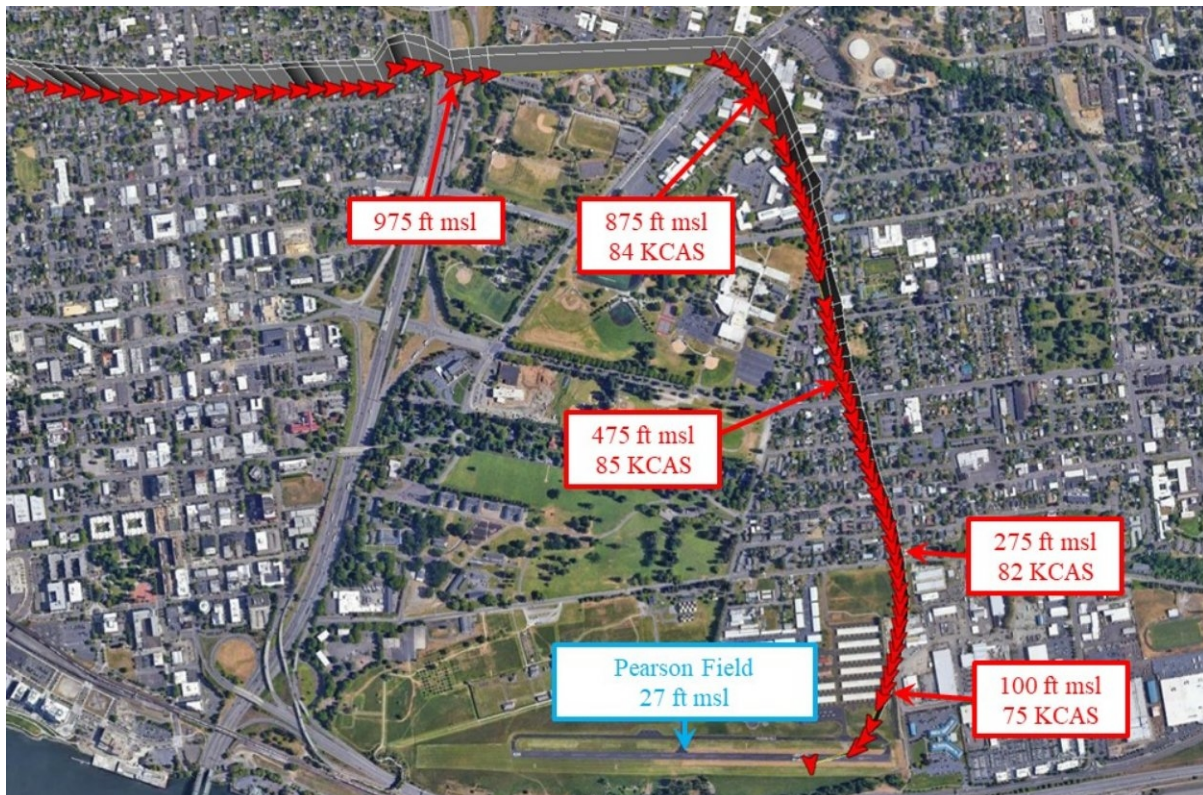
An analysis of the ADS-B data from 0736 to the time of the accident combined with winds aloft data showed that the airplane had an average descent rate of about 1,000 fpm, an average airspeed of about 80 knots calibrated airspeed, bank angles of about 7°, and an average angle of attack of about 5° on the base leg of the traffic pattern.

Figure 2: Airplane's flight path with altitude and airspeeds

The airplane's stall speed was computed using the stall chart from the airplane POH. The stall chart incorporates a maximum bank angle of 60°, which the airplane exceeded during its turn to final approach. According to the stall chart, the airplane's stall speed as it turned to final approach would have been exceeded 80 kts. An analysis of the ADS-B data showed that the airplane's airspeed at this time would have been about 73 KCAS.
