Aviation Investigation Final Report

Location:	Challis, Idaho	Accident Number:	WPR22LA238
Date & Time:	June 26, 2022, 19:45 Local	Registration:	N1231C
Aircraft:	Piper PA20	Aircraft Damage:	Substantial
Defining Event:	Controlled flight into terr/obj (CFIT)	Injuries:	2 Fatal
Flight Conducted Under:	Part 91: General aviation - Personal

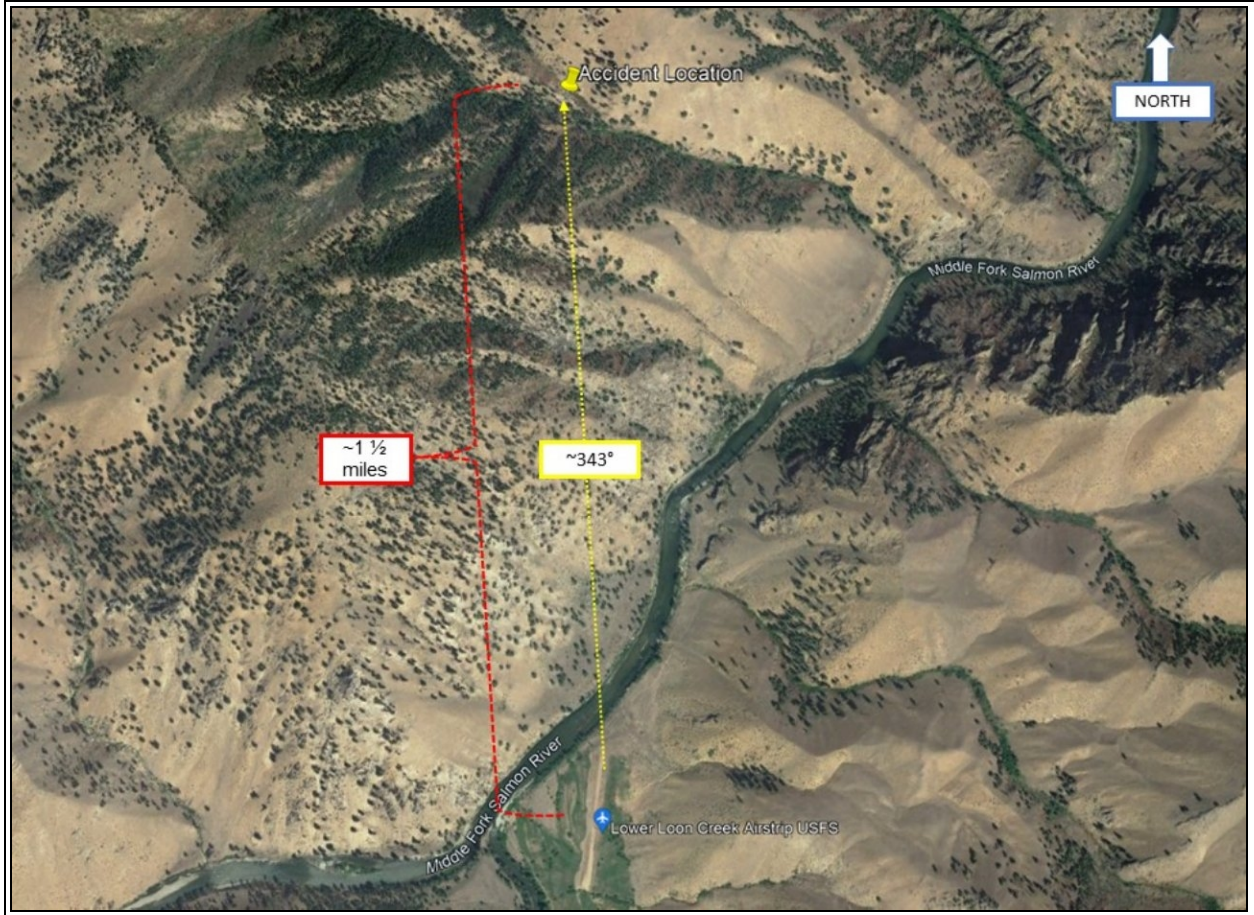
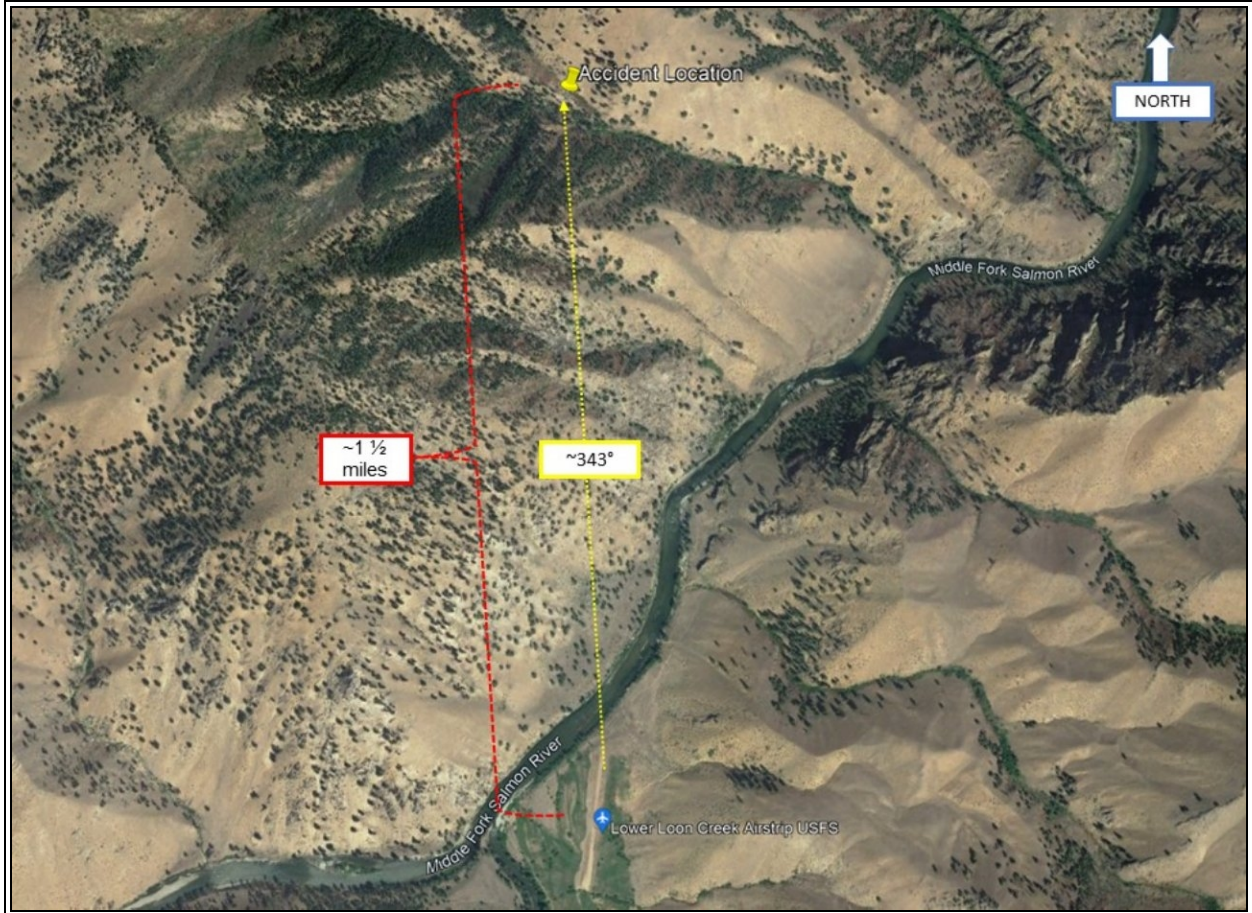
Figure 1: Overview of the accident site location.

The accident site was in a box canyon about 1 1/2 miles north of the airport at an elevation of 6,240 ft above mean sea level (msl). The change in elevation from the departure airport to the accident location was about 2,040 ft. As the airplane climbed, the calculated climb performance from the departure airport to the accident site location would have likely degraded from about 477 ft per minute (fpm) to about 360 fpm. The accident is consistent with the pilot turning toward rising terrain with limited climb performance that resulted in the pilot's failure to maintain obstacle clearance and a subsequent impact with terrain.

First responders located the airplane wreckage by air, about 1 ½ miles north of C53. The airplane impacted steep, rising mountainous terrain at an elevation of about 6,240 ft msl on an approximate southerly heading. The main wreckage came to rest upright about 30 ft below the initial impact point and was mostly consumed by fire. All major structural components of the airplane were observed at the accident site.
