# Aviation Investigation Final Report

<b>Location:</b>	Boulder City, Nevada	<b>Accident Number:</b>	WPR22FA240
<b>Date &amp; Time:</b>	July 3, 2022, 08:49 Local	<b>Registration:</b>	N343BH
<b>Aircraft:</b>	EXTRA FLUGZEUGBAU GMBH EA 300/L	<b>Aircraft Damage:</b>	Destroyed
<b>Defining Event:</b>	Aerodynamic stall/spin	<b>Injuries:</b>	1 Fatal
<b>Flight Conducted Under:</b>	Part 91: General aviation - Personal

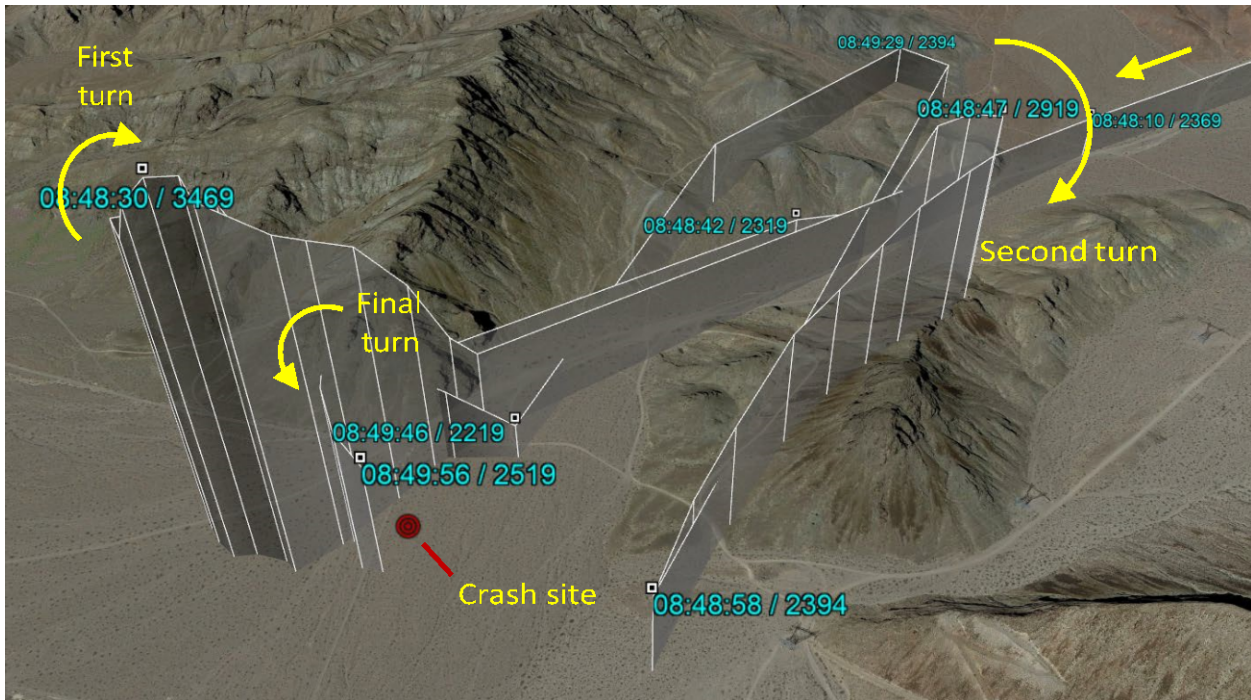
Figure 1:

Three turn reversals were accomplished. On the first turn maneuver, the climb rate was nearly 15,000 fpm and the descent rate more than 10,000 fpm. Additionally, the load factor peaked about 3 g. On the second turn maneuver, the climb rate was about 8,000 fpm and the descent rate was about 5,000 fpm. On the third, and final turn maneuver, when the accident occurred, the climb rate was about 6,500 fpm and the descent rate was about 6,800 fpm. During the peak altitude of the maneuvers, the airplane's roll angles exceeded 90° and the airspeed was close to the stall speed on the first and last turn maneuvers.

During portions of the maneuvers near the end of the flight, the airplane was less than 200 ft above ground level. The last flight data point indicated that the airplane's altitude was about 2,519 ft msl and was at a ground speed of 48 knots. Subsequently, the airplane impacted desert terrain at an elevation of about 2,050 ft msl. A postimpact fire consumed most of the wreckage.

View of the maneuvers looking southwest. Times and altitudes (msl) are indicated for select points.
