# Aviation Investigation Final Report

| <b>Location:</b> | Topeka, Kansas | <b>Accident Number:</b> | WPR22FA254 |
| <b>Date &amp; Time:</b> | July 16, 2022, 11:53 Local | <b>Registration:</b> | N283S |
| <b>Aircraft:</b> | STUCKY STEVEN D RV-7 | <b>Aircraft Damage:</b> | Substantial |

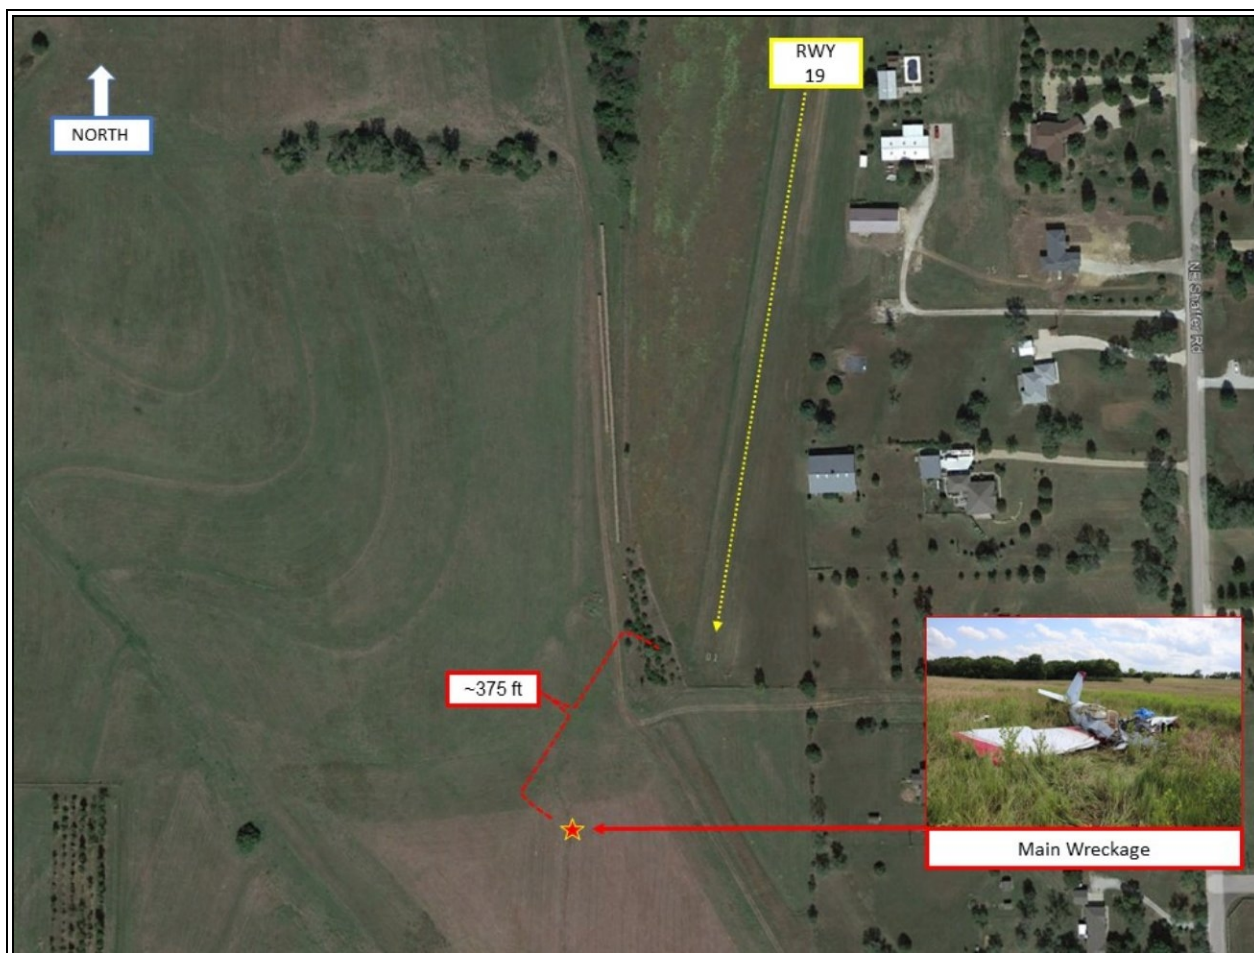
Examination of the accident site revealed that the airplane came to rest upright after it impacted an open grass field about 375 ft southwest of the departure end of runway 19. The wreckage came to rest on a heading of about 340° magnetic. No visible ground scars were observed in the area near the wreckage. All major structural components of the airplane were located at the accident location.

Figure 1: View of the accident site diagram.
