Aviation Investigation Final Report

Location:	Chapelle, New Mexico	Accident Number:	CEN22FA317
Date & Time:	July 16, 2022, 19:20 Local	Registration:	N911SZ
Aircraft:	Bell UH-1H	Aircraft Damage:	Destroyed
Defining Event:	Powerplant sys/comp malf/fail	Injuries:	4 Fatal
Flight Conducted Under:	Public aircraft

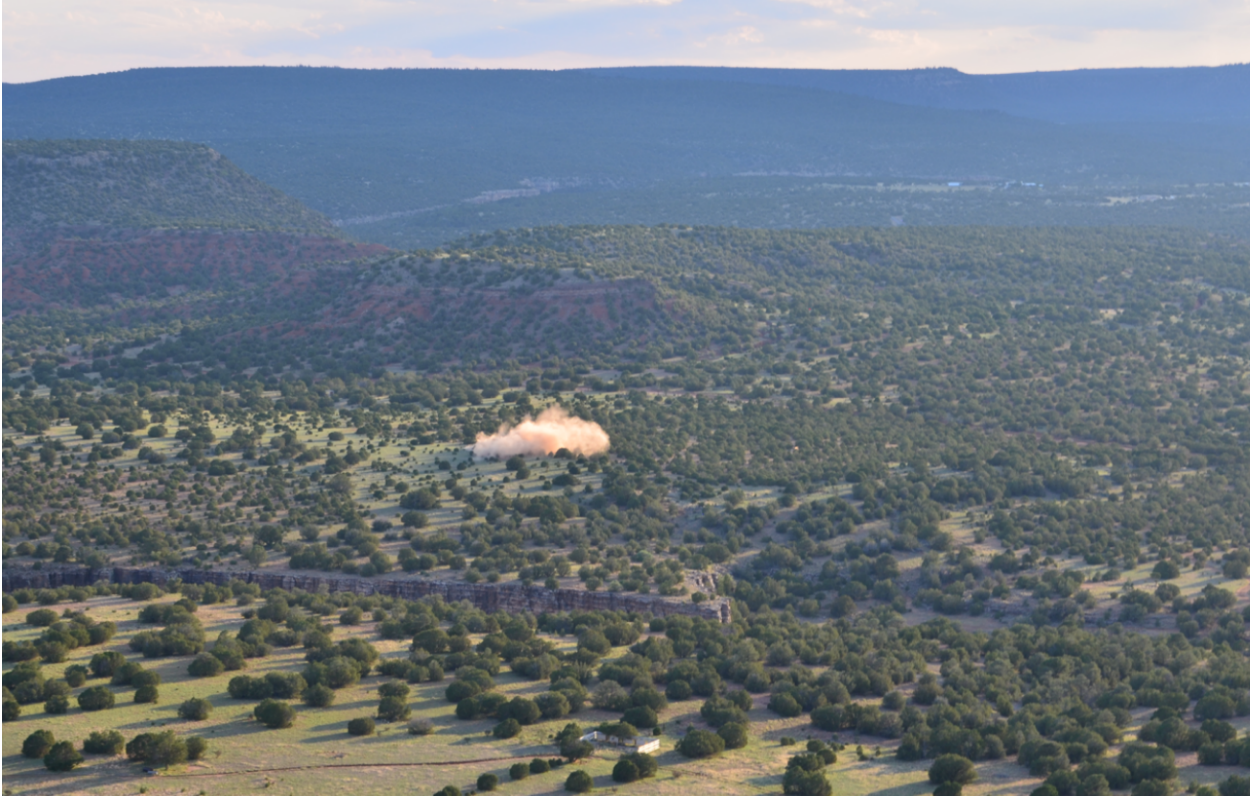
Two witnesses observing the sunset from a ridge about 0.5 mile east of the accident site reported that the helicopter flew past their location westbound, then rapidly descended without making any turns. After the helicopter impacted the ground, a large plume of dust was observed. (See photo 1.)

Photo 1. Accident Site Area with Dust from Helicopter (provided by witness)

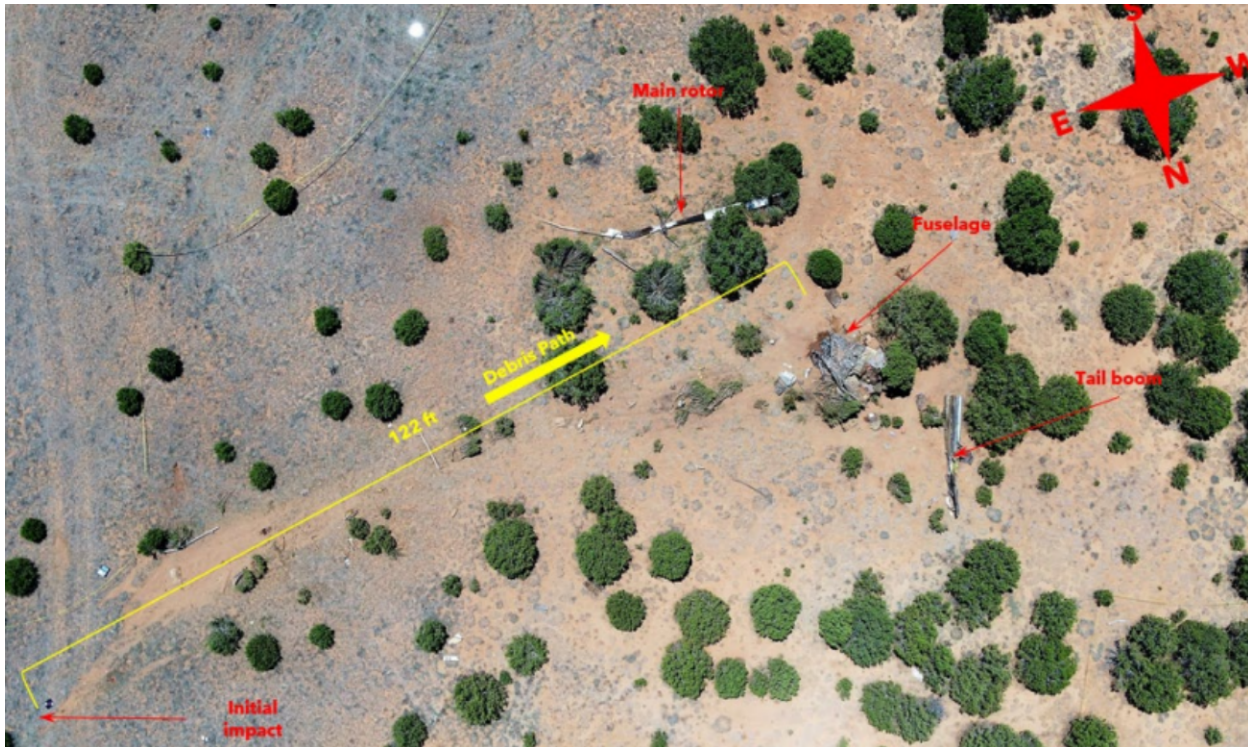
The wreckage was located in high southwestern desert terrain that was populated with scrub juniper bushes. (See photo 2.) The initial impact was identified by disturbed ground in the shape of the helicopter tail and fuselage. The tailboom was crushed and the tail skid "stinger" was bent upwards significantly, consistent with very hard contact with the ground.

The tail boom separated from the main fuselage, both of which were located about 122 ft west of the initial impact. The main rotor was about 40 ft to the left of the main wreckage, with the main rotor mast fractured immediately below the hub. One main rotor blade was minimally

damaged and the other blade was fractured at the spar. The main rotor blade grips had minimal damage.

Photo 2. Wreckage at the accident Site
