# Aviation Investigation Final Report

<b>Location:</b>	North Las Vegas, Nevada	<b>Accident Number:</b>	ERA22FA318
<b>Date &amp; Time:</b>	July 17, 2022, 12:03 Local	<b>Registration:</b>	N97CX (A1); N160RA (A2)
<b>Aircraft:</b>	Piper PA-46-350P (A1); Cessna 172N (A2)	<b>Aircraft Damage:</b>	Destroyed (A1); Destroyed (A2)
<b>Defining Event:</b>	Midair collision	<b>Injuries:</b>	2 Fatal (A1); 2 Fatal (A2)
<b>Flight Conducted Under:</b>	Part 91: General aviation - Personal (A1); Part 91: General aviation - Instructional (A2)

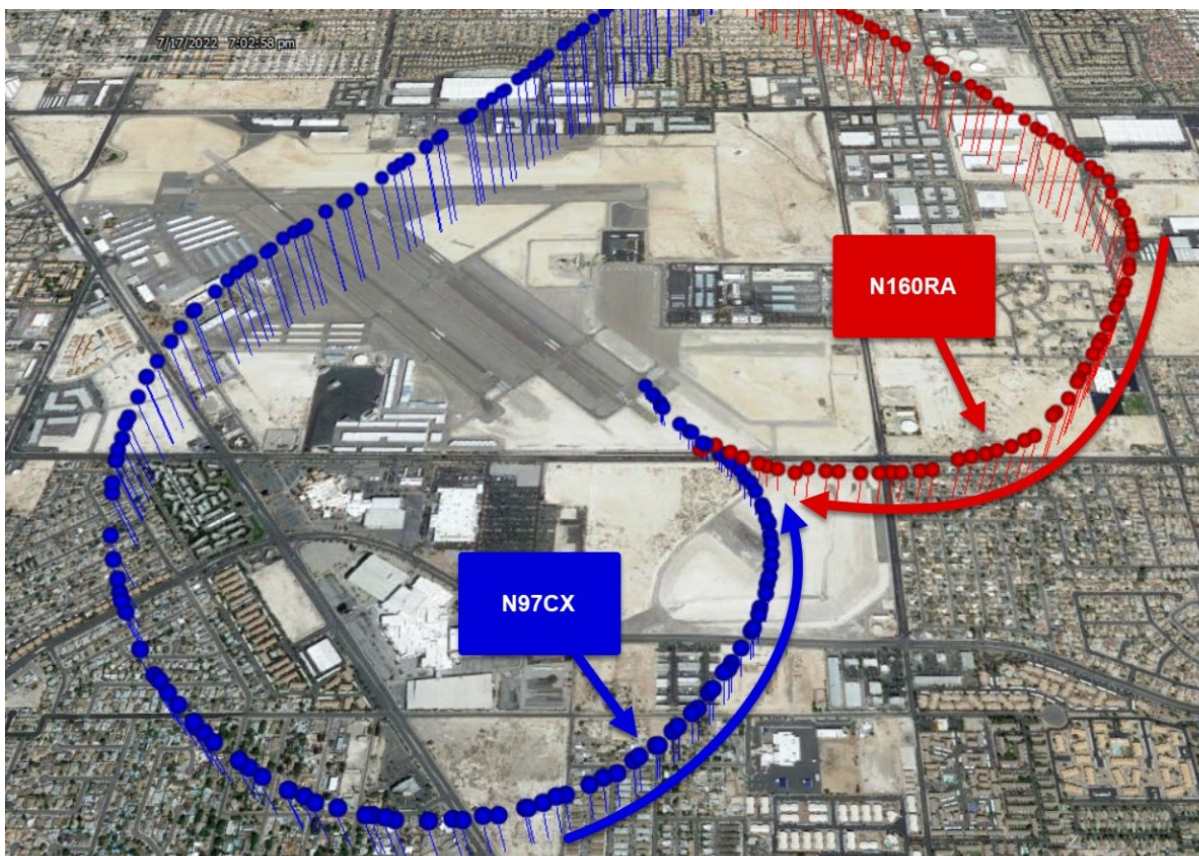
Automatic Dependent Surveillance-Broadcast (ADS-B) flight track data indicated that, after crossing over the runway, the low-wing airplane performed a continuous, descending turn through the final approach path for runway 30L and rolled out aligned with the final approach path for runway 30R. The airplanes collided about ¼ nautical mile from the approach end of the runway.

Review of ADS-B data indicated that, after correctly acknowledging their clearance to land on runway 30L, the low-wing airplane flew a close-in downwind leg and performed a continuous left turn through the final approach path to runway 30L, rolling out of the turn aligned with the final approach path to runway 30R. (See Figure 1.)

Figure 1. Overhead view of airplanes’ flight tracks overlaid on satellite imagery (N97CX, low-wing airplane, N160RA, high-wing airplane).
