Aviation Investigation Preliminary Report

Location:	Las Vegas, NV	Accident Number:	ERA22FA318
Date & Time:	July 17, 2022, 12:04 Local	Registration:	N97CX (A1); N160RA (A2)
Aircraft:	Piper PA 46-350P (A1); Cessna 172N (A2)	Injuries:	2 Fatal (A1); 2 Fatal (A2)
Flight Conducted Under:	Part 91: General aviation - Personal (A1); Part 91: General aviation - Instructional (A2)

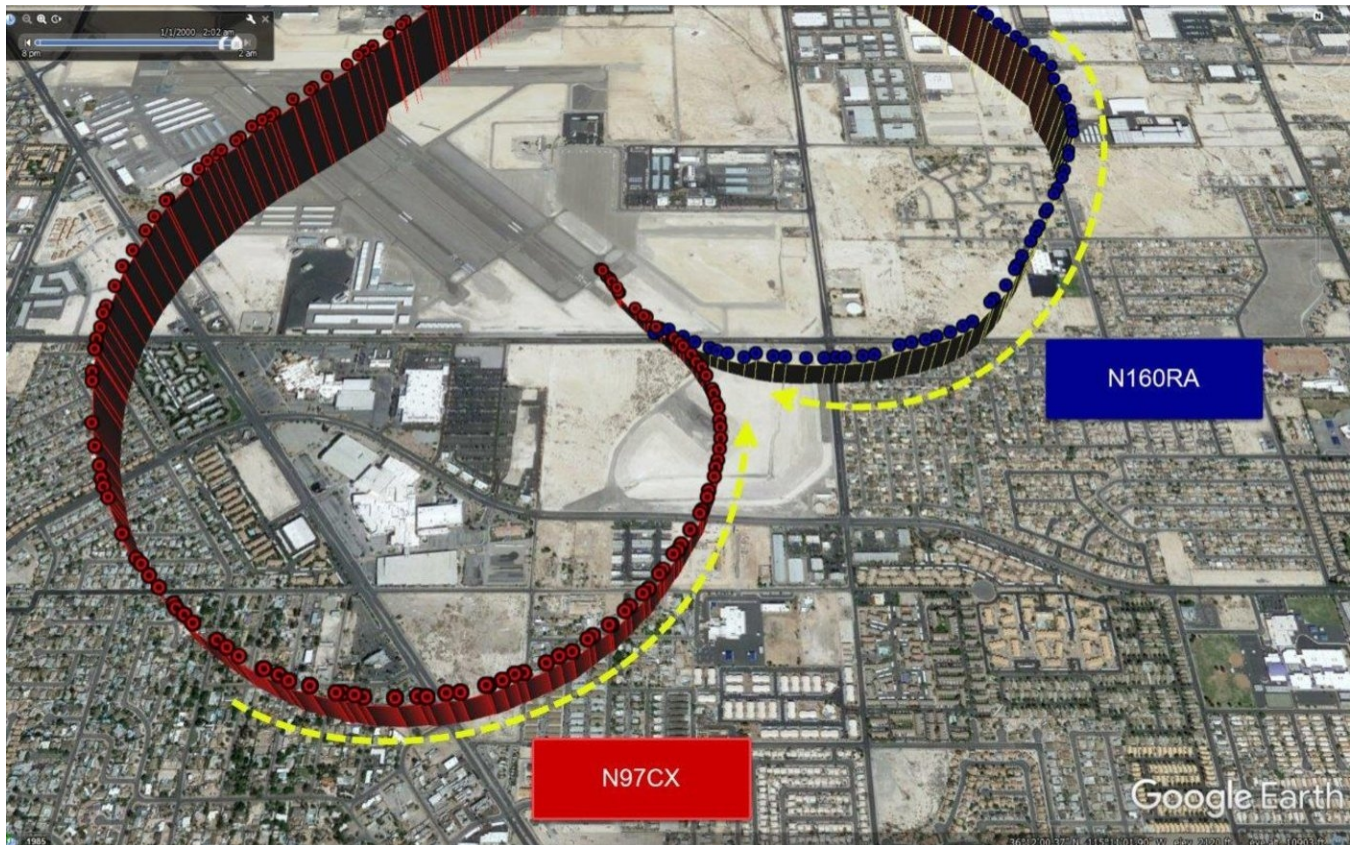
Figure 1. ADS-B Flight Paths for N97CX (PA-46) and N160RA (Cessna 172)

Both airplanes were maneuvering to land at North Las Vegas Airport (VGT), Las Vegas Nevada, when the accident occurred. N97CX had been instructed by air traffic control (ATC) to fly left traffic for runway 30L and N160RA had been instructed to fly right traffic for runway 30R. The airplanes collided about 0.25 nautical miles from the approach end of runway 30R. Figure 1 shows a simplified flight path diagram for the accident flights based on Federal Aviation Administration Automatic Dependent Surveillance – Broadcast (ADS-B) data.
