Aviation Investigation Final Report

Location:	Fallbrook, California	Accident Number:	WPR22FA265
Date & Time:	July 23, 2022, 13:31 Local	Registration:	N787AS
Aircraft:	North American T-28B	Aircraft Damage:	Substantial
Defining Event:	Fuel starvation	Injuries:	1 Fatal, 1 Minor
Flight Conducted Under:	Part 91: General aviation - Personal

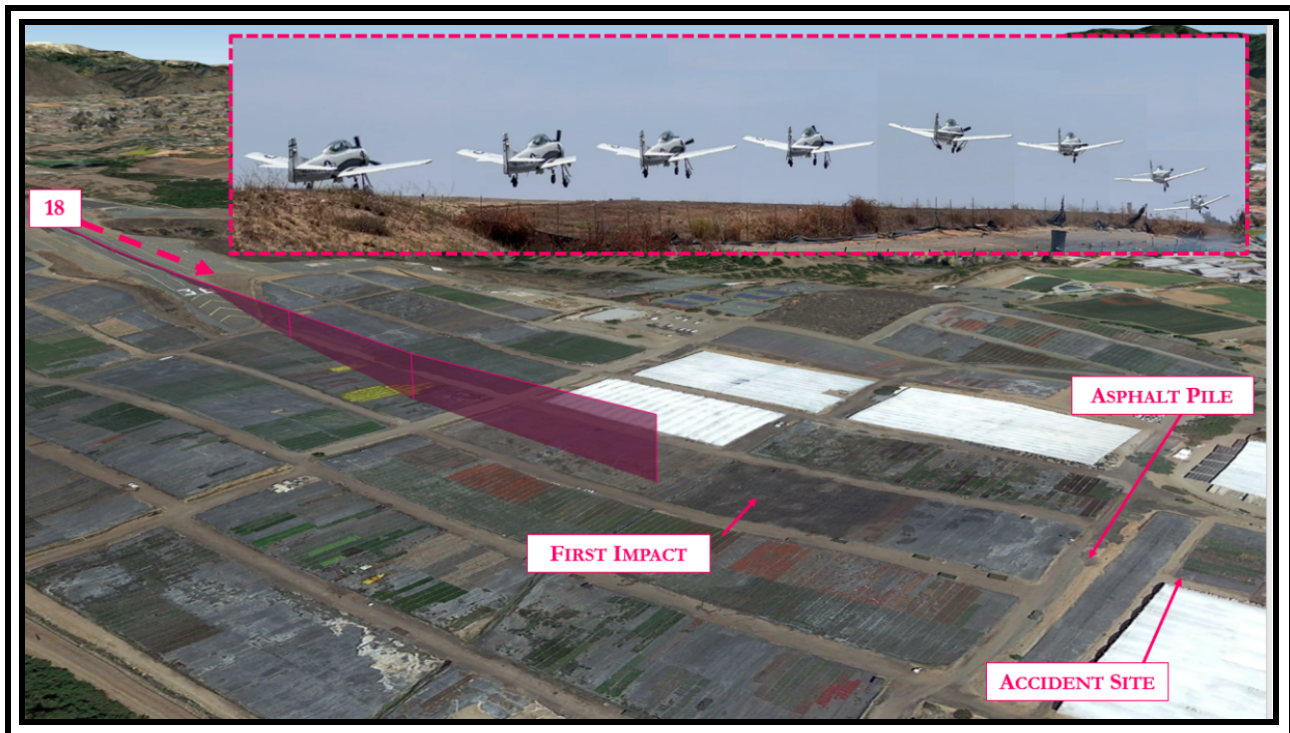
Figure 1: ADS-B Plot with Inset of Video Images of the Takeoff

Investigators reviewed video recordings, audio recordings, and flight track data covering the area of the accident during the time surrounding the accident using automatic dependent surveillance-broadcast (ADS-B) data. A review of the data revealed that the T-28 landed in Fallbrook about 1255. At 1326:01 the airplane taxied to runway 18 and began the takeoff roll at 1331:20. The airplane began the departure roll and was midfield about 12 seconds later at a ground speed of 88 kts. At 1331:44, the airplane was about 300 ft south of the runway identifier markings and the airspeed was 97 knots. The last position recorded was at 1331:49

and located about 160 ft north of the first identified impact point; the airspeed at that point was 94 knots and the airplane was on a heading of about 180° (see Figure 1 below).

A sound spectrum analysis from a witness's recorded cell phone video revealed the engine was idling smoothly about 1,530 rpm. Thereafter, it was running rough for about 10 seconds as it increased its speed to about 2,420 rpm and the airplane was moving along the runway. The engine was then running smoothly for the next 12 seconds as it passed by the camera. The engine then suddenly decreased in rpm, similar to when it was at idle, and the airplane impacted several seconds later.

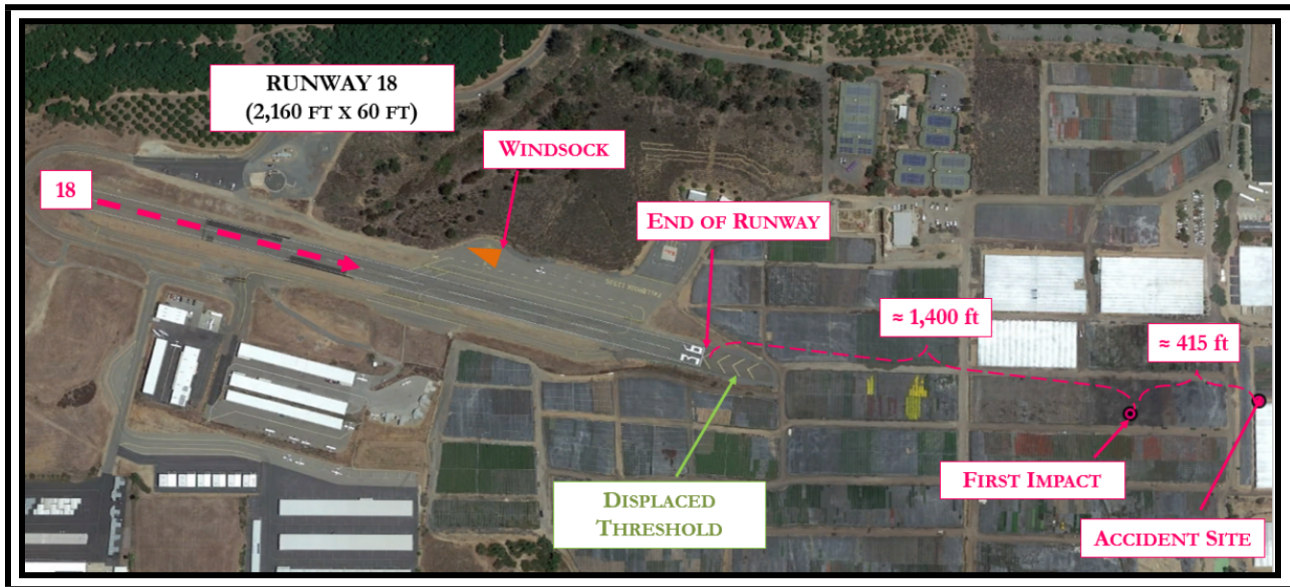
Figure 2: Map of Accident Site

The accident site was located in a nursery about 1,815 feet from the departure end of runway 36. The debris field was located on upsloping terrain with numerous plants in plastic crates and an asphalt pile toward the end. The main wreckage, consisting of the engine and almost all the fuselage, came to rest upright and the right-wing had impacted a greenhouse structure.

The wreckage was found distributed over a 415 ft distance on a median magnetic bearing of about 175° (see Figure 2 below).

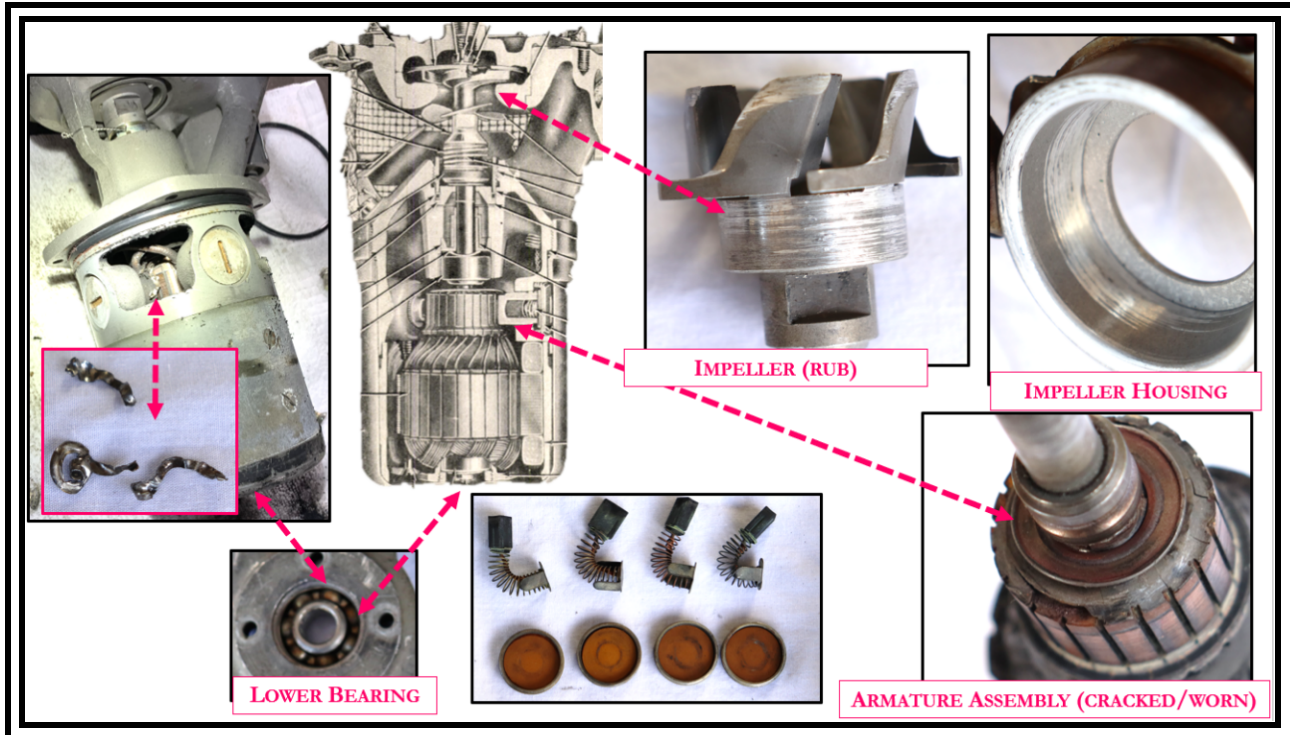
Figure 3: Inside Components of Electric Fuel Pump

Disassembly of the electric fuel pump revealed that metal shavings were lodged in the armature creating a short in the system. The blades on the impeller showed wear consistent with instability of the shaft during rotation. The upper commutator was cracked and showed wear on the upper portion. The pump-end bearing was worn on the outside with the labyrinth seal, washer, and shims deformed. The bearing cage was determined to be the metal pieces shorting out the armature.

The header tank contained trace amounts of fuel and the electronic fuel boost pump was intact. Investigators' efforts to obtain continuity of the electronic fuel pump revealed that there was a short with the electronic connector box on the pump. The box contained a copper jumper between two posts (presumably high and low setting). Disassembly of the electronic fuel pump revealed that metal shavings were lodged in the armature creating a short in the system. The blades on the impeller showed wear consistent with instability of the shaft during rotation. The upper commutator was cracked and showed wear on the upper portion. The brushes appeared normal.

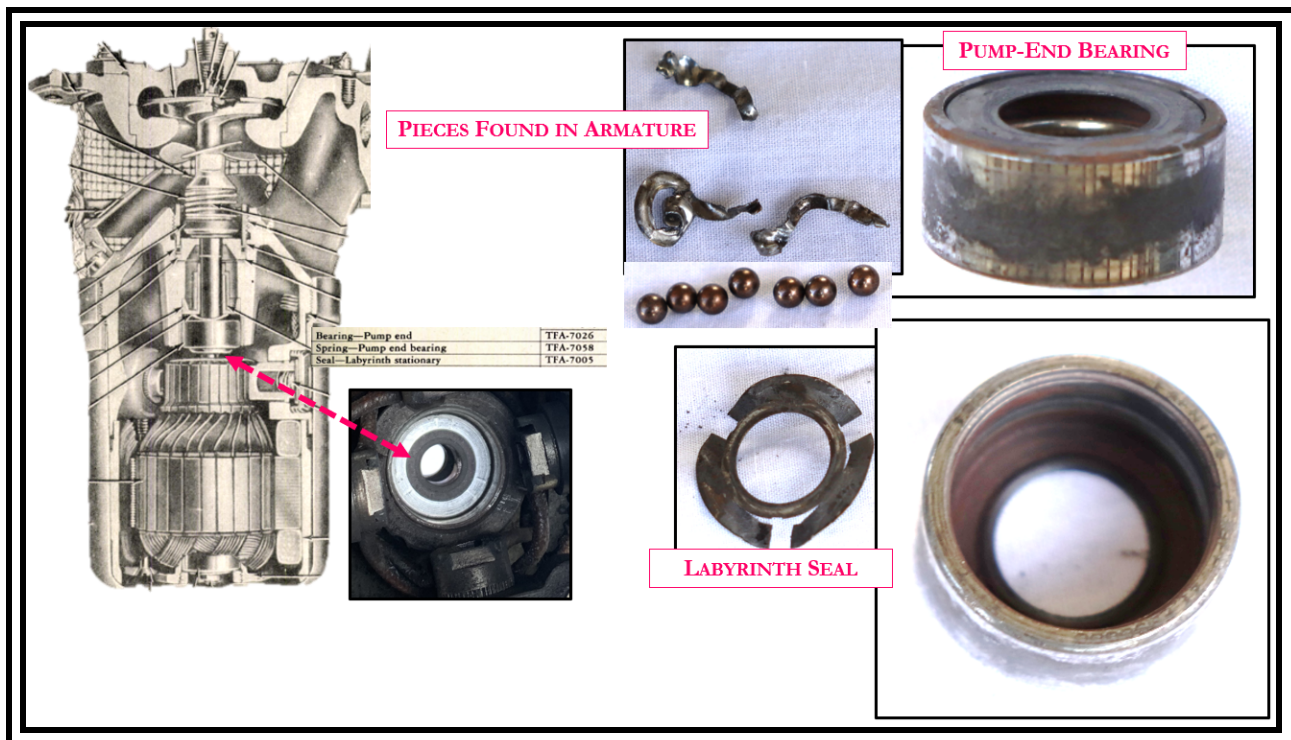
Figure 4: Pump-End Bearing and Fragments Inside the Pump

Further disassembly revealed that the pump-end bearing was worn on the outside with the labyrinth seal, washer, and shims deformed. The bearing cage was absent. Further examination of the metal pieces in the armature revealed that they were shaped with rounded lips consistent with being pieces of the bearing cage.
