# Aviation Investigation Final Report

<b>Location:</b>	Tryon, Nebraska	<b>Accident Number:</b>	WPR22FA266
<b>Date &amp; Time:</b>	July 25, 2022, 08:39 Local	<b>Registration:</b>	N192MH
<b>Aircraft:</b>	HOLLAND MIKE RV9A	<b>Aircraft Damage:</b>	Destroyed
<b>Defining Event:</b>	Loss of control in flight	<b>Injuries:</b>	2 Fatal
<b>Flight Conducted Under:</b>	Part 91: General aviation - Personal

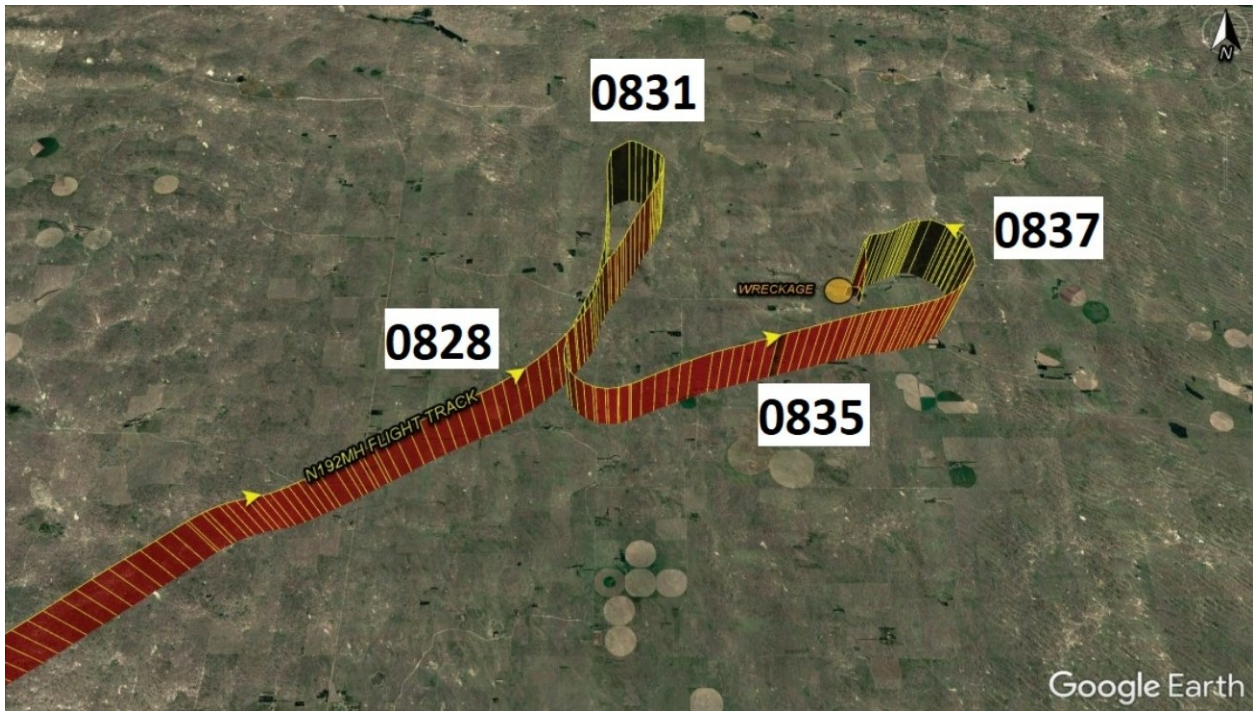
Figure 1 – Flight Track

At 0837, the pilot reported they were at 12,300 ft and "still in the soup." The airplane remained at that altitude about 90 seconds before the airplane started a descending left-hand turn. The following 20 seconds of radar data indicated that the airplane descended about 4,800 ft and accelerated past its maximum airspeed of 182 knots TAS to about 249-264 knots TAS before the radar data ended (see figures 1 and 2).

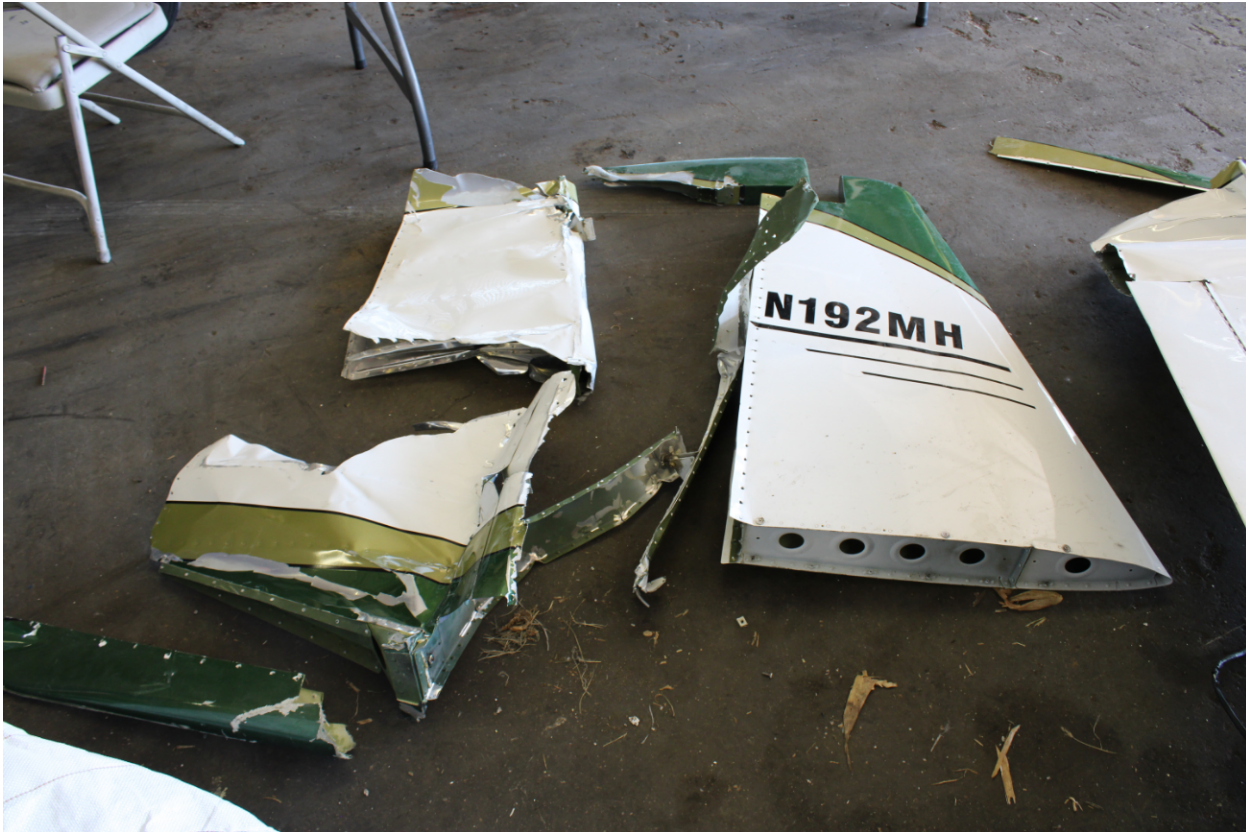
The vertical stabilizer separated mostly intact from the empennage. The front spar was fractured and deformed aft at the fracture location. The rear spar was pulled from the vertical stabilizer and the vertical stabilizer skins were splayed open. The rudder was separated and fractured into 5 pieces. The rudder counterweight was separated from the top of the rudder. The upper half of the rudder was mostly intact, but the riveted trailing edge was splayed open. A section of the left center rudder skin was recovered separately, and a section of the right center rudder skin was not recovered. The lower section of rudder remained attached to the vertical stabilizer rear spar at the center hinge. The vertical stabilizer rear spar had diagonal buckling damage along most of its length. The upper rudder hinge plates were pulled from the spar and the upper half of the spar was deformed and twisted to the right. The lower rudder cap was separated.

Figure 3 - Separated vertical stabilizer and rudder.

The observed damage was consistent with structural failure initiated by flutter of the rudder and no anomalies were found during examinations of the wreckage.
