Aviation Investigation Final Report

Location:	Huntington Beach, California	Accident Number:	WPR22LA268
Date & Time:	July 22, 2022, 13:30 Local	Registration:	N3666K
Aircraft:	Piper J3C-65	Aircraft Damage:	Substantial
Defining Event:	Fuel starvation	Injuries:	1 Minor
Flight Conducted Under:	Part 91: General aviation - Banner tow

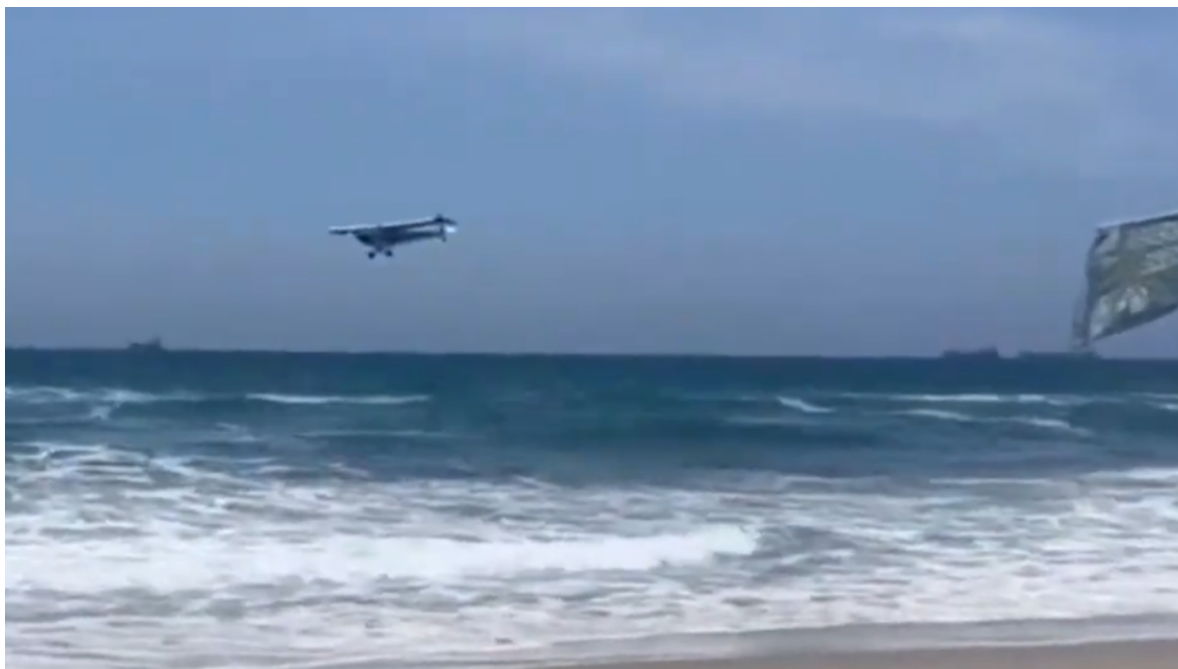
A video, courtesy of a local news agency, revealed an airplane, towing a banner, as it descended to the water. (See figure 1.) The airplane impacted nose-first and came to rest with the fuselage submerged and the wings floating on the water. According to the operator, the banner was 40 ft by 80 ft and weighed about 55 to 60 pounds.

Figure 1. Image captured from a video showing the accident airplane as it descended to the water. Photo courtesy of KESQ.
