Aviation Investigation Final Report

Location:	Livermore, California	Accident Number:	WPR22LA287
Date & Time:	July 30, 2022, 08:00 Local	Registration:	N2591V
Aircraft:	Cessna 177RG	Aircraft Damage:	Substantial
Defining Event:	Loss of engine power (total)	Injuries:	1 None
Flight Conducted Under:	Part 91: General aviation - Personal

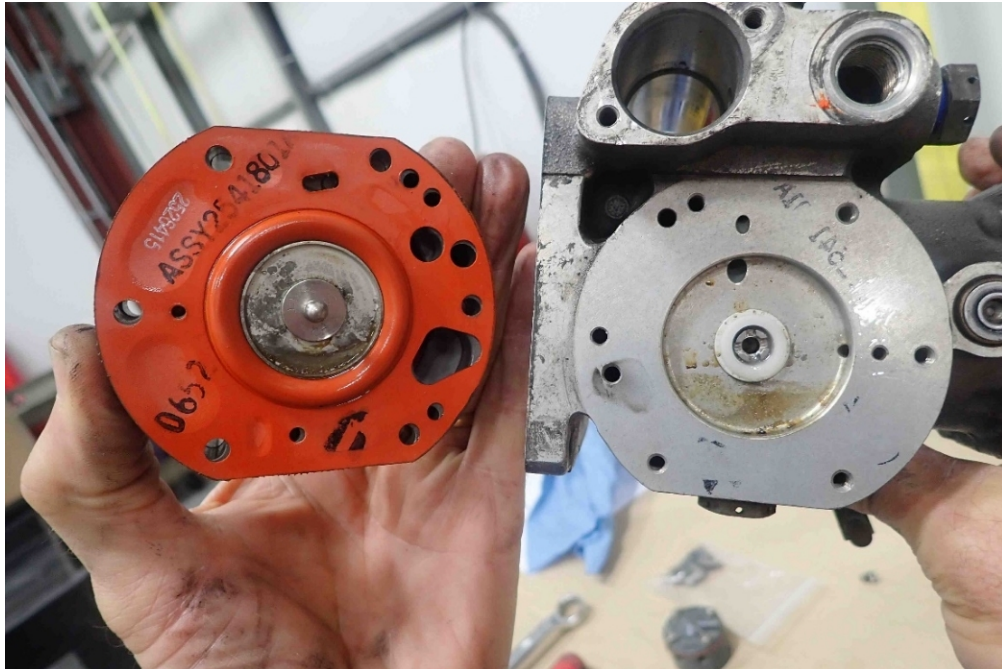
However, disassembly of the fuel injection servo revealed significant internal corrosion and corrosion deposits throughout. The diaphragm cavities displayed “water lines” and corrosion on the metered and unmetered fuel sides, consistent with water contamination (figures 1 and 2). Corrosion deposits were present in the servo valve seat cavity and in the mixture control assembly (figures 3 and 4).

Figure 1 - Water line and corrosion on metered side

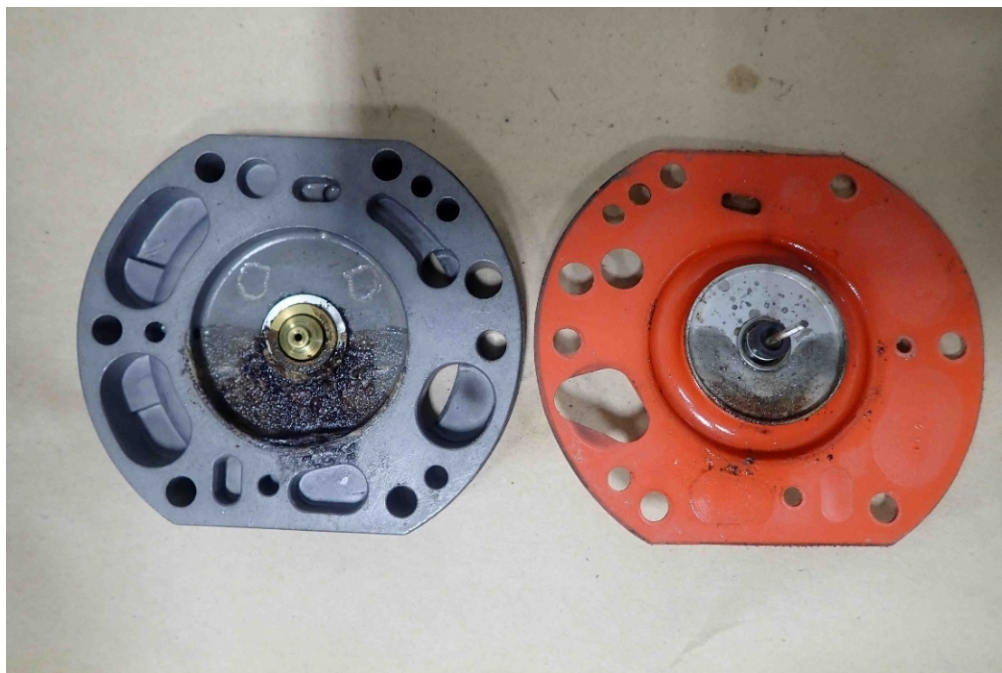
Figure 2 - Water line and corrosion on unmetered side

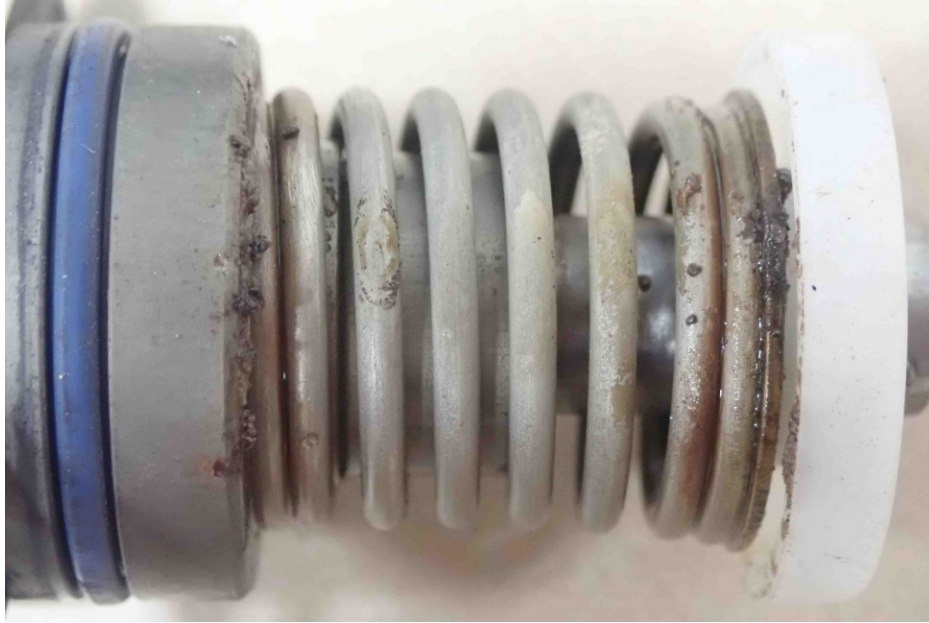
Figure 3 - Corrosion deposits on the lower side of the mixture control spring

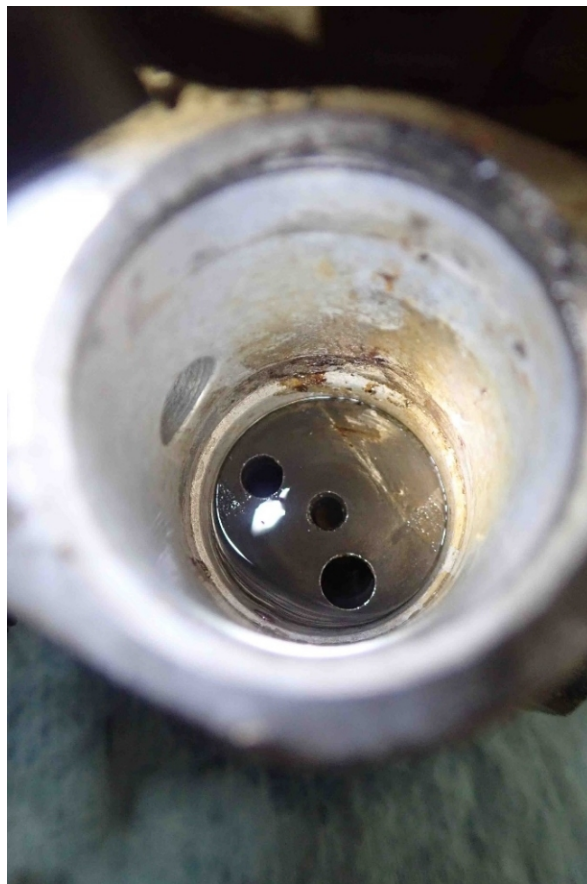
Figure 4 - Corrosion on the surfaces of the idle and mixture valve housing bore
