Aviation Investigation Final Report

Location:	Camarillo, California	Accident Number:	WPR22LA310
Date & Time:	August 18, 2022, 13:40 Local	Registration:	N995GS
Aircraft:	STUCKER GARY BANTY	Aircraft Damage:	Substantial
Defining Event:	Loss of control in flight	Injuries:	1 Serious
Flight Conducted Under:	Part 91: General aviation - Personal

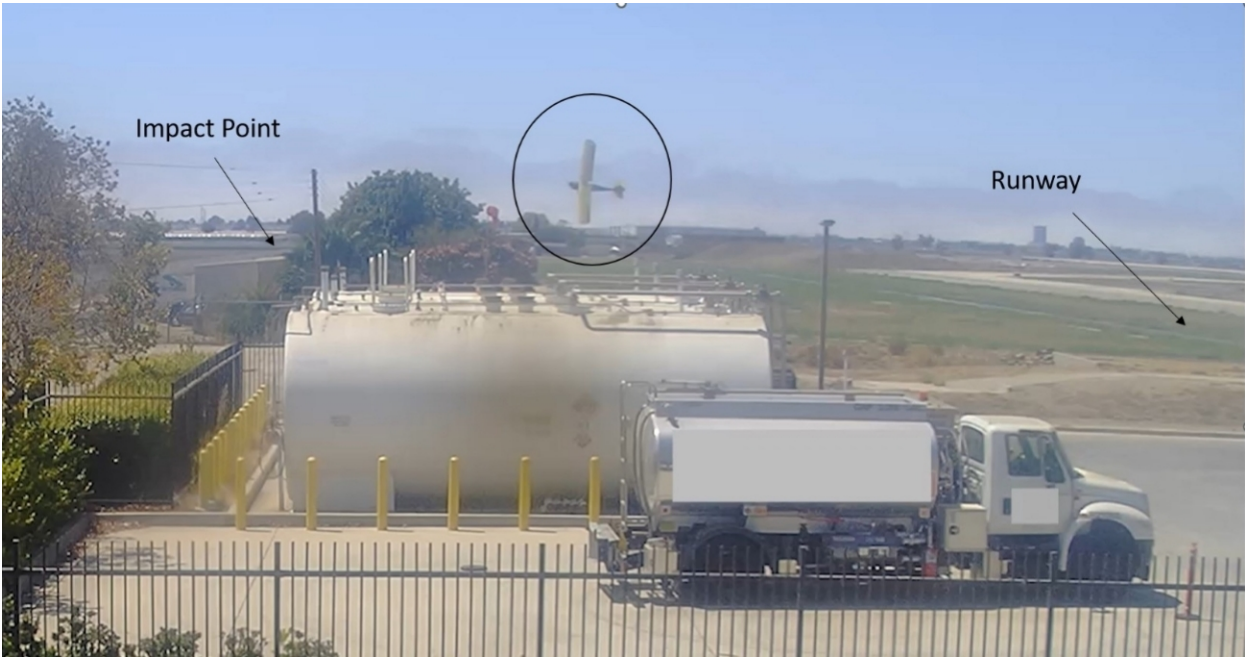
Figure. Picture of Takeoff (Security Video Capture)

Airport security video captured the airplane as it departed to the west from the ultralight runway at Camarillo Airport. The airplane became airborne and began an immediate climbing left turn. The airplane climbed to about treetop level, with an increase in bank angle to greater than 60° as the airplane completed about 90° of turn (see figure). The airplane then descended from view behind trees. The wreckage came to rest inverted on top of an airport hangar.
