Aviation Investigation Final Report

Location:	Scio, Oregon	Accident Number:	WPR22FA312
Date & Time:	August 21, 2022, 14:03 Local	Registration:	N184DJ
Aircraft:	JACKSON DENNIS RV-8	Aircraft Damage:	Substantial
Defining Event:	Collision with terr/obj (non-CFIT)	Injuries:	2 Fatal
Flight Conducted Under:	Part 91: General aviation - Personal

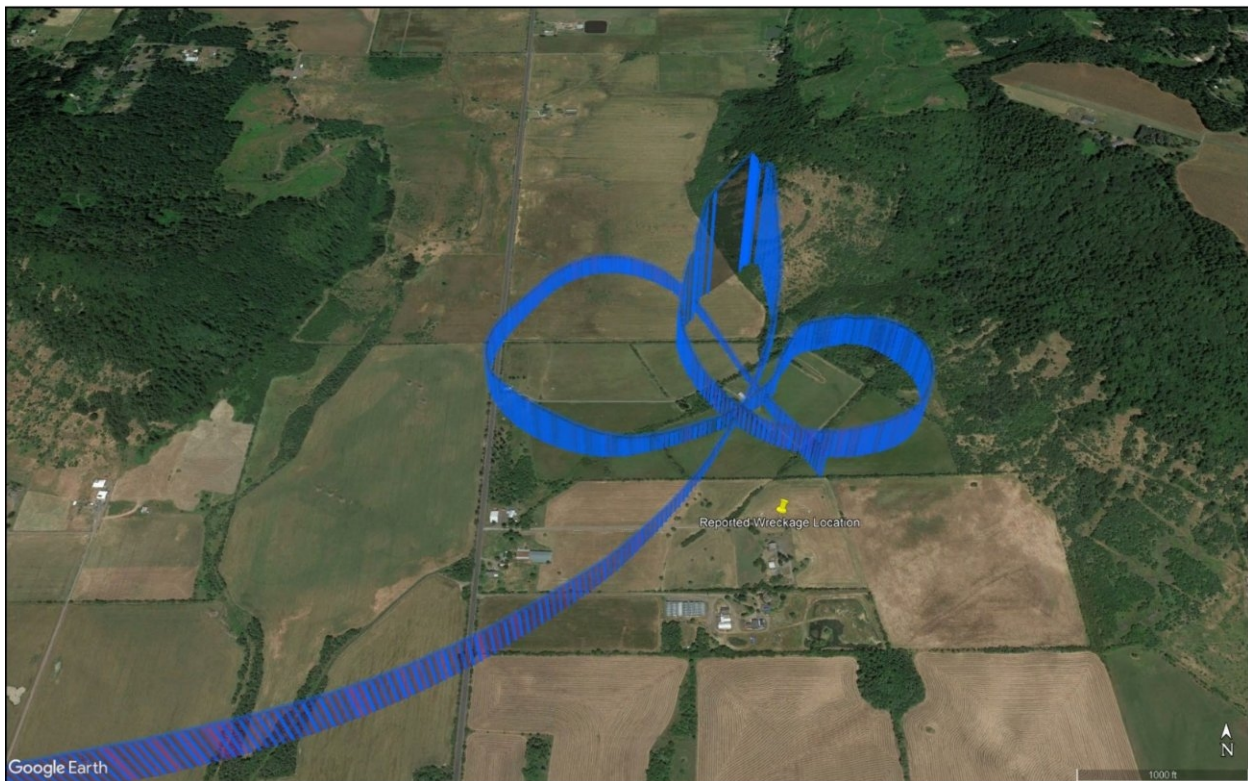
Figure 1. The accident airplane’s flight path.

Relatives of the pilot told investigators the pilot would often conduct low-altitude flights and perform aerobatic maneuvers over their home, and they were aware he was going to overfly their home on the day of the accident. Flight data recovered from a Dynon SV-D1000 unit onboard the airplane showed the airplane departed Albany Municipal Airport (S12), Albany, Oregon, about 1353, and proceeded easterly towards the relative’s home. The airplane then entered the area of the accident from the west to the east and performed a series of maneuvers near the accident site (Figure 1).

The relatives of the pilot observed the airplane make three passes over their home before the accident. The accident occurred during the third pass after the airplane flew over about 100 ft above the ground from north to south. The airplane “rolled like a barrel roll” and then descended out of sight behind trees, where they heard it impact the ground.
