# Aviation Investigation Final Report

<b>Location:</b>	Wilder, Idaho	<b>Accident Number:</b>	WPR22LA314
<b>Date &amp; Time:</b>	August 20, 2022, 18:00 Local	<b>Registration:</b>	N4133S
<b>Aircraft:</b>	Beech F33A	<b>Aircraft Damage:</b>	Substantial
<b>Defining Event:</b>	Loss of engine power (total)	<b>Injuries:</b>	2 Minor
<b>Flight Conducted Under:</b>	Part 91: General aviation - Personal

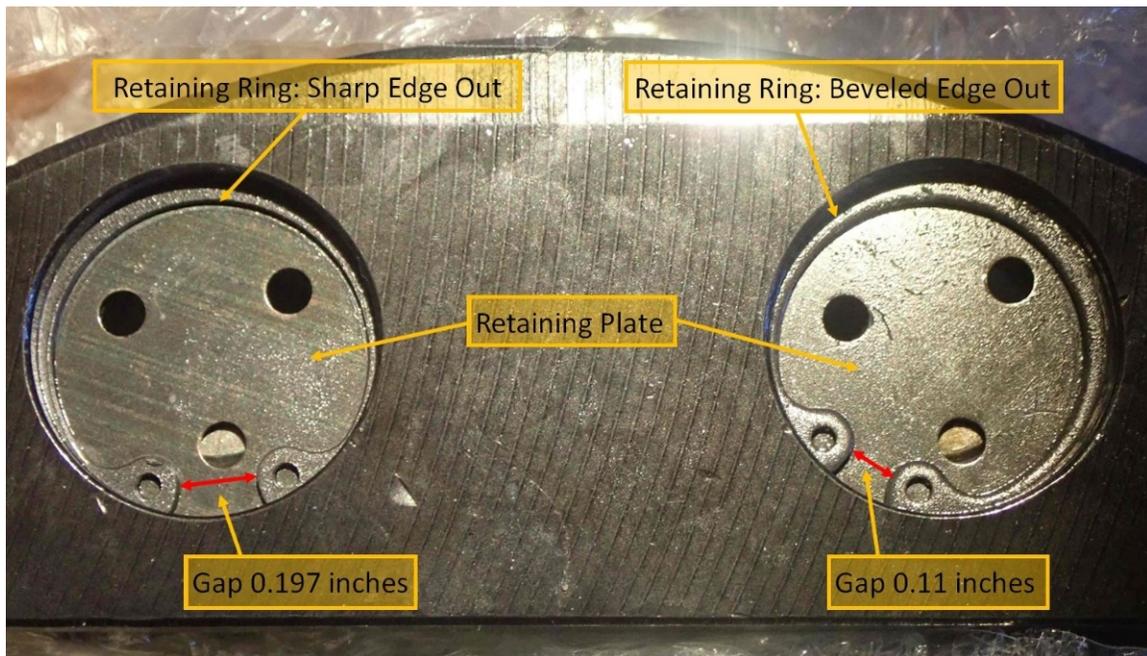
Catastrophic engine failure during the initial climb due to an incorrectly installed crankshaft counterweight retaining ring.

The Continental Maintenance Manual applicable to the engine gives specific instructions for the installation of the counterweight assembly. It states that the retaining rings, which are stamp-cut, have a sharp side and a beveled side, and should be installed with the sharp side out. The retaining ring ears should be installed towards the crankshaft centerline, and to confirm proper fitment after installation the gap between the ears should be no less than 0.179 inches (Figure 1).

**Figure 1 – One of the counterweights with its retaining plates and rings, showing the incorrectly installed ring on the right.**

Examination of the engine revealed that one retaining ring on each of the remaining counterweights was installed incorrectly with the sharp side in, and both had ear-gaps of 0.11 (Figure 1) and 0.14 inches respectively.
