Aviation Investigation Final Report

Location:	Shafter, California	Accident Number:	WPR22FA331
Date & Time:	September 2, 2022, 11:00 Local	Registration:	N5943
Aircraft:	Yakovlev YAK-11	Aircraft Damage:	Destroyed
Defining Event:	Loss of control in flight	Injuries:	1 Fatal
Flight Conducted Under:	Part 91: General aviation - Personal

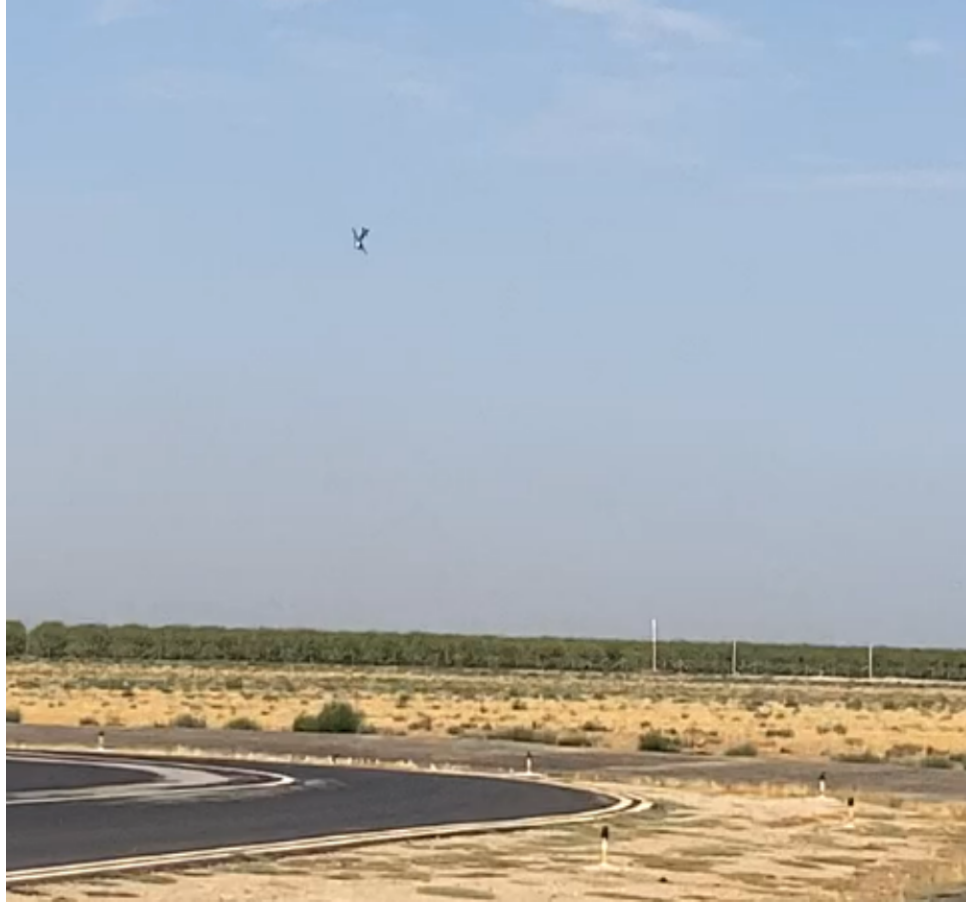
A video of the airplane showed that the airplane was in a left bank attitude during the nose-down dive. The airplane rolled right and pitched up just before impact. The video also showed that the propeller was rotating through the duration of the video.

One witness captured a video of the final moments of the accident sequence. Review of the video showed that at the start of the recording, the airplane was descending rapidly in a steep nose-low, left bank attitude (Figure 1). The airplane began to roll to the right and pitch upward, until just before impact, when the airplane rolled slightly left. Throughout the video, the propeller was observed rotating.

Figure 1: A capture of the start of the witness-provided video.

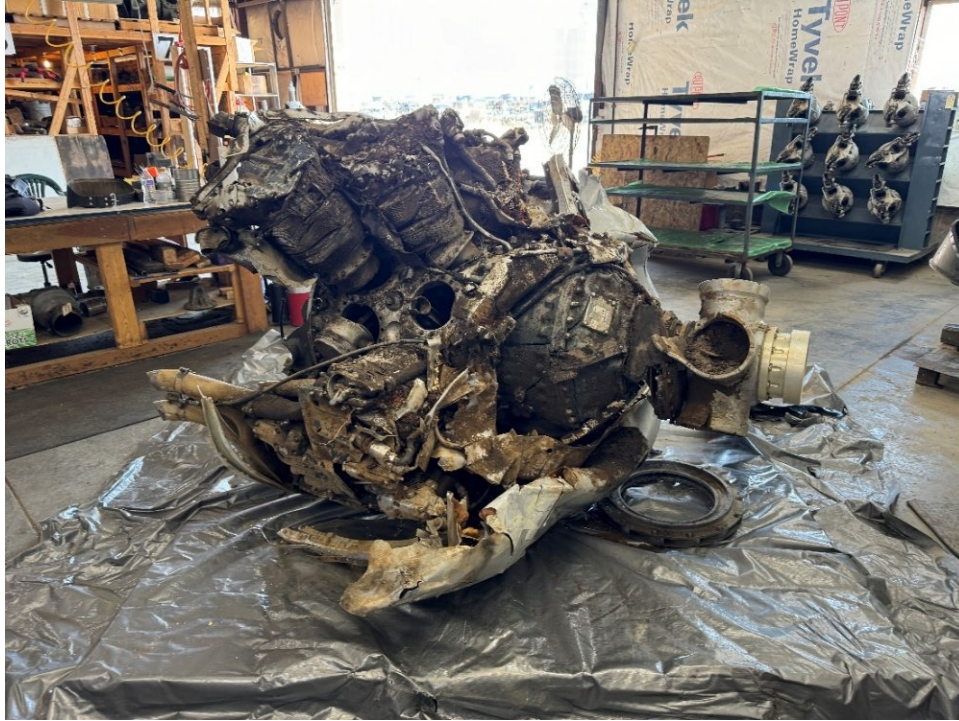
The induction system and exhaust exhibited varying degrees of impact damage. Cylinder Nos. 8 and 9 were impact damaged. Cylinder Nos. 12 and 13 were separated. Cylinder Nos. 10, 11, and 14 were partially attached. The front case and front accessory case was cracked in various locations, consistent with impact damage.

Figure 2: Forward section of the engine with the area of impact damage and displaced cylinders.

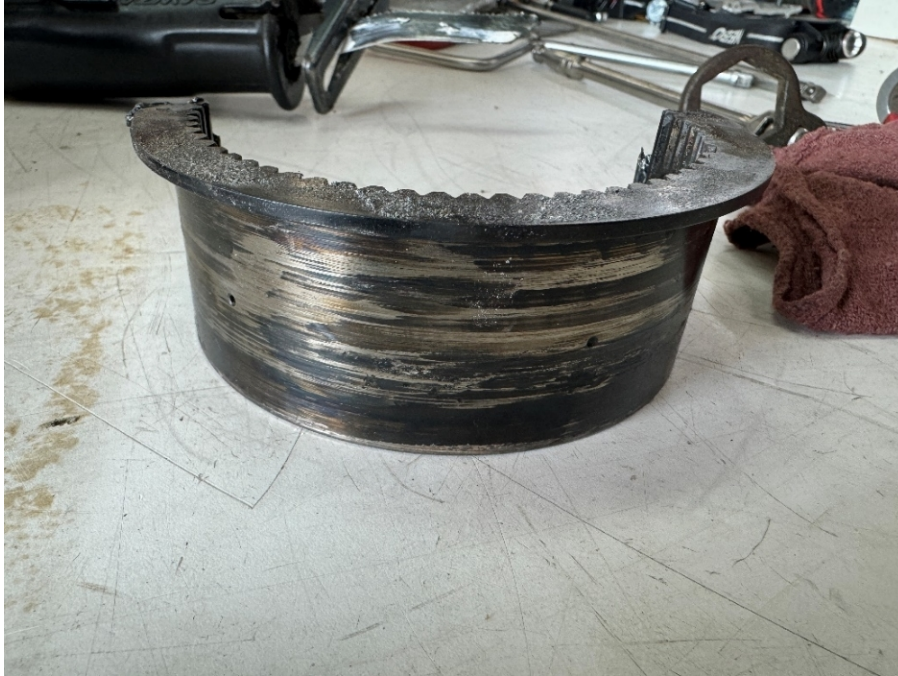
Postaccident examination of the engine revealed that the front and rear counterbalances and counterbalance bearings were thermally discolored consistent with abnormal wear. The front secondary counterbalance bearing failed and was fused to the crankshaft. The rear counterbalance bearing exhibited severe scoring and displaced bearing material. An abundance of metallic debris was located throughout the engine and oil system, including the scavenge pump filter, engine oil filter, and sump plug.

The front case and propeller shaft were removed from the main case. Metallic fragments were observed throughout the front case. Fragments of the front secondary counterbalance bearing was observed on the front case side of the main case. Thermal discoloration of the front secondary counterbalance assembly was observed. The front secondary counterbalance bearing was fused to the crankshaft. The bearing was cut off using a cutting torch. Portions of the removed bearing exhibited thermal discoloration and scoring along the outer area of the bearing.

Figure 3: Portion of the front secondary counterbalance bearing.

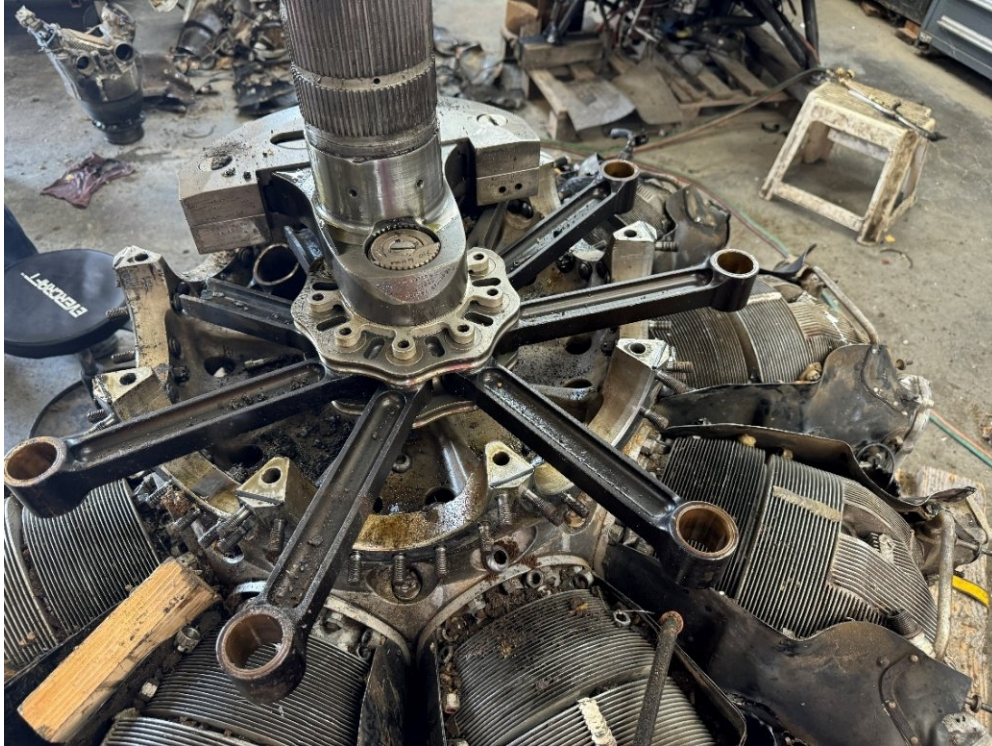
The front cylinders (cylinder Nos. 1, 3, 5, 7, 9, 11, 15, 17) were removed along with the forward section of the main case. The pistons on cylinder Nos. 1, 3, 5, 7, 9, 11, 15, and 17, exhibited light scoring on the piston skirts; however, were otherwise unremarkable. The front link rods and master rod moved freely once the cylinders and pistons were removed. No thermal discoloration was observed on the master rod or link rods. No visible areas of thermal discoloration were observed on any of the rear cylinder link rods, or master rod. The front crankshaft bearing and counterweight were unremarkable.

Figure 4: View of the front link rods, master rod, and crankshaft bearing assemblies.
