Aviation Investigation Final Report

Location:	Mount Baldy, California	Accident Number:	WPR22LA333
Date & Time:	September 4, 2022, 07:57 Local	Registration:	N687AM
Aircraft:	Bell 407	Aircraft Damage:	Substantial
Defining Event:	Loss of control in flight	Injuries:	1 Serious
Flight Conducted Under:	Part 91: General aviation - Other work use

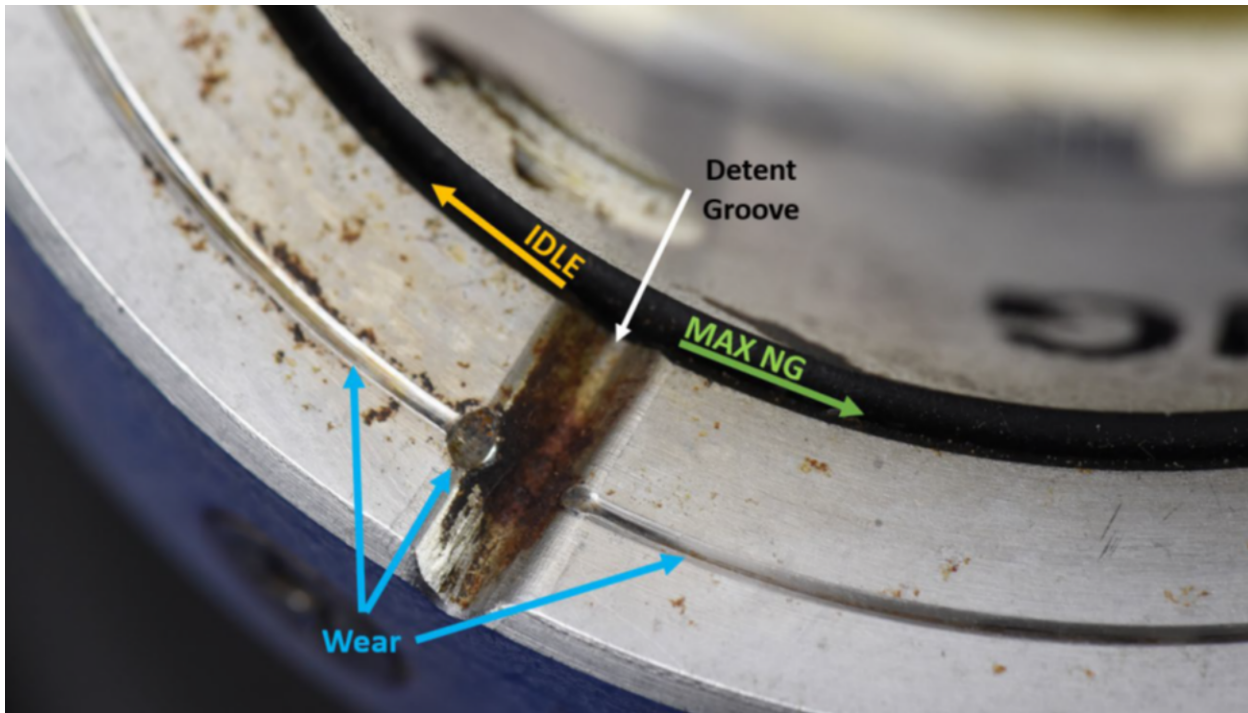
throttle through the FLY detent position. Disassembly of the collective assembly revealed the detent where the ball plunger in the throttle engages at the FLY position was worn, which likely reduced the force required to move the throttle out of the FLY position towards IDLE. No other preimpact anomalies were found with the engine or airframe systems.

The accident is consistent with the pilot not ensuring the throttle was in the FLY detent position as the helicopter made an approach to land which resulted in reduced engine power, a low main rotor RPM condition, and subsequent impact with terrain. The worn throttle detent bracket likely contributed to the pilot unknowingly rolling the throttle towards idle prior to commencing the approach to land and subsequently not recognizing that the throttle had moved.

The pilot's failure to ensure the throttle was properly positioned before commencing an approach to land, which resulted in a low rotor rpm condition and impact with terrain. Contributing to the accident was a worn throttle detent.

The collective stick was disassembled, and the throttle assembly was examined. Wear was evident where the ball plunger in the throttle control engaged the detent bracket (Figure 1). No other preimpact anomalies were found with the engine or airframe systems.

Figure 1. Collective detent bracket wear. (Source: Bell)

Maintenance records indicated the throttle friction should have been verified in accordance with the manufacturer's recommended inspection schedule and maintenance procedures. The procedures directed maintenance personnel to set throttle friction to the appropriate amount by adjusting the ball plunger on the throttle. Although the ball plunger disengaged from the FLY position detent in postaccident testing with less force than specified by the manufacturer, it could not be determined if maintenance personnel did not properly adjust the ball plunger in accordance with the manufacturer's specified procedures, or if the worn detent reduced the ability of the ball plunger to maintain the correct torque after being set properly. Although the maintenance procedures did not require inspection of the throttle detent, if the specified throttle friction forces were unable to be achieved during the inspection, this should have provided the opportunity necessary for maintenance personnel to identify and correct the worn throttle detent.

The throttle friction adjustment procedures direct maintenance personnel to adjust the throttle friction by verifying the condition of the ball plunger and adjusting the depth of the ball plunger to apply pressure to the throttle bracket at the detent to achieve the specified friction. Neither the throttle Friction Check nor the throttle Friction Adjustment procedure specifies a check for wear at the FLY detent position.
