Aviation Investigation Final Report

Location:	Santa Monica, California	Accident Number:	WPR22FA338
Date & Time:	September 8, 2022, 16:26 Local	Registration:	N126WK
Aircraft:	CZECH SPORT AIRCRAFT Piper Sport	Aircraft Damage:	Destroyed
Defining Event:	Abrupt maneuver	Injuries:	2 Fatal
Flight Conducted Under:	Part 91: General aviation - Instructional

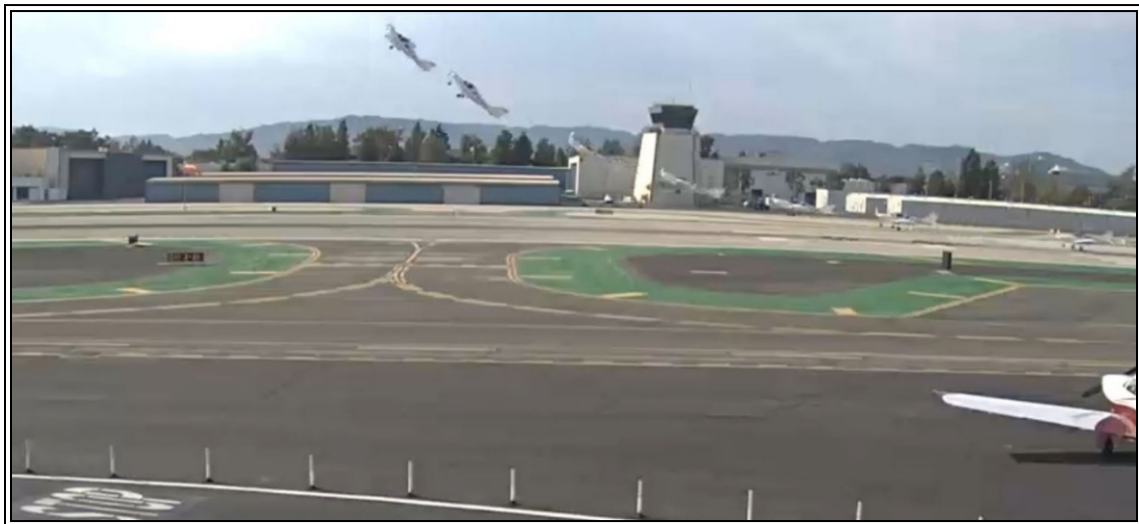
the airplane descending over the runway threshold markings at an altitude of about 25 ft agl and then passing to the left and out of the camera's field of view. A second camera, similarly positioned but facing northwest, captured the other end of the runway threshold markings. As the airplane came into view, the main landing gear was already on the ground and the airplane then began to climb in a slightly nose-up attitude. Over the next three seconds, the airplane pitched up to an almost vertical attitude and climbed out of the camera's field of view (see Figure 1). The shadow of the airplane on the runway surface indicated that it continued to climb for another two seconds before descending and striking the ground about 5 seconds later (see Figure 2).

Figure 1 – Composite video image of pitch-up maneuver.

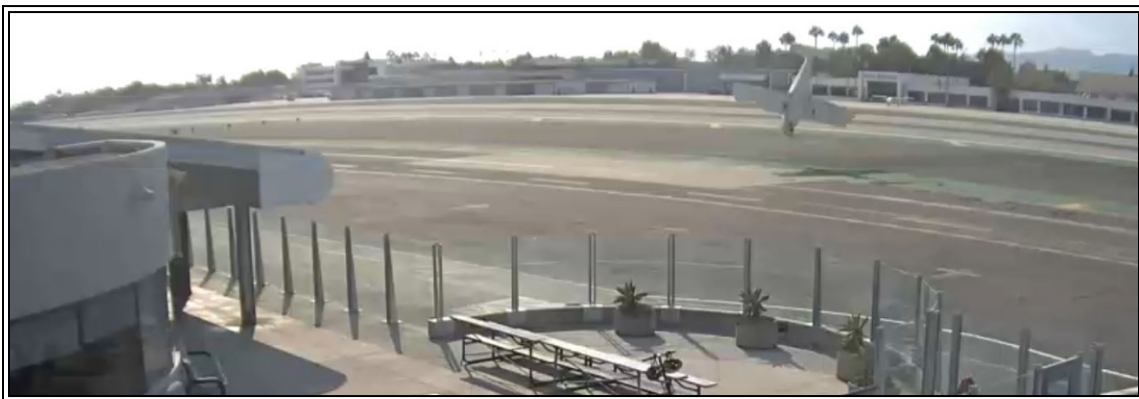
Figure 2 – Video image of the airplane just before impact.

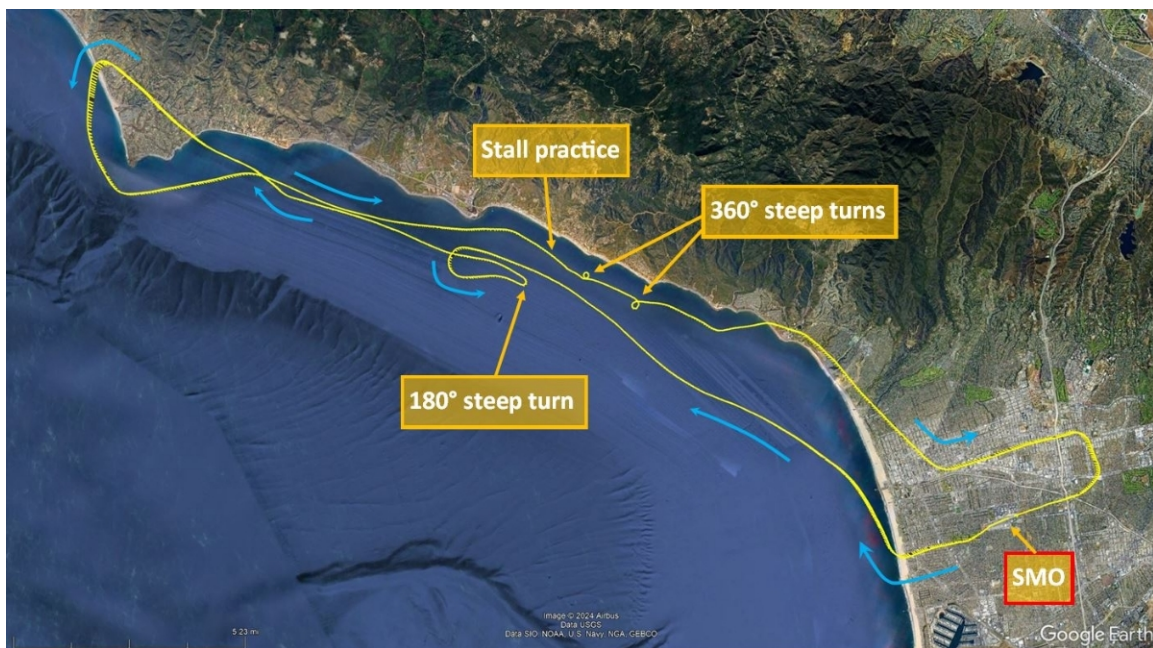
Review of ADS-B data (Figure 3) indicated that about 10 minutes after takeoff, the airplane began a 180° turn to the left, at a bank angle based on speed and turn radius that would have been between 25° and 30°. About 90 seconds later, the airplane began a more aggressive 180 left turn, this time at a bank angle that would have reached almost 75°. For the next 13 minutes the flight progressed with changes in heading, speed, and bank angle consistent with basic training maneuvers. At 1615:40, the airplane's calibrated airspeed had slowed to about 33 kts, consistent with a practice stall maneuver, and within one minute of completion of the maneuver, the airplane then performed a 360° turn to the left, followed by a 360° turn to the right at bank angles of between 60° and 65°.

Figure 3 – ADS-B flight track

The load factors during a 30°, 60°, and 75° turn are about 1G, 2G, and 3.4G respectively.
