# Aviation Investigation Final Report

<b>Location:</b>	Santa Monica, California	<b>Accident Number:</b>	WPR22FA338
<b>Date &amp; Time:</b>	September 8, 2022, 16:26 Local	<b>Registration:</b>	N126WK
<b>Aircraft:</b>	CZECH SPORT AIRCRAFT Piper Sport	<b>Aircraft Damage:</b>	Destroyed
<b>Defining Event:</b>	Abrupt maneuver	<b>Injuries:</b>	2 Fatal
<b>Flight Conducted Under:</b>	Part 91: General aviation - Instructional

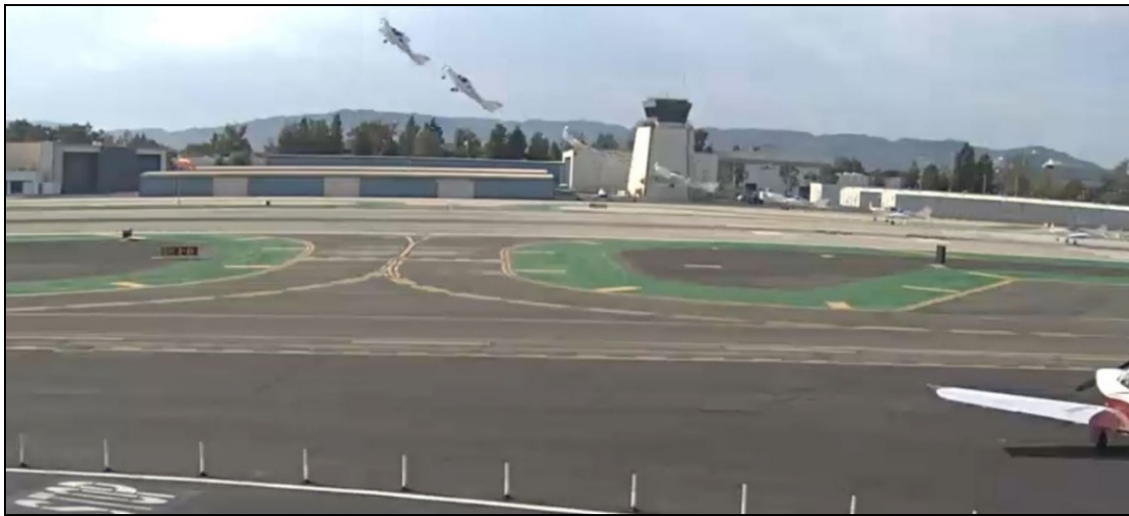
the airplane descending over the runway threshold markings at an altitude of about 25 ft agl and then passing to the left and out of the camera's field of view. A second camera, similarly positioned but facing northwest, captured the other end of the runway threshold markings. As the airplane came into view, the main landing gear was already on the ground and the airplane then began to climb in a slightly nose-up attitude. Over the next three seconds, the airplane pitched up to an almost vertical attitude and climbed out of the camera's field of view (see Figure 1). The shadow of the airplane on the runway surface indicated that it continued to climb for another two seconds before descending and striking the ground about 5 seconds later (see Figure 2).

*Figure 1 – Composite video image of pitch-up maneuver.*

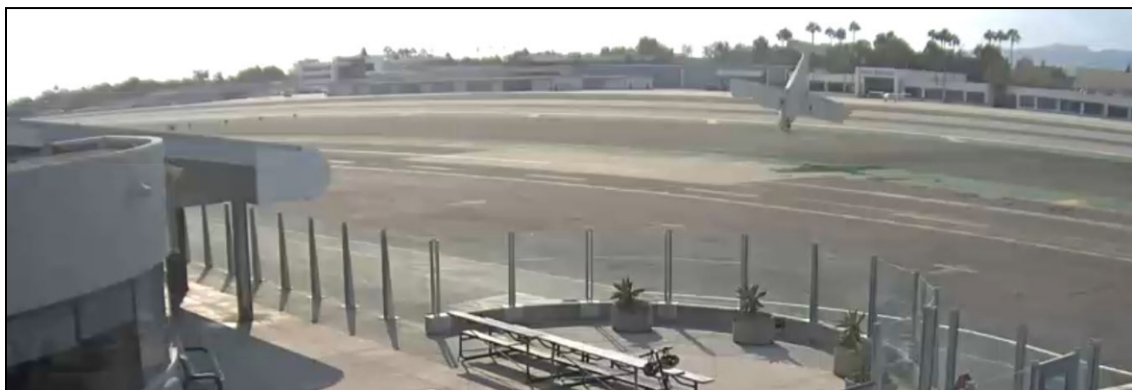
*Figure 2 – Video image of the airplane just before impact.*

The airplane struck the ground in a nose-down attitude and came to rest at the intersection of taxiway B and B4, about 375 ft south of the runway 21 threshold.

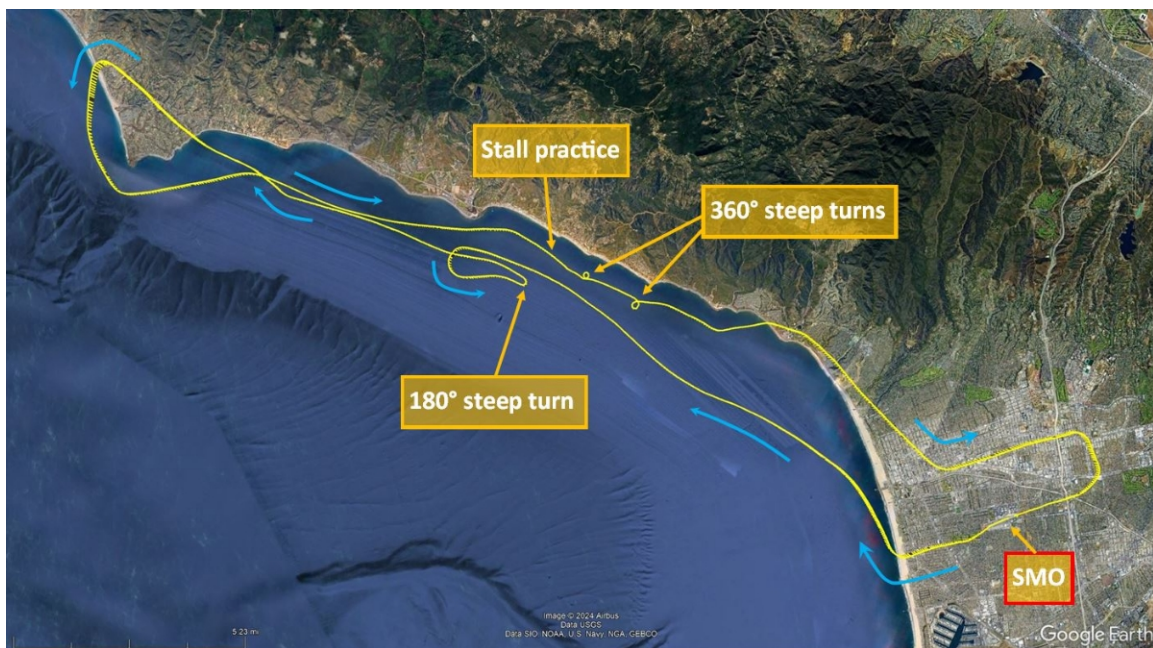
Review of ADS-B data (Figure 3) indicated that about 10 minutes after takeoff, the airplane began a 180° turn to the left, at a bank angle based on speed and turn radius that would have been between 25° and 30°. About 90 seconds later, the airplane began a more aggressive 180 left turn, this time at a bank angle that would have reached almost 75°. For the next 13 minutes the flight progressed with changes in heading, speed, and bank angle consistent with basic training maneuvers. At 1615:40, the airplane's calibrated airspeed had slowed to about 33 kts, consistent with a practice stall maneuver, and within one minute of completion of the maneuver, the airplane then performed a 360° turn to the left, followed by a 360° turn to the right at bank angles of between 60° and 65°.

Figure 3 – ADS-B flight track

The load factors during a 30°, 60°, and 75° turn are about 1G, 2G, and 3.4G respectively.
