# Aviation Investigation Final Report

<b>Location:</b>	Preston, Idaho	<b>Accident Number:</b>	WPR22FA347
<b>Date &amp; Time:</b>	September 14, 2022, 10:55 Local	<b>Registration:</b>	N992KS
<b>Aircraft:</b>	SKILES KENNETH C RV-6A	<b>Aircraft Damage:</b>	Substantial
<b>Defining Event:</b>	VFR encounter with IMC	<b>Injuries:</b>	2 Fatal
<b>Flight Conducted Under:</b>	Part 91: General aviation - Personal

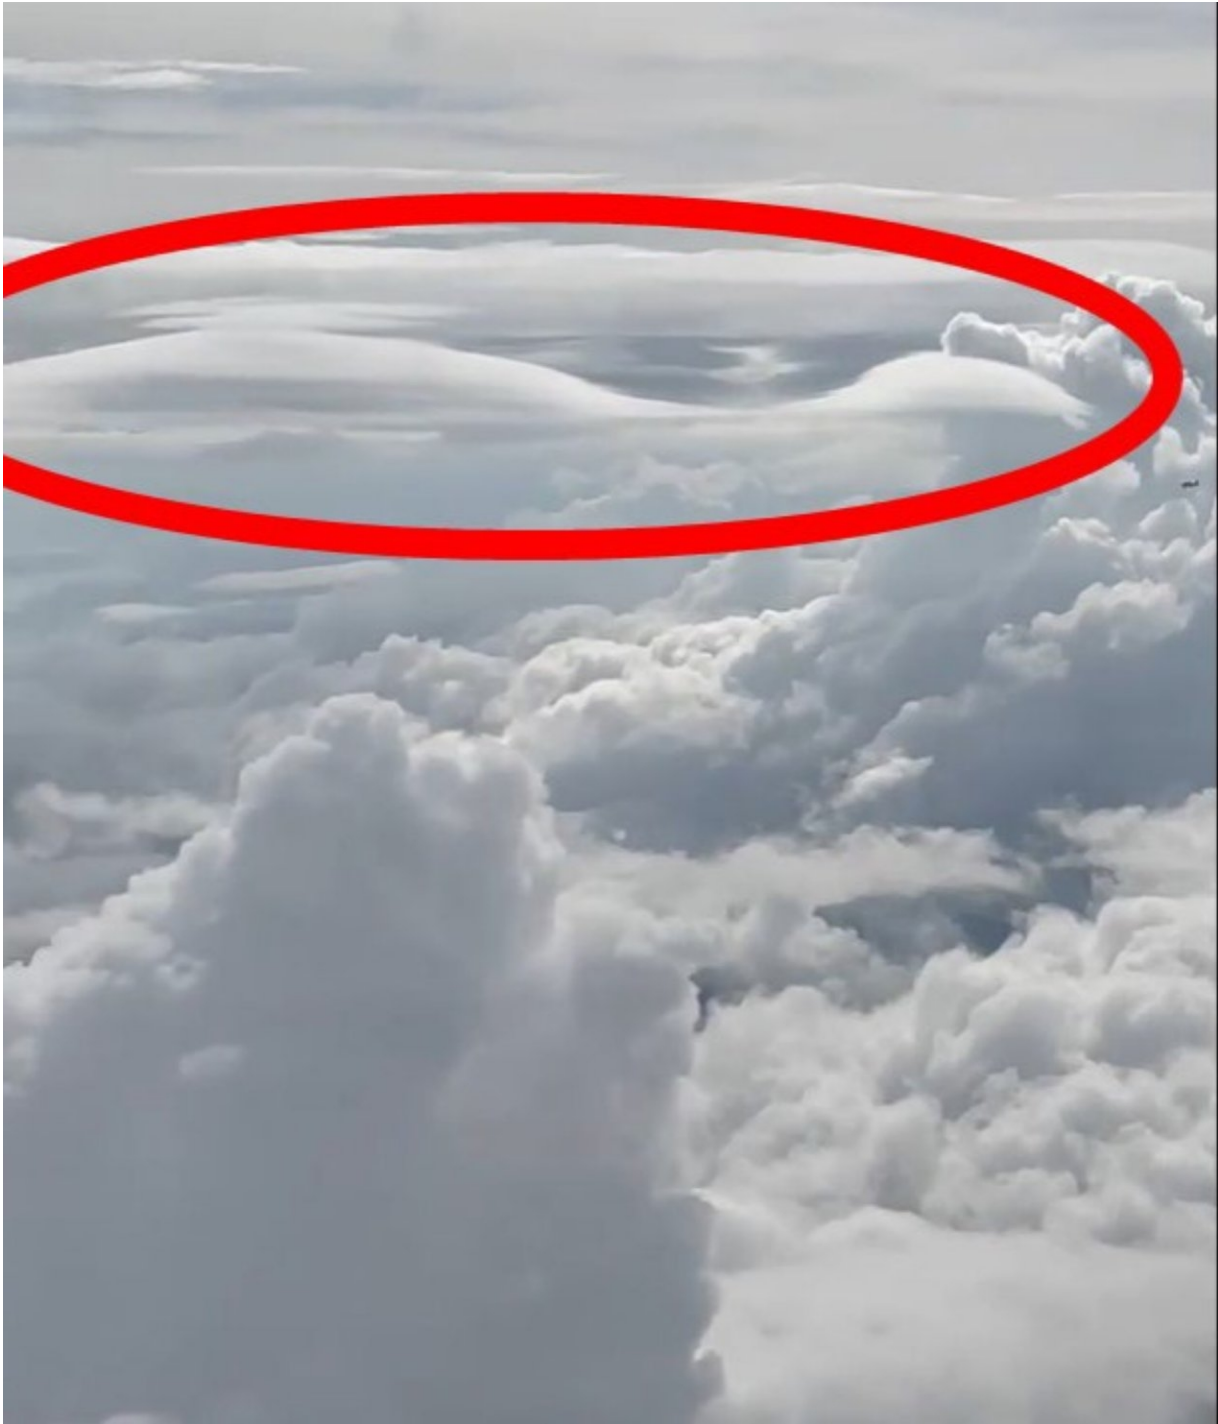
The cellular phone video footage from the second airplane depicted what appeared to be standing lenticular clouds. These clouds are generally the result of standing wave action, but do not guarantee hazardous conditions or turbulence. The video also depicted cumulonimbus and cumulostratus clouds ahead of the accident airplane (Figure 1).

*Figure 1: Photo of accident airplane in the vicinity of clouds.*
