# Aviation Investigation Final Report

<b>Location:</b>	Preston, Idaho	<b>Accident Number:</b>	WPR22FA347
<b>Date &amp; Time:</b>	September 14, 2022, 10:55 Local	<b>Registration:</b>	N992KS
<b>Aircraft:</b>	SKILES KENNETH C RV-6A	<b>Aircraft Damage:</b>	Substantial
<b>Defining Event:</b>	VFR encounter with IMC	<b>Injuries:</b>	2 Fatal
<b>Flight Conducted Under:</b>	Part 91: General aviation - Personal

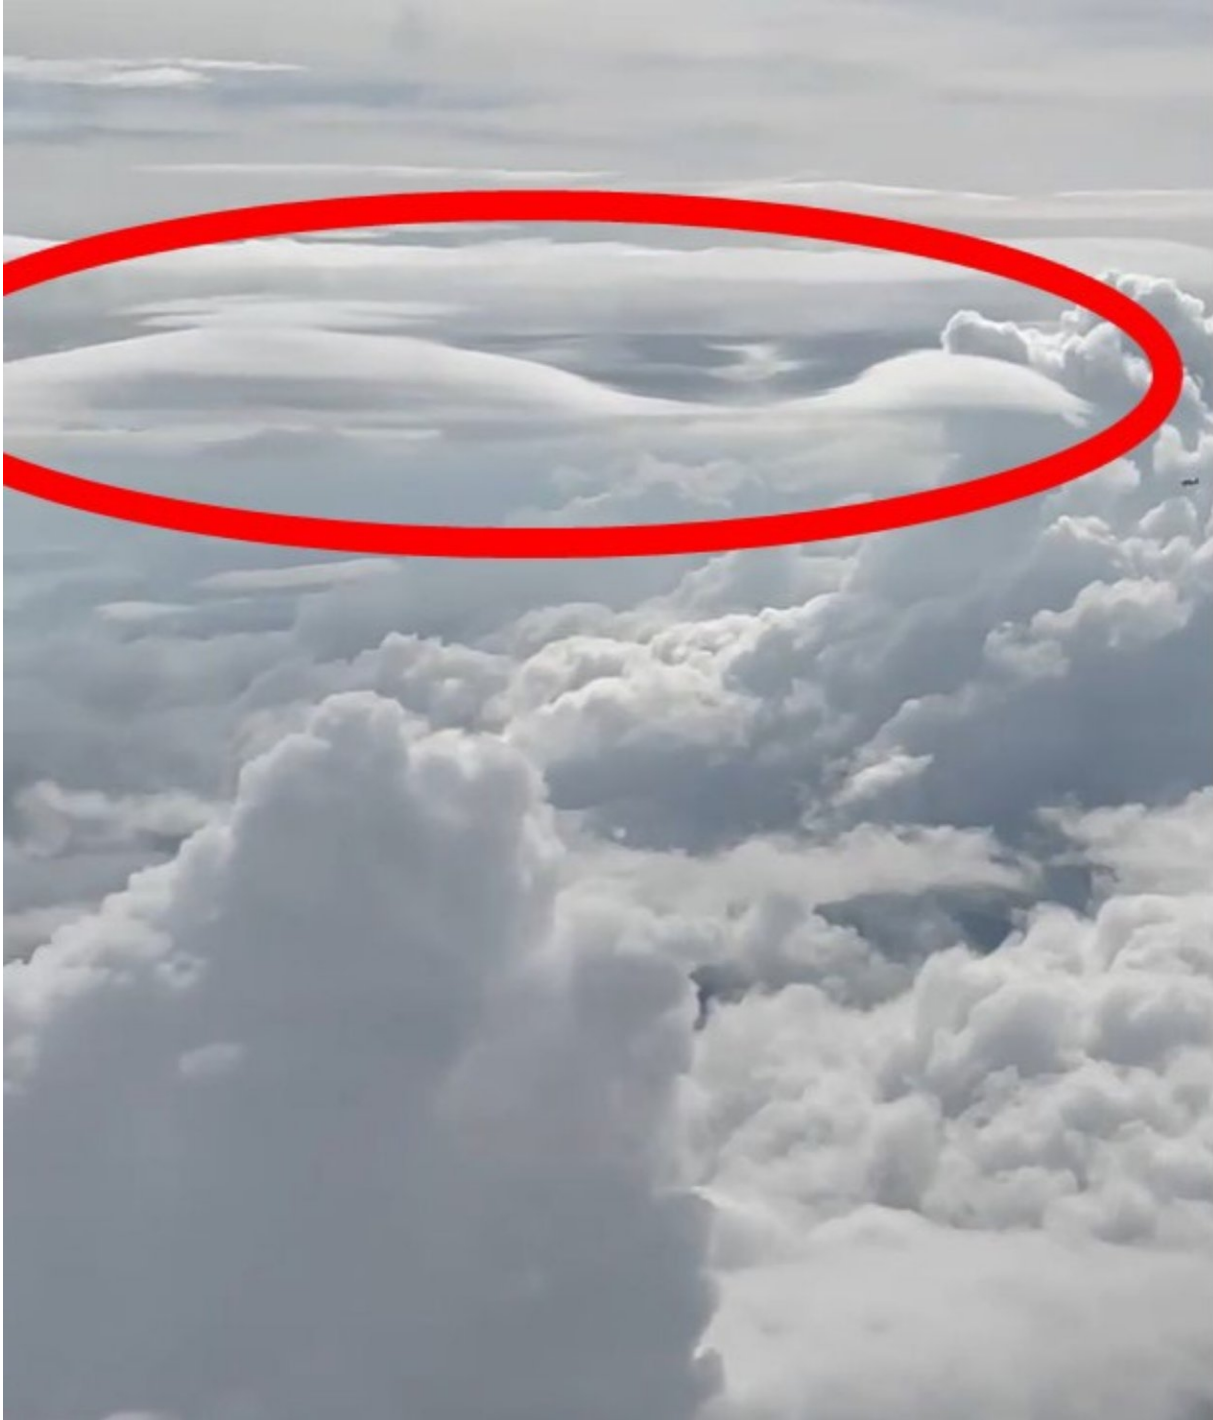
The second pilot recorded a short video of the accident airplane while the two airplanes were cruising at 11,500 ft. The footage showed the accident airplane flying over a broken to overcast cloud ceiling with cumulus and standing lenticular clouds present. A pilot report near the accident site issued about 15 minutes before the accident included clouds from 9,000 ft to 12,000 ft msl.

The cellular phone video footage from the second airplane depicted what appeared to be standing lenticular clouds. These clouds are generally the result of standing wave action, but do not guarantee hazardous conditions or turbulence. The video also depicted cumulonimbus and cumulostratus clouds ahead of the accident airplane (Figure 1).

*Figure 1: Photo of accident airplane in the vicinity of clouds.*
