Aviation Investigation Final Report

Location:	Skwentna, Alaska	Accident Number:	ANC22LA080
Date & Time:	September 25, 2022, 13:00 Local	Registration:	N9728B
Aircraft:	Cessna 180A	Aircraft Damage:	Substantial
Defining Event:	Sys/Comp malf/fail (non-power)	Injuries:	1 Fatal
Flight Conducted Under:	Part 91: General aviation - Personal

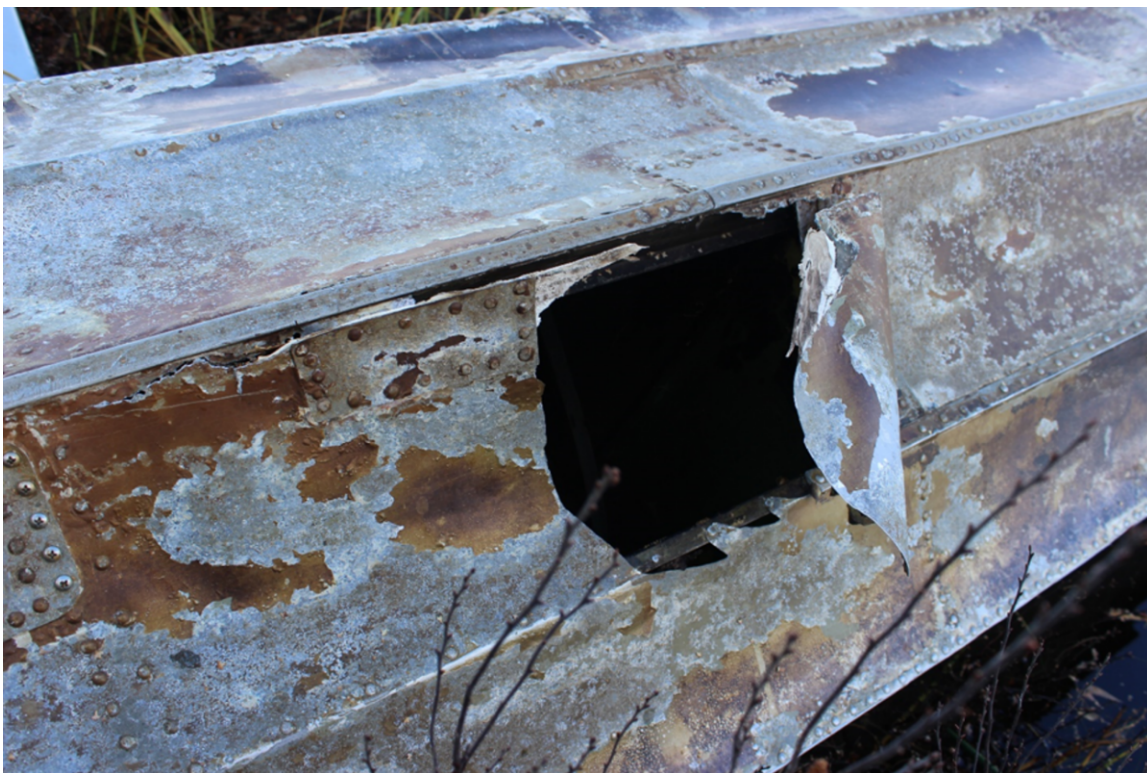
Postaccident examination of the wreckage revealed that both floats were heavily corroded and separated from the fuselage. There was no evidence that either float had contacted a foreign object in the water. A portion of the hull on the right float tore open and bent back. It is likely that tear in the float resulted in the airplane impacting the water during the takeoff. Maintenance records were not available for review during the investigation.

The failure of the landing gear float due to inadequate maintenance of the floats and corrosion.

The bottoms of both floats were heavily corroded and discolored.

The right float remained attached to the airframe by the fly wire. There were six patches of varying size noted on the hull of the right float. A portion of the float hull, about midspan from the tip of the float to the step, was partially separated and bent aft. No evidence of impact with a foreign object was noted. (See Figure 1.)

Figure 1 View of partially separated section on hull of the right float.
