Aviation Investigation Final Report

Location:	Houma, Louisiana	Accident Number:	CEN22LA430
Date & Time:	September 24, 2022, 18:11 Local	Registration:	N811TA
Aircraft:	Agusta AW139	Aircraft Damage:	Substantial
Defining Event:	Electrical system malf/failure	Injuries:	6 None
Flight Conducted Under:	Part 135: Air taxi & commuter - Non-scheduled

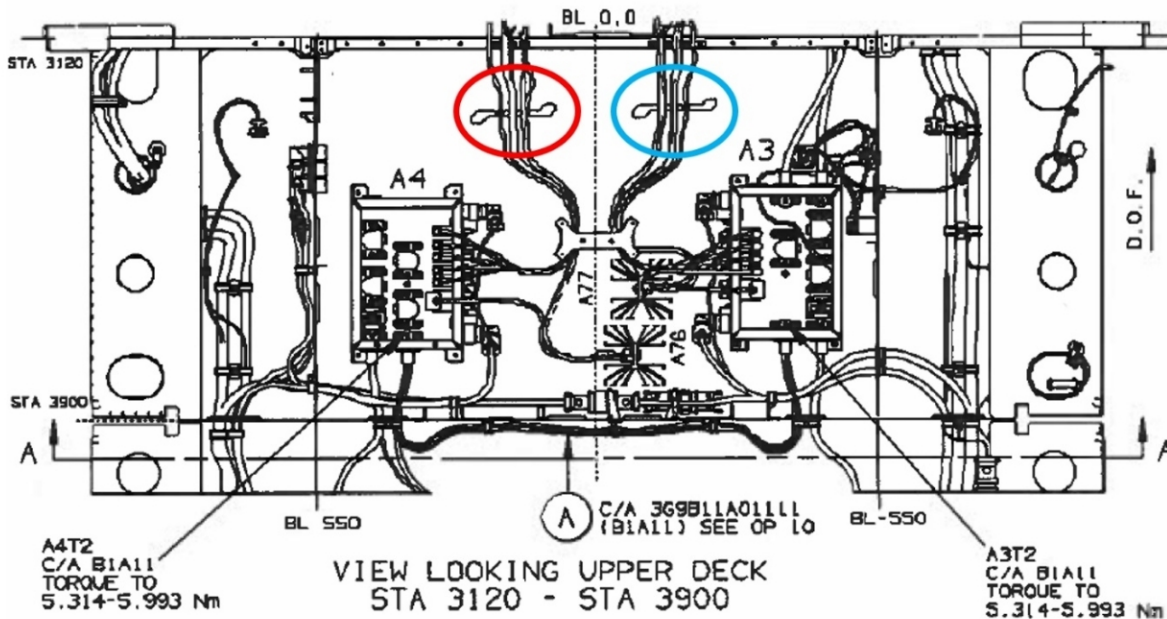
When the helicopter was assembled, the Completion and Finishing of Power C/A Card, No. 3G0630A04112C4R, contained instructions on the installation and routing of electrical power cables from the cockpit nose area to the cabin roof and subsequently to the power distribution panels. Figure 1 is a drawing excerpt from the job card depicting the cable routing in the cabin roof.

Figure 1. A drawing excerpt from the “Completion and Finishing of Power C/A Card” showing the power cable routing on the cabin roof with left and right wiring support strip assemblies. (Courtesy of Leonardo Helicopters, modified by NTSB)

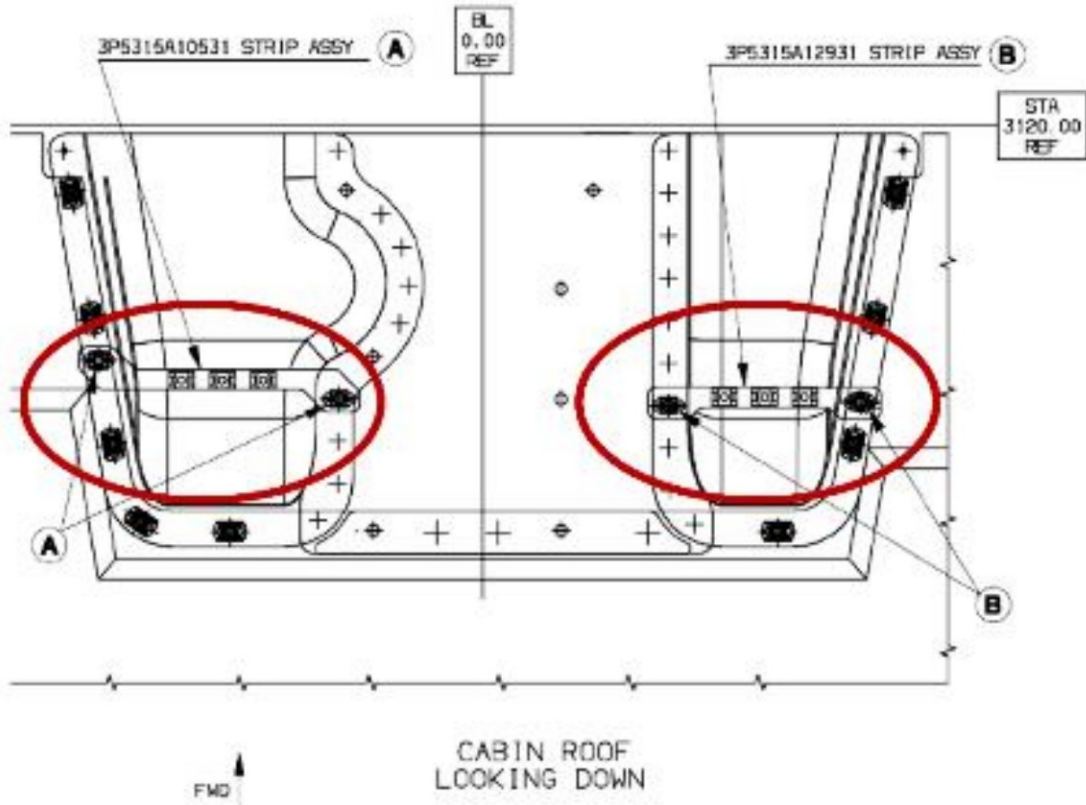
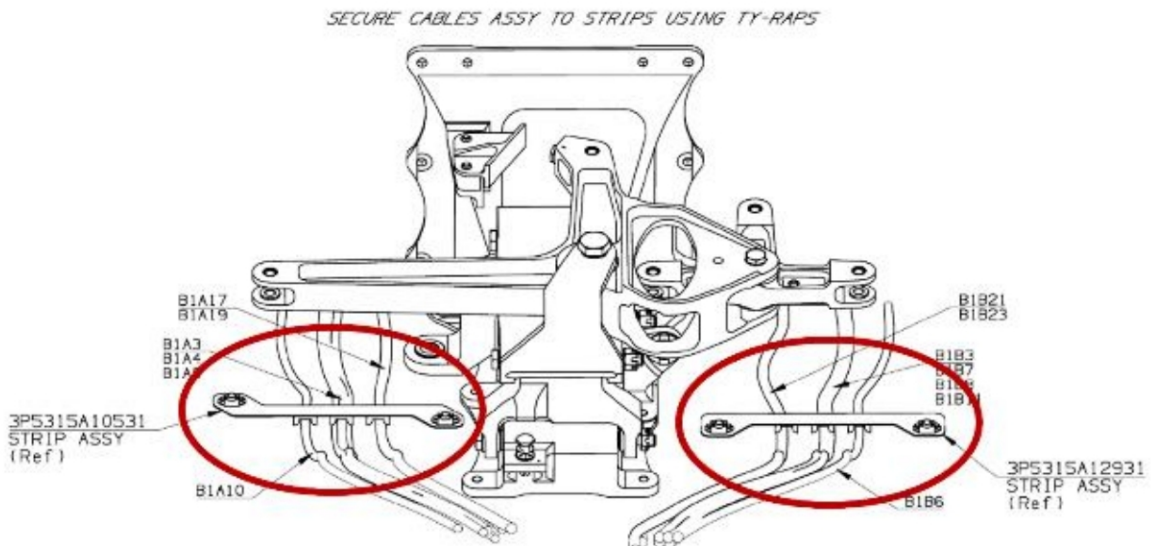
On December 20, 2014, after the helicopter was assembled, the 3NB Pax Ceiling Panels Closeout Card was updated to version 8, and included two installation diagrams, shown below as Figure 4 and Figure 5.

Figure 4. Diagram from 3NB Pax Ceiling Panel Closeout Job Card (Red ellipses were added for emphasis by NTSB)

Figure 5. Diagram from 3NB Pax Ceiling Panel Closeout Job Card (Red ellipses were added for emphasis by NTSB)

The updated job task card also included the statement, “Ensure that the moving parts of the flight control rods in the area has at least 0.5 inch clearance from the surrounding fixed parts.” However, the updated job task card did not mention nor provide specific instructions for the inspection of wiring in the same area.

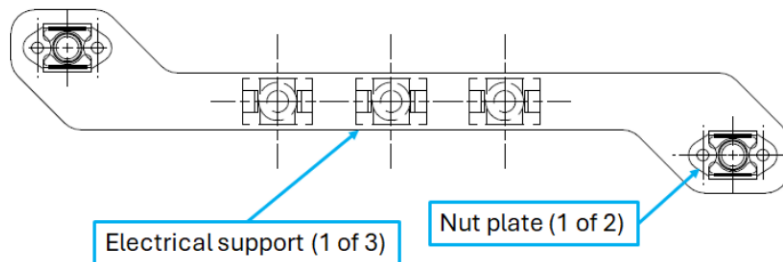
At the time of its manufacture, the manufacturing job card for the left-side wiring support strip assembly, No. 3P5315A10531, contained only a single planform view of the strip assembly, as shown in Figure 6. According to Leonardo Helicopters, the solid drawing lines for the nut plates (anchor nuts) versus the dashed drawing lines for the electrical supports implied that the electrical supports were mounted on the side opposite that of the nut plates.

Figure 6. The single view of the left strip assembly in its manufacturing job card. (Courtesy of Leonardo Helicopters, modified by NTSB)

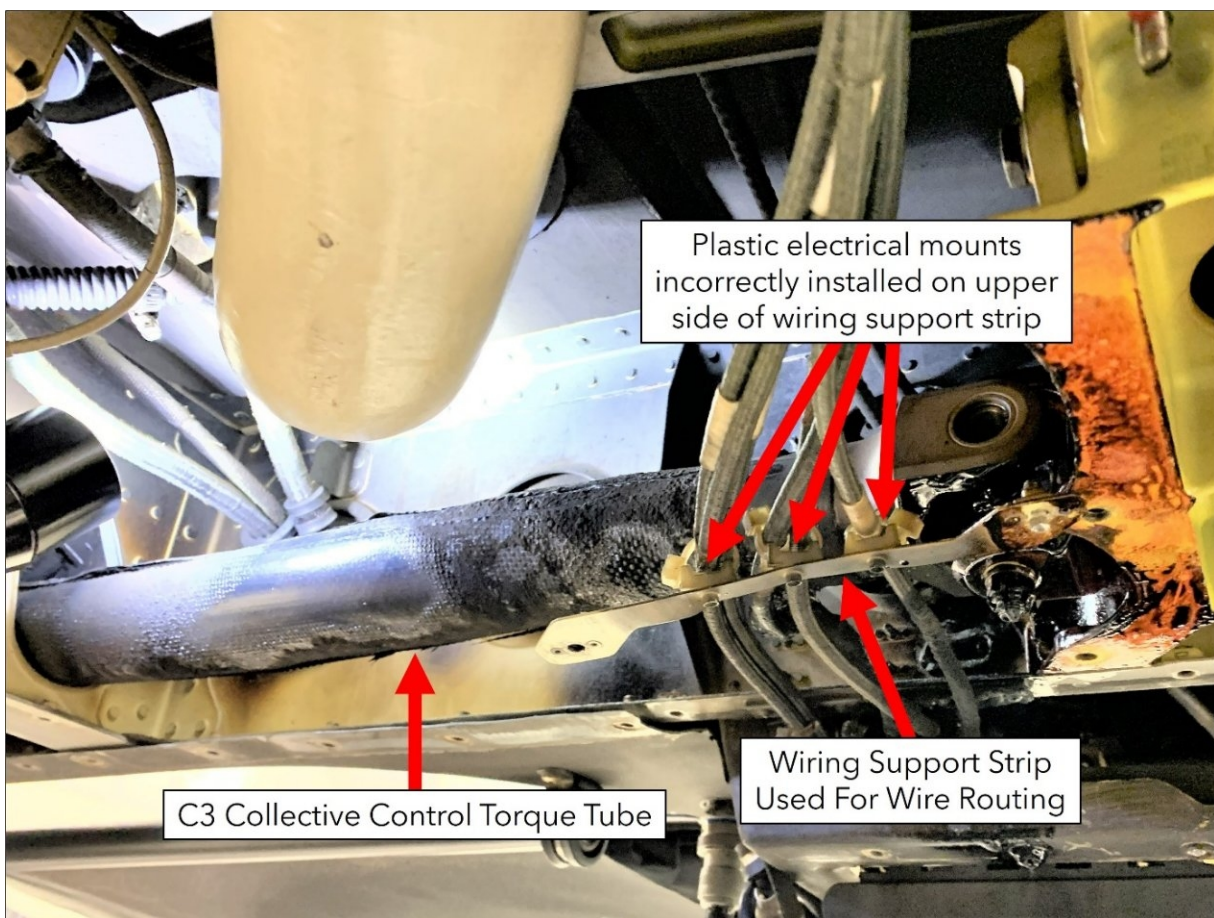
A visual examination revealed thermal damage and a longitudinal split of the C3 torque tube, as shown in Figure 9. The C3 torque tube was installed at both ends, with all fasteners installed and intact. A static test of the collective system without hydraulic pressure was conducted by moving the collective between the minimum and maximum pitch settings and observing the C3 torque tube. The outboard end of the C3 collective tube twisted while the inboard end by the mixing unit remained stationary with the C3 torque tube deformed torsionally along its length. The helicopter's cockpit flight controls are hydraulically-assisted via a dual hydraulic system; typically, the C3 torque tube does not rotate without hydraulic pressure engaged.

The wire assemblies routed to the overhead circuit breaker panels are intended to pass under wiring support strips; however, the accident helicopter's left-side wiring support strip had plastic electrical mounts installed on the upper side of the metal strip, as shown in Figure 9. The chafed wire was secured by one of the electrical mounts that was installed on the upper side of the left-side wiring support strip. Additionally, the right-side wiring support strip also had plastic electrical mounts installed on the upper side of the metal strip; however, unlike the left-side support strip, there was no evidence of chafed wiring.

Figure 9. C3 collective torque tube and wiring support strip used for wire routing

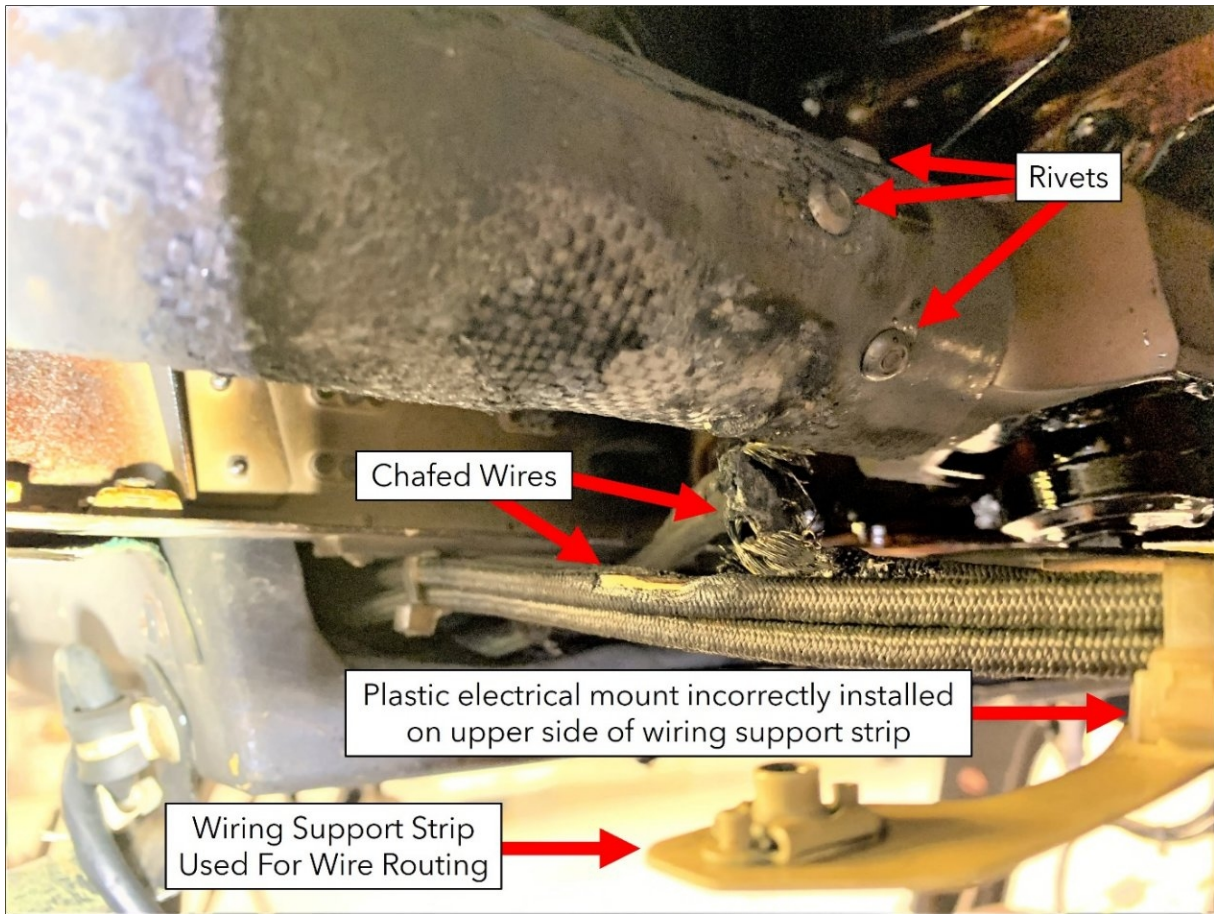
Electrical power to the helicopter is provided by two, 30 volt / 300 ampere direct current generators. Wire P190A6-G (p/n 3G9B11A1911) receives electrical power from the No. 1 generator through the T3 terminal on the No. 1 diode module and connects to the No. 5 distribution bar on the No. 1 essential bus in the cockpit overhead. Wire P190A6-G was found chafed through its insulation consistent with contact with the C3 collective torque tube, as

shown in Figure 10. The chafed area was in line with a rivet line installed circumferentially on the C3 torque tube, as shown in Figure 10 and Figure 11. In addition to melted resin from the C3 collective torque tube, soot was found laterally along the entire overhead and on the panels that covered the C3 torque tube.

Figure 10. Chafed wires and rivets on C3 collective torque tube

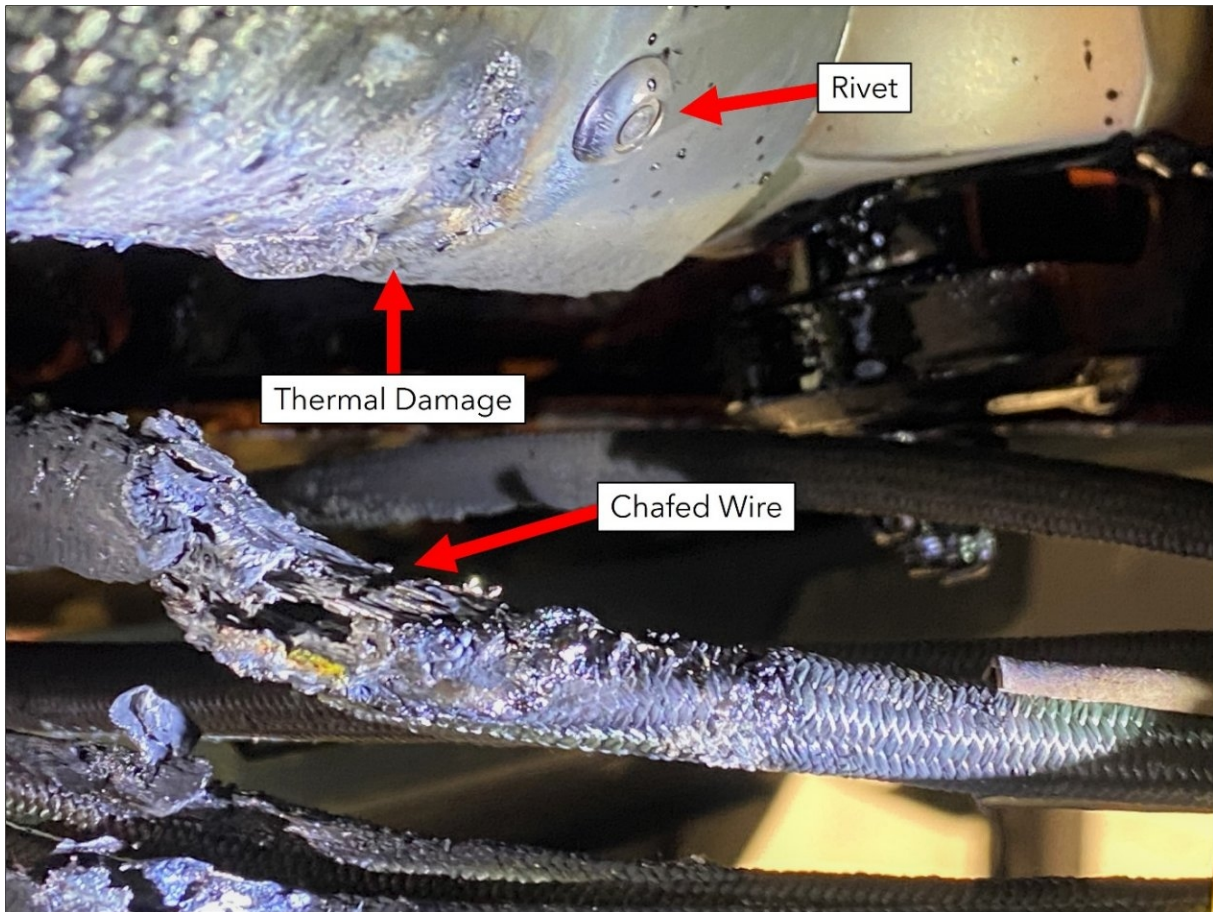
Figure 11. Chafed wires and thermal damage to C3 collective torque tube

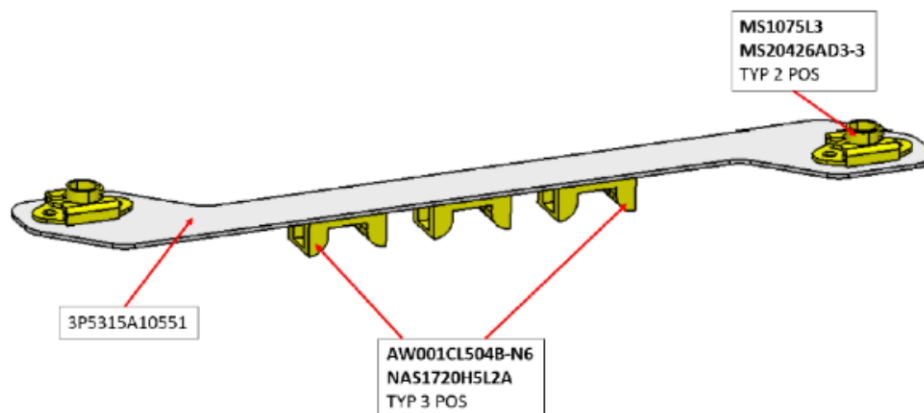
Figure 12. The 3D figure included with the updated strip assembly manufacturing card

The manufacturing job card, No. 3P5315A10531, was updated on October 24, 2022, to include a 3-dimensional (3D) graphic of the completed strip assembly, as shown in Figure 12.

The updated manufacturing card also includes the statement, “Note: Pay attention to correct assembly, the anchor nuts must be mounted on the side opposite to the electrical supports.”

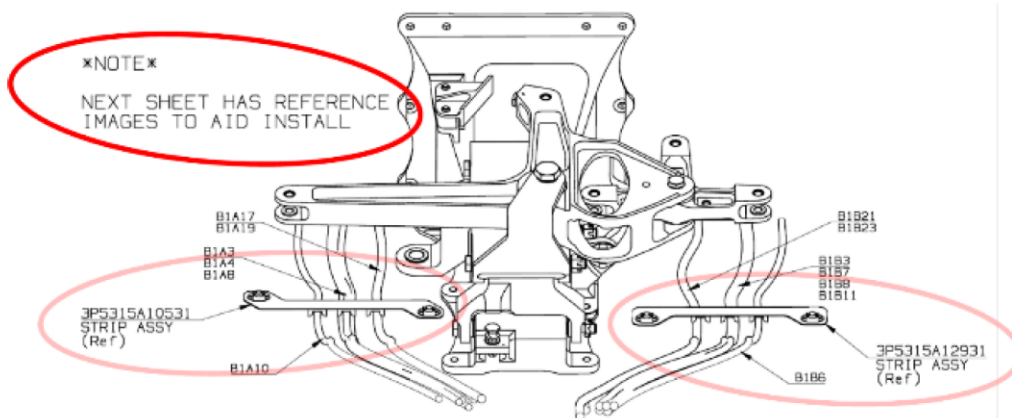
Figure 13. Updated diagram used in Production Assembly Job Card No. 3P5333A00134C1. Pale red ellipses depict the previous job card updates; dark red ellipses depict the Version 9 card revision.

Additionally, revisions to the Production Assembly 3NB Pax Ceiling Panel Closeout Job Card, No. 3P5333A00134C1, now include a note (Figure 13) and a reference photo (Figure 14) showing proper wiring routing below the support strips.

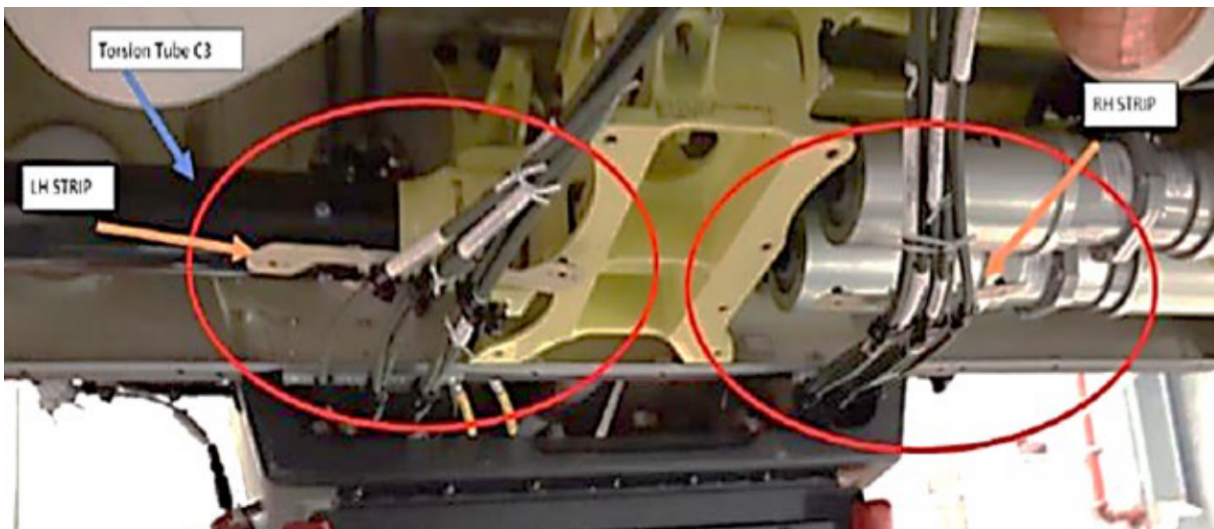
Figure 14. Reference photo included in Production Assembly Job Card No. 3P5333A00134C1, to aid installation of wiring. The reference photo was cropped by NTSB to show the specific area where the wiring support strips are located.
