Aviation Investigation Final Report

Location:	Allentown, Pennsylvania	Accident Number:	CEN22FA436
Date & Time:	September 28, 2022, 13:40 Local	Registration:	N7329F
Aircraft:	Piper PA-28-140	Aircraft Damage:	Destroyed
Defining Event:	Loss of engine power (partial)	Injuries:	1 Fatal, 1 Serious
Flight Conducted Under:	Part 91: General aviation - Instructional

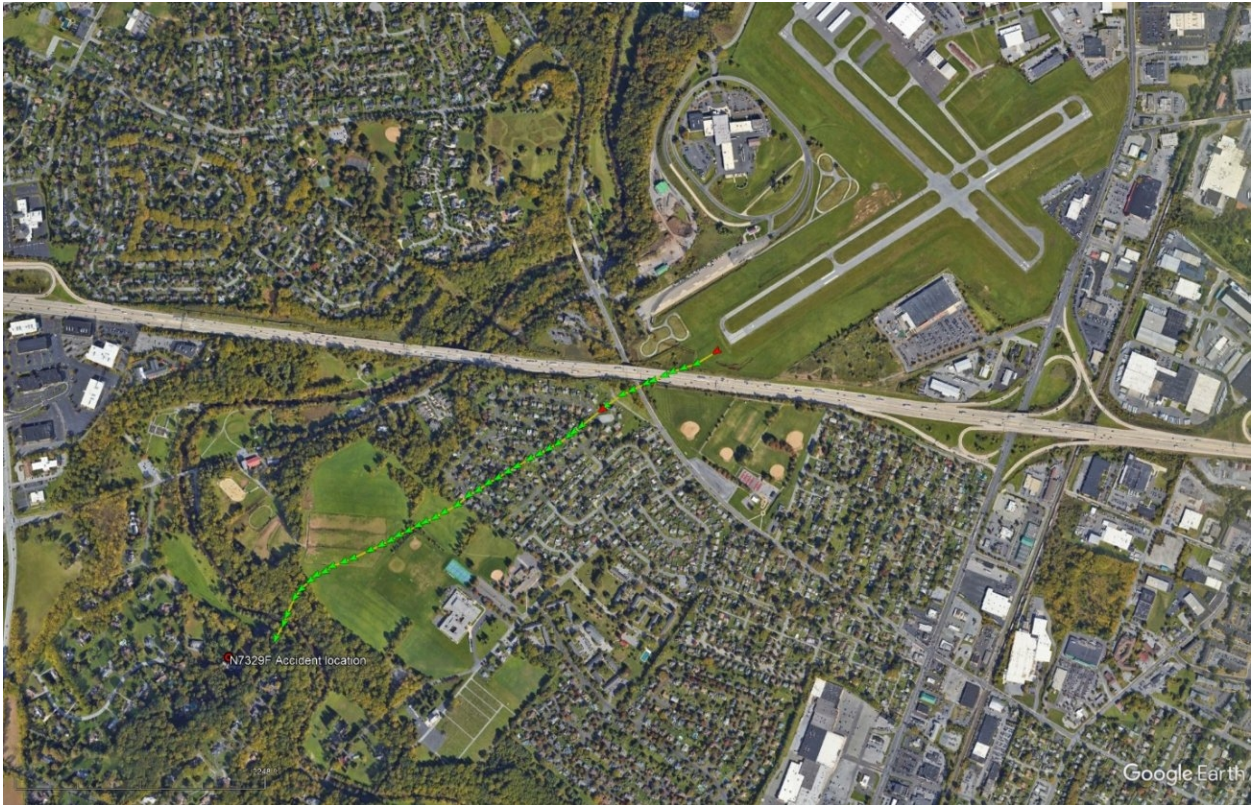
Recorded Automatic Dependent Surveillance-Broadcast (ADS-B) data showed that the airplane departed and continued for about 0.8 miles on runway heading, then made a slight left turn before the end of the data. The accident site was about 450 ft and 250° from the final recorded location. The reported wind at the departure airport was from 310° at 8 kts.

Examination of the data, taking into account the reported surface winds, showed that the airspeed during the final portion of the flight was below V_x but above the listed stall speed from the airplane owner's manual. The owner's manual listed a stall speed with 0° flap setting at maximum gross weight was 64 mph.

Figure 1. Overhead view of the accident flight path.
