# Aviation Investigation Final Report

<b>Location:</b>	Sahuarita, Arizona	<b>Accident Number:</b>	WPR22FA361
<b>Date &amp; Time:</b>	September 28, 2022, 09:00 Local	<b>Registration:</b>	N74349
<b>Aircraft:</b>	GRUMMAN AMERICAN AVN. CORP. AA-5B	<b>Aircraft Damage:</b>	Destroyed
<b>Defining Event:</b>	Loss of control in flight	<b>Injuries:</b>	1 Fatal
<b>Flight Conducted Under:</b>	Part 91: General aviation - Personal

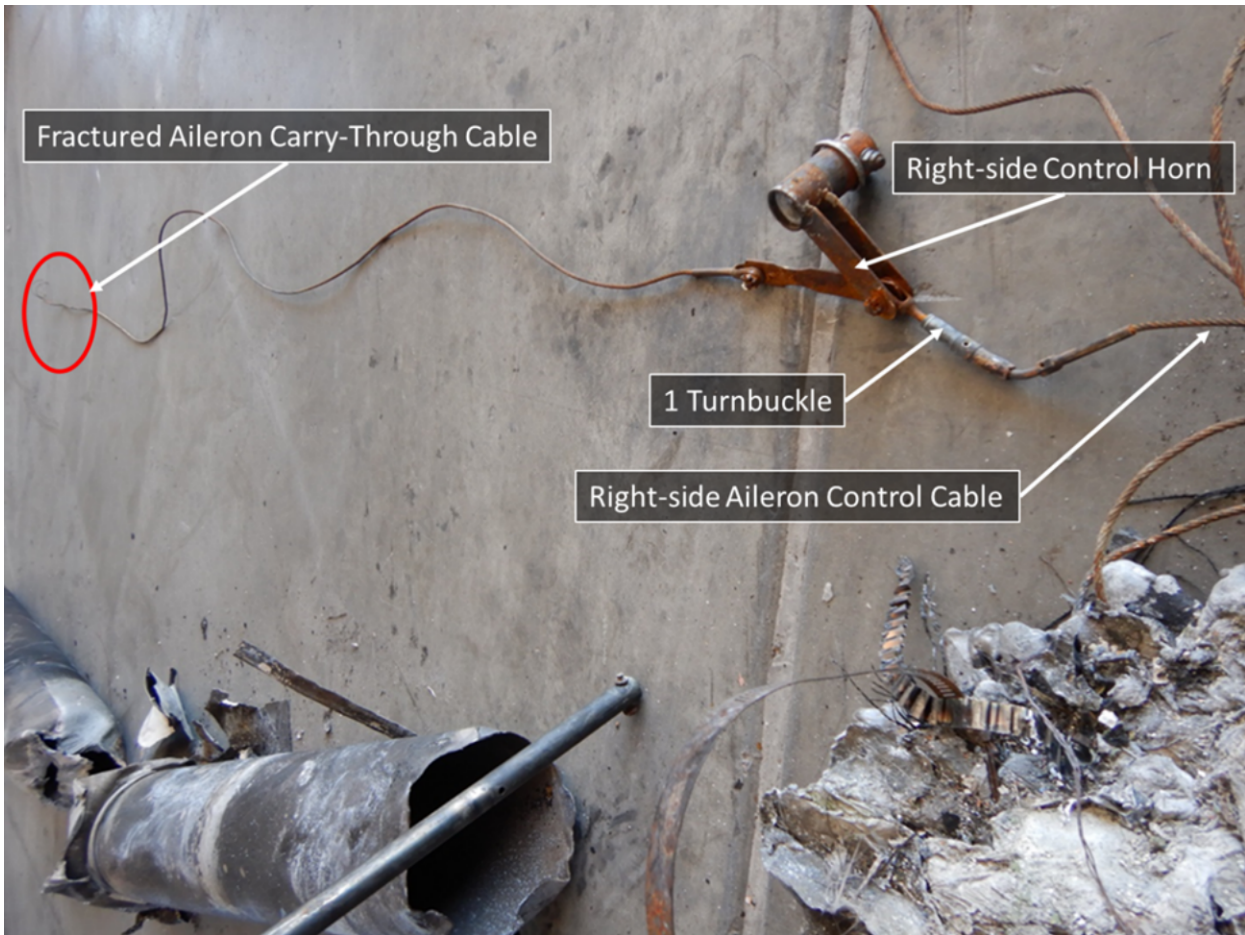
Postaccident examination of the airframe revealed a section of the right aileron carry-through cable had fractured. The fractured end exhibited two strands fractured about 5 inches from the remaining fractured cable strands, as depicted in Figures 2 and 3.

Figure 2. Image showing the components of the right aileron control system.

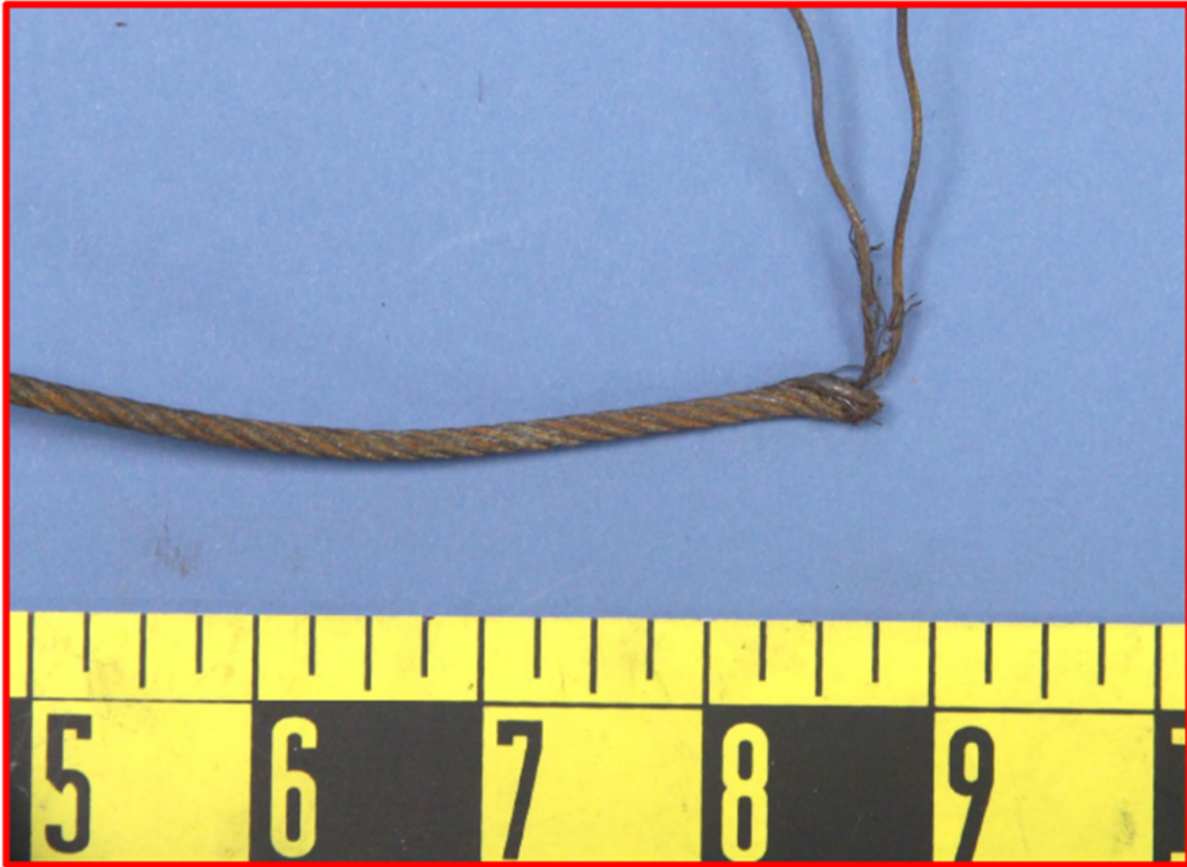
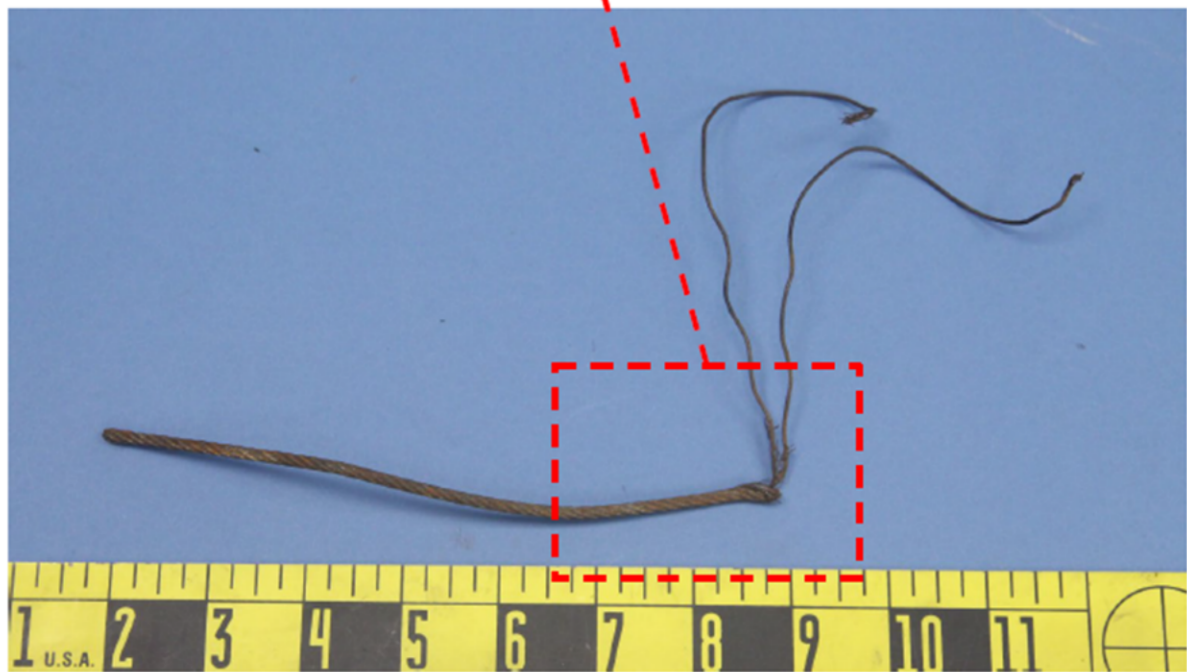
The fractured end of the cable was shipped to the National Transportation Safety Board's Materials Laboratory for further examination. Examination of the aileron control cable revealed areas of flat, elongated, angular fracture surfaces on the ends of many of the wires. The angular fracture surfaces displayed rub marks and the cross sections of the wires adjacent to separations had thinned wires still grouped together into strands. The orientation and characteristics of the fractured wire ends were consistent with between-strand wear and subsequent overstress separation. The remaining wires had cup-and-cone-like fracture surfaces accompanied by adjacent necking of the wire cross-section, consistent with overstress separation.

Figure 3. Fractured section of the aileron carry-through cable, showing the two distinctive break areas.

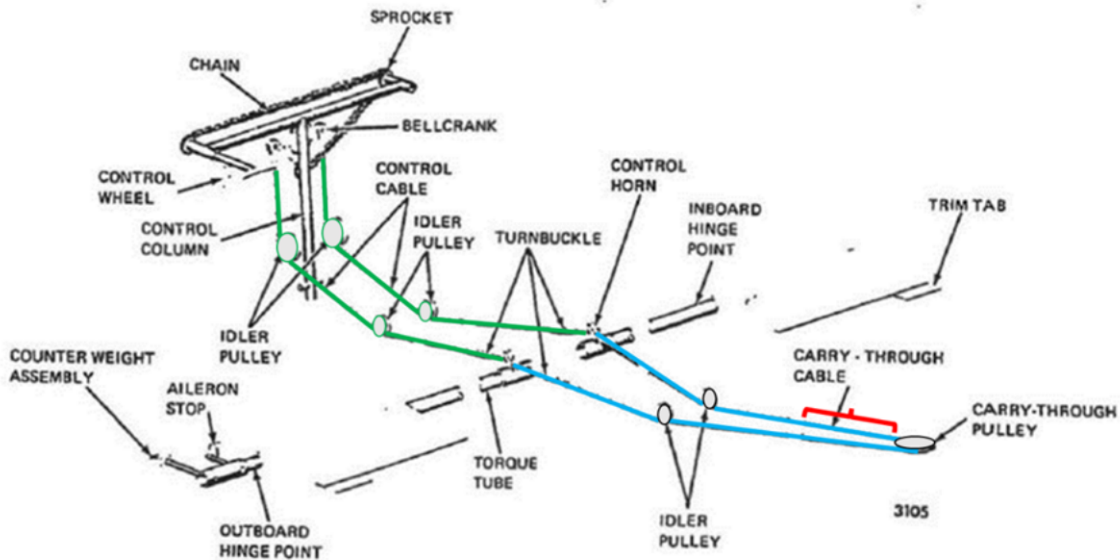
According to the maintenance manual for the AA-5 series airplane, "A carry-through cable, attached to the control horns, extends aft to the carry-through pulley in the aft fuselage. The cable provides completion of the aileron control loop such that as one aileron moves up, the other aileron moves down." Figure 4 is an illustration of the aileron control system.

Figure 4. Illustration of the aileron control system. The control cables are highlighted in green, the carry-through cable is highlighted in blue, and the estimated location of the break is identified in red. Illustration courtesy of the AA-5 Series Maintenance Manual.
