Aviation Investigation Final Report

| Location: | Hermantown, Minnesota | Accident Number: | ERA23FA001 |
| Date & Time: | October 1, 2022, 23:17 Local | Registration: | N262TA |
| Aircraft: | Cessna 172S | Aircraft Damage: | Substantial |

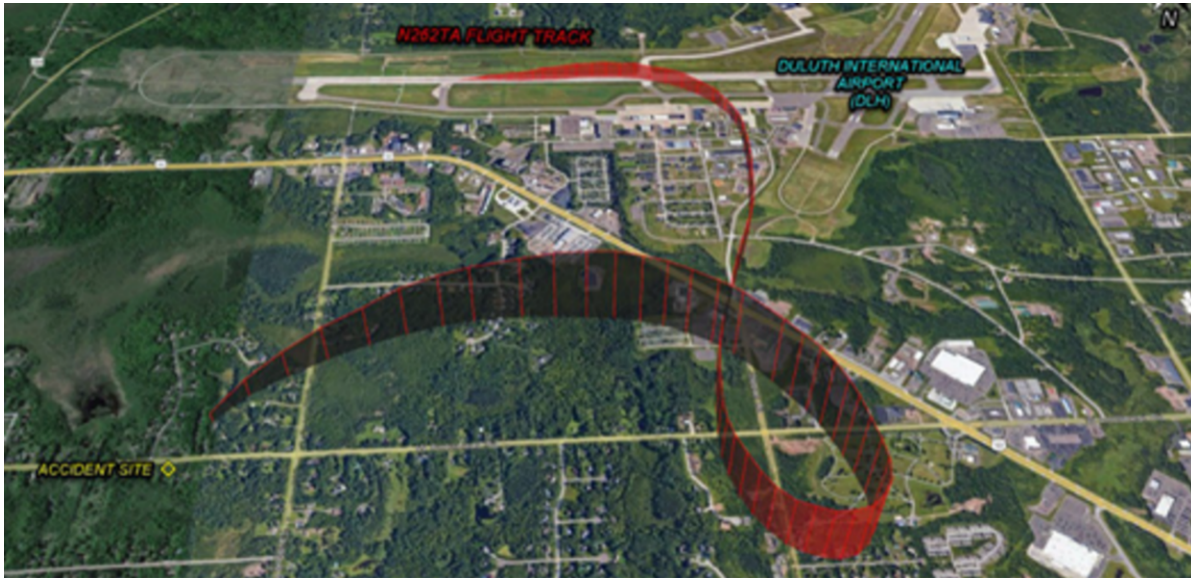
A review of ADS-B data revealed the airplane departed at 2312. It made a right turn toward the south while climbing to about 1,750 ft msl. The airplane then made a steep left turn to a track of about 270° while climbing to 2,800 ft msl before it began to descend (see figures 1 and 2).

Figure 1 - ADS-B data depicting an orthogonal plot of the airplane's flight track in profile in red.

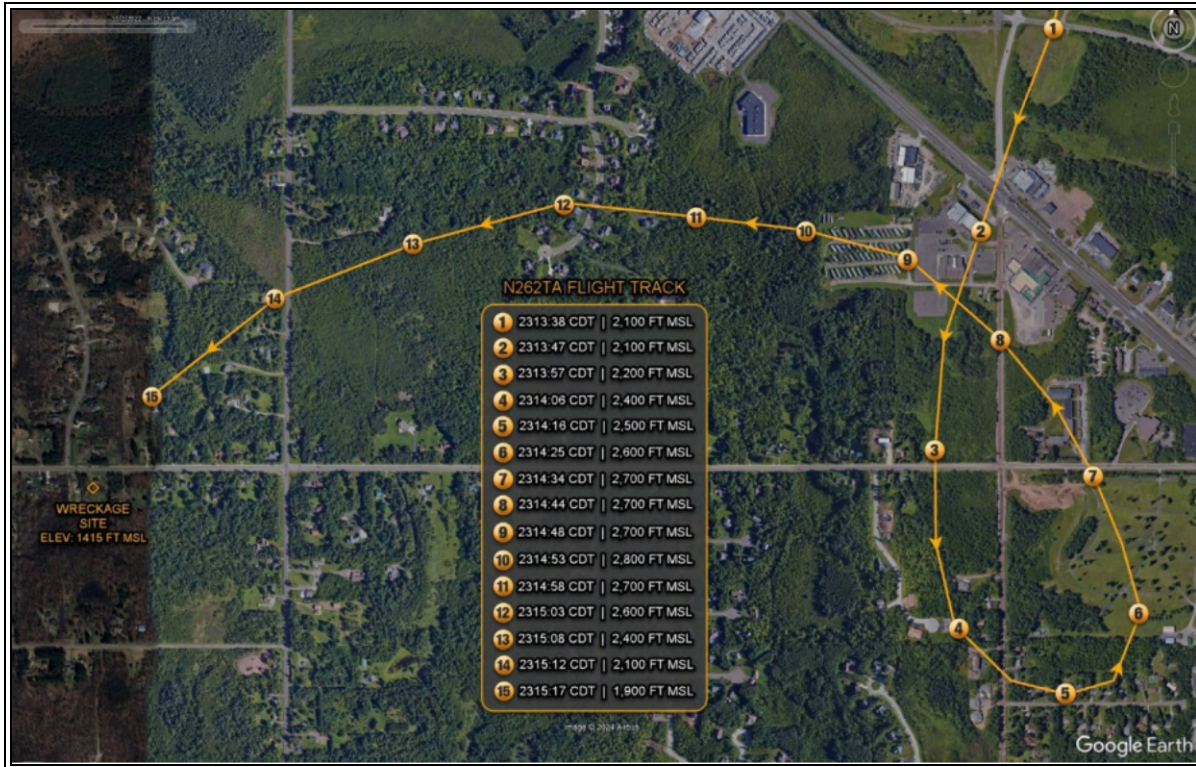
Figure 2 – Overhead plot of the airplane’s flight track with points depicting the airplane’s position, altitude, and time annotated.

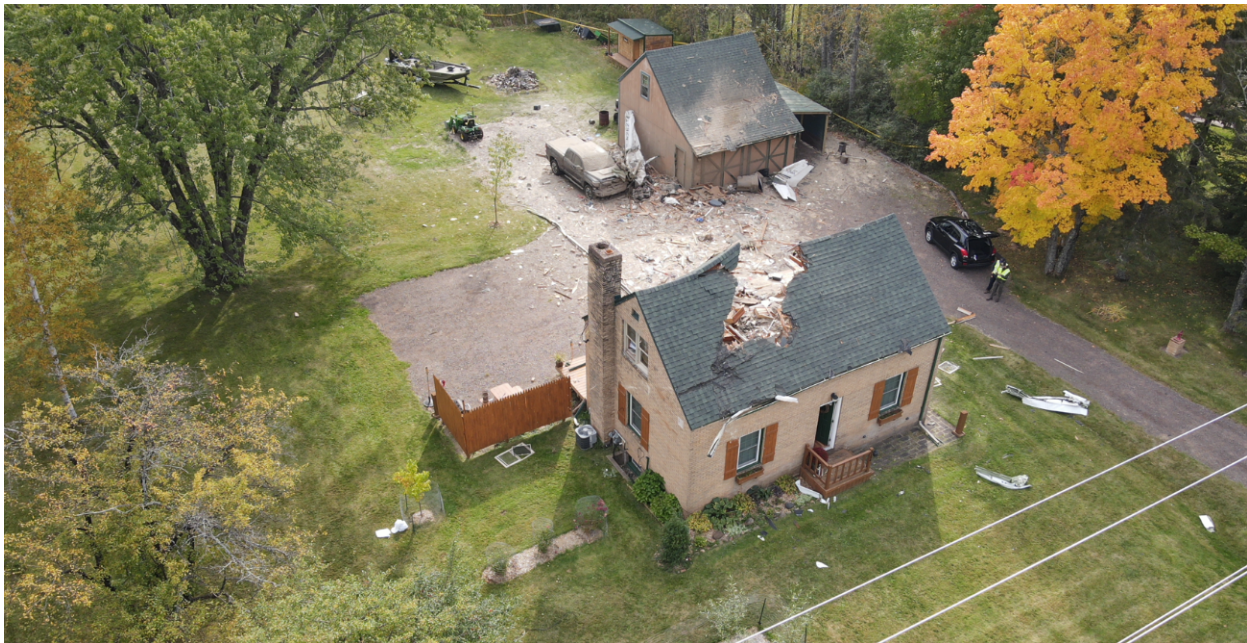
The airplane impacted electrical transmission wires and a 2-story home. The wing and left landing gear imprint on the house were consistent with the airplane impacting it in a 40° left bank as the airplane passed through the structure. It passed through two upstairs bedrooms as the occupants of the house slept, and then exited the home and came to rest inverted between a vehicle and a detached garage. There was no post-impact fire. The wreckage path was oriented on a magnetic heading of 205° and was about 175 ft in length. All major components of the airplane were located within the wreckage site.

Figure 3 - Aerial photograph of the accident site including the damaged house and the debris field that extended beyond it (photo courtesy of the Hermantown Police Department)
