Aviation Investigation Final Report

Location:	Perma, Montana	Accident Number:	WPR23LA001
Date & Time:	October 2, 2022, 09:00 Local	Registration:	N892SP
Aircraft:	SCODA AERONAUTICA LTDA SUPER PETREL LS	Aircraft Damage:	Substantial
Defining Event:	Low altitude operation/event	Injuries:	1 Fatal
Flight Conducted Under:	Part 91: General aviation - Personal

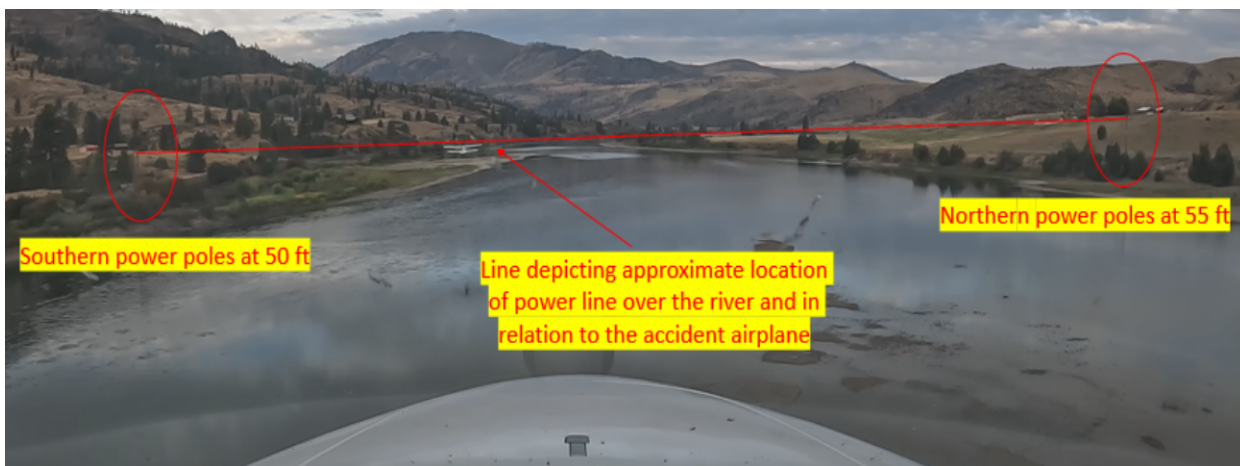
According to the trailing pilot, he was following the accident pilot on an impromptu low-level flight over a river. Without incident, they departed Polson Airport, Polson, MT, about 0800, as a flight of two. He reported that about an hour later, while trailing the accident airplane and flying westbound about 50 feet above the river, he saw the lead airplane abruptly pitch up, descend to the right, and impact the water. A still image from a video captured by the trailing pilot showed that the accident airplane was about the height of the powerline poles shortly before the airplane pitched up (see Figure 1).

Figure 1. Photo of power pole and line in relation to accident airplane before impact, with added depiction of the powerline over the river (courtesy of witness)

According to the power company, the “H” configured 2-pole structure on the north side of the river is about 50 ft above the ground (agl) and the structure on the south side of the river is about 55 ft agl, with a lineal span of 1026 ft. They estimated that the distribution powerline spanned above the water between 40 and 80 ft agl and that the line was not marked at the time of the accident.

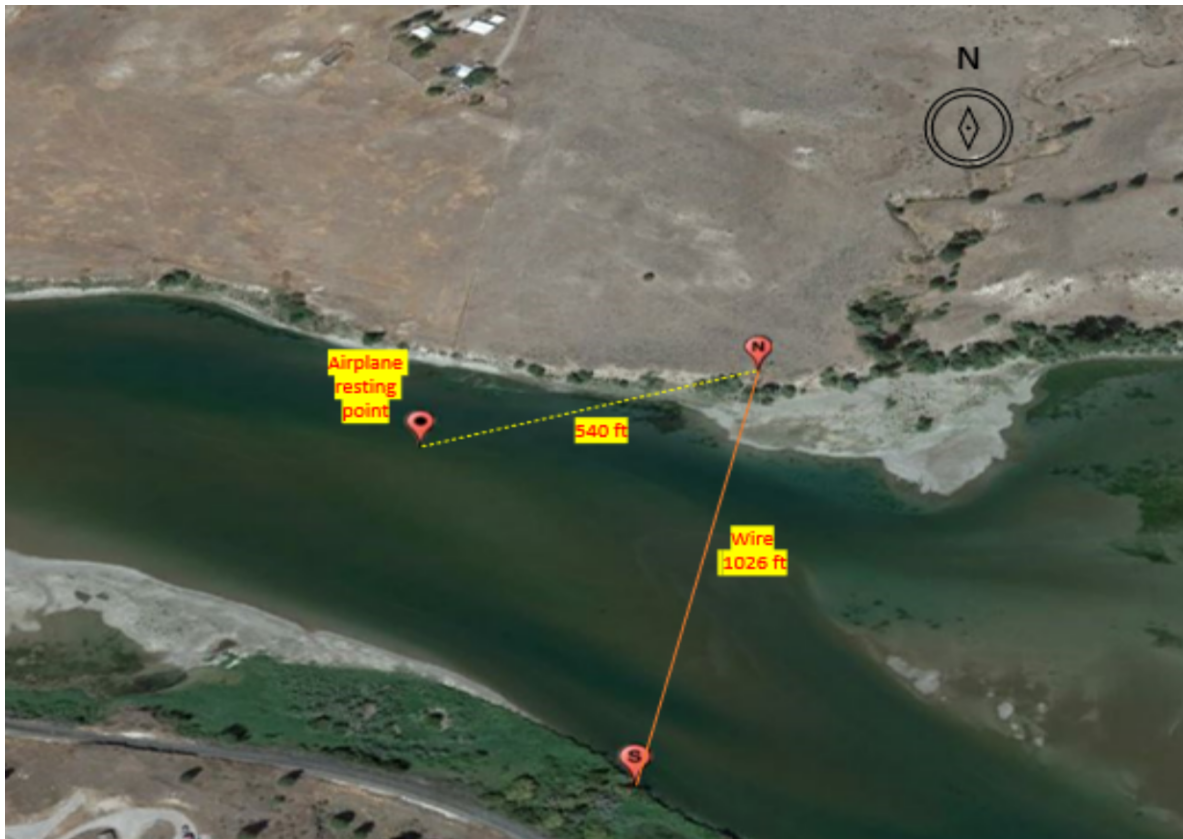
Figure 2. Map depiction of wreckage site in relation to powerlines

The airplane came to rest upright on a gravel bar that was about 4 ft below the water level and about 540 feet southwest of the northern power pole structure (see Figure 2). The engine and cabin were submerged with the wings and aft fuselage being above water. The tailcone was partially separated midspan; the empennage was inverted and partially submerged in the water. The airplane sustained substantial damage to the fuselage and both wings.
