# Aviation Investigation Final Report

<b>Location:</b>	Perma, Montana	<b>Accident Number:</b>	WPR23LA001
<b>Date &amp; Time:</b>	October 2, 2022, 09:00 Local	<b>Registration:</b>	N892SP
<b>Aircraft:</b>	SCODA AERONAUTICA LTDA SUPER PETREL LS	<b>Aircraft Damage:</b>	Substantial
<b>Defining Event:</b>	Low altitude operation/event	<b>Injuries:</b>	1 Fatal
<b>Flight Conducted Under:</b>	Part 91: General aviation - Personal

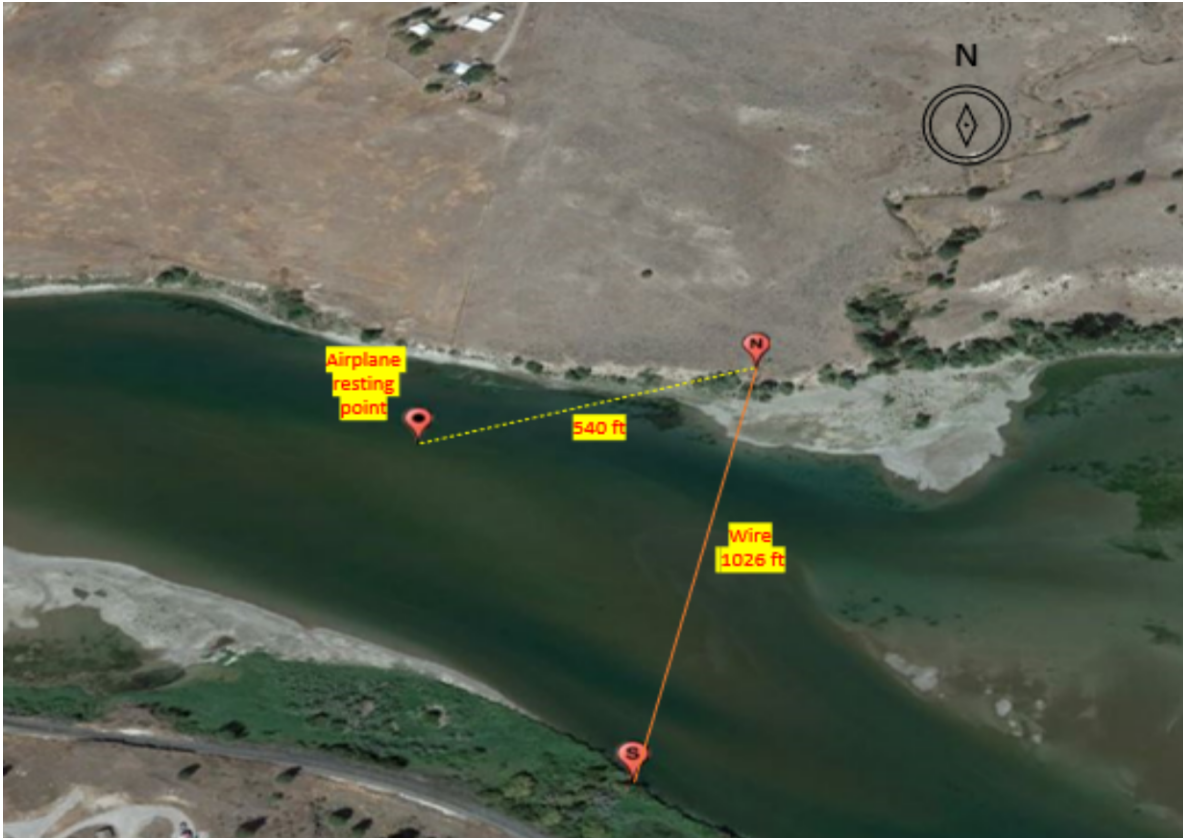
Figure 2. Map depiction of wreckage site in relation to powerlines

The airplane came to rest upright on a gravel bar that was about 4 ft below the water level and about 540 feet southwest of the northern power pole structure (see Figure 2). The engine and cabin were submerged with the wings and aft fuselage being above water. The tailcone was partially separated midspan; the empennage was inverted and partially submerged in the water. The airplane sustained substantial damage to the fuselage and both wings.
