# Aviation Investigation Final Report

<b>Location:</b>	Arundel, Maine	<b>Accident Number:</b>	ERA23FA006
<b>Date &amp; Time:</b>	October 5, 2022, 13:56 Local	<b>Registration:</b>	N902AT
<b>Aircraft:</b>	Beech A36	<b>Aircraft Damage:</b>	Destroyed
<b>Defining Event:</b>	Controlled flight into terr/obj (CFIT)	<b>Injuries:</b>	2 Fatal
<b>Flight Conducted Under:</b>	Part 91: General aviation - Business

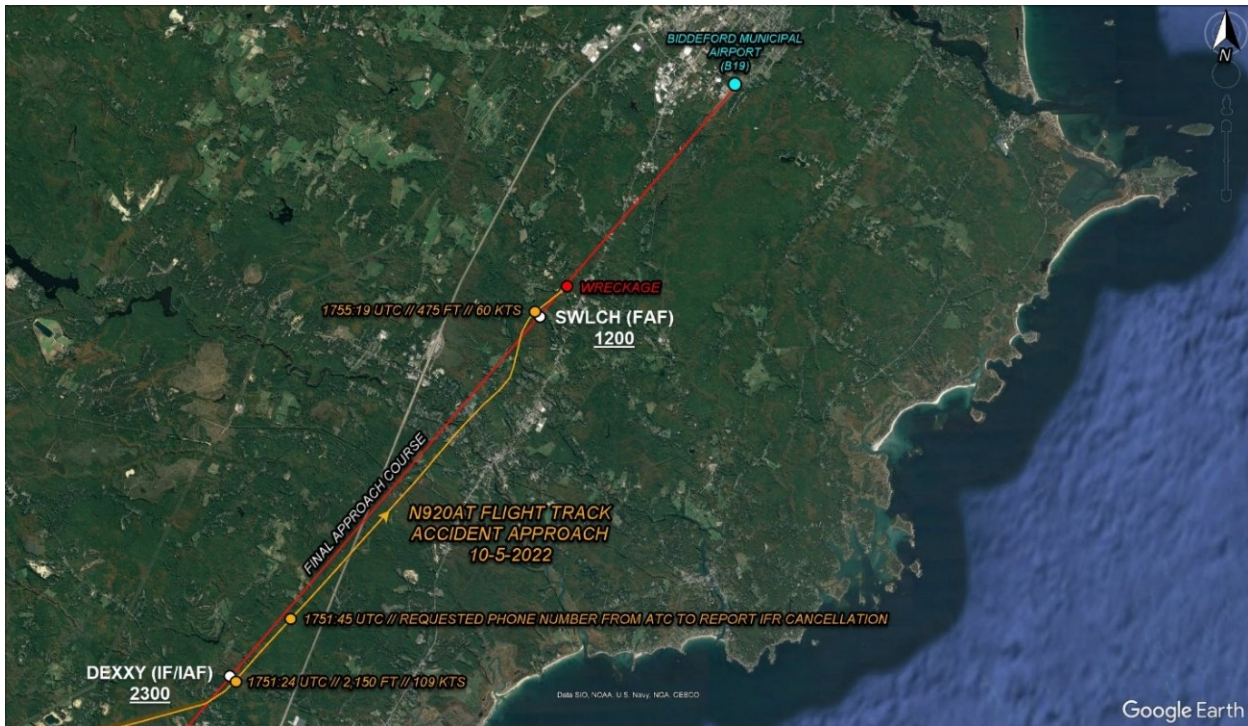
Figure 2 - View of Approach Track of Accident Flight with Altitudes at IAF and FAF (NTSB)

The airplane passed the final approach fix at 550 ft, which was 750 ft below the minimum descent altitude for that segment of the approach and had slowed to 58 kts ground speed. The airplane continued to descend over the next .75 miles at a ground speed about 60 kts before the data ended in the vicinity of the accident site.

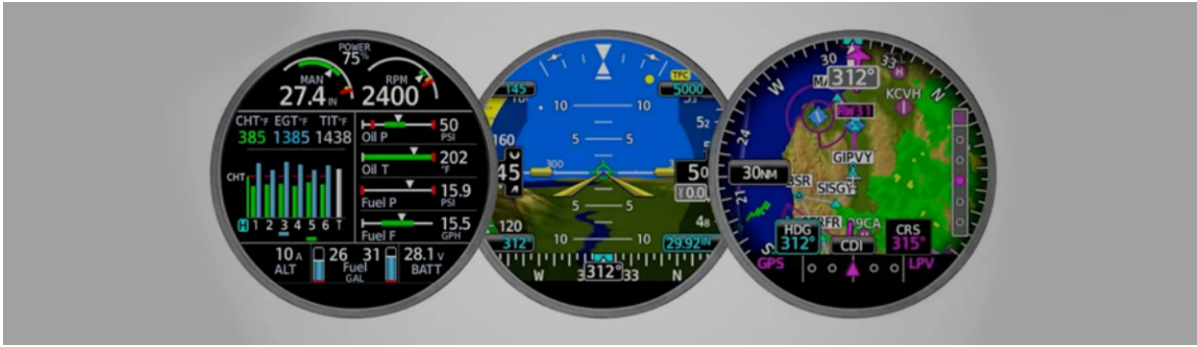
Figure 3 – Garmin GI 275 Attitude Indicator [AI/ADI] (Garmin.com)

Airworthiness documentation indicated that dual Garmin GI 275 electronic flight instruments (Attitude/Attitude Direction Indicator) were installed in the airplane on February 4, 2022. (See figure 3.) The FAA Form 337 filed for the installation stated, "Installed Dual Garmin GI275 with internal ADAHARS as Directional Gyro and GI275 with Autopilot interface as Attitude Indicator, and GI275 as Copilot ADI...per STC SA02658SE." According to a flight instructor who flew with the pilot following installation of the GI275s, the system installed in the accident airplane integrated with the airplane's S-TEC 55X autopilot.

The pilot logged 33.8 hours of experience in the accident airplane between the installation of the Garmin GI 275 displays and the accident flight, of which 7.2 hours was in actual instrument meteorological conditions. He logged 2 hours of dual flight instruction received on February 28, 2022. In the notes section, he annotated "familiarization" with the new avionics, two RNAV approaches flown, and a "go around" performed. There were no further dual-instruction-received entries annotated.

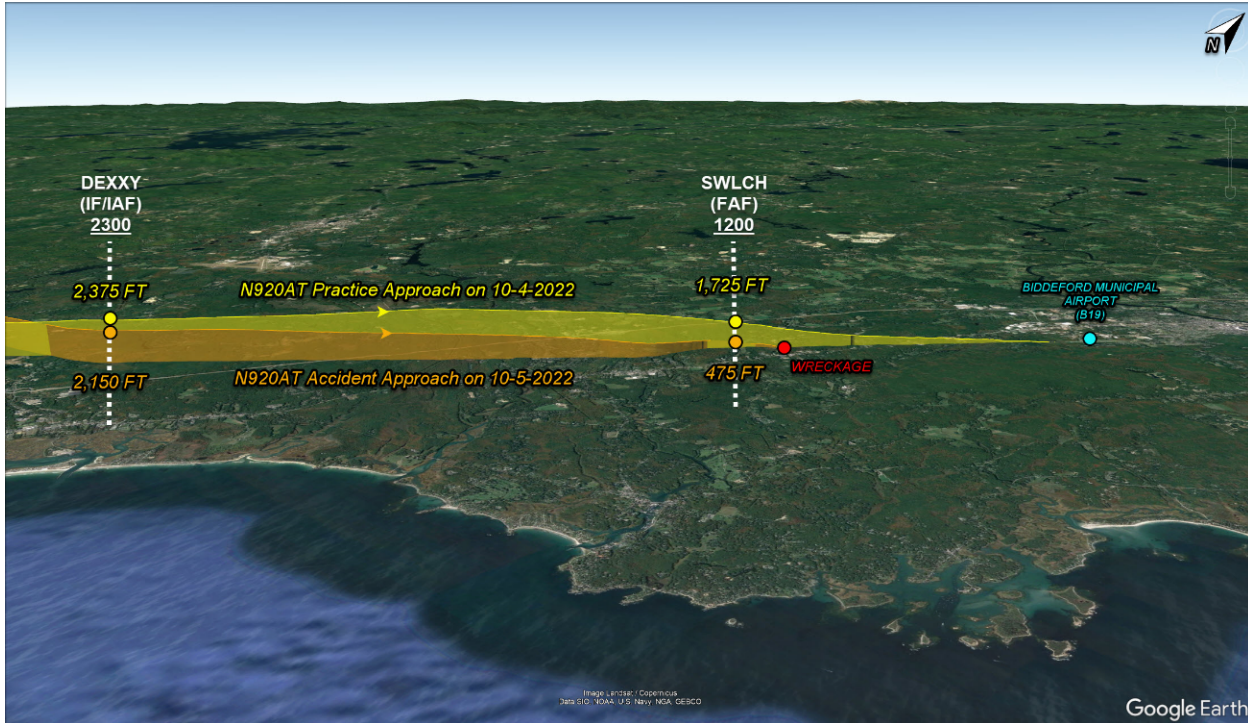
Figure 5 – Profile View of Practice and Accident Approaches at B19 (NTSB)

Once the airplane had reversed course and aligned with the inbound course of the approach, the data depicted an unstabilized approach with significant divergences in both airspeed and altitude, which was inconsistent with the use of the autopilot in a rate/descent mode.
