Aviation Investigation Final Report

Location:	Marietta, Ohio	Accident Number:	ERA23FA024
Date & Time:	October 18, 2022, 07:09 Local	Registration:	N515GK
Aircraft:	Beech E-90	Aircraft Damage:	Substantial
Defining Event:	Loss of control in flight	Injuries:	2 Fatal
Flight Conducted Under:	Part 91: General aviation - Positioning

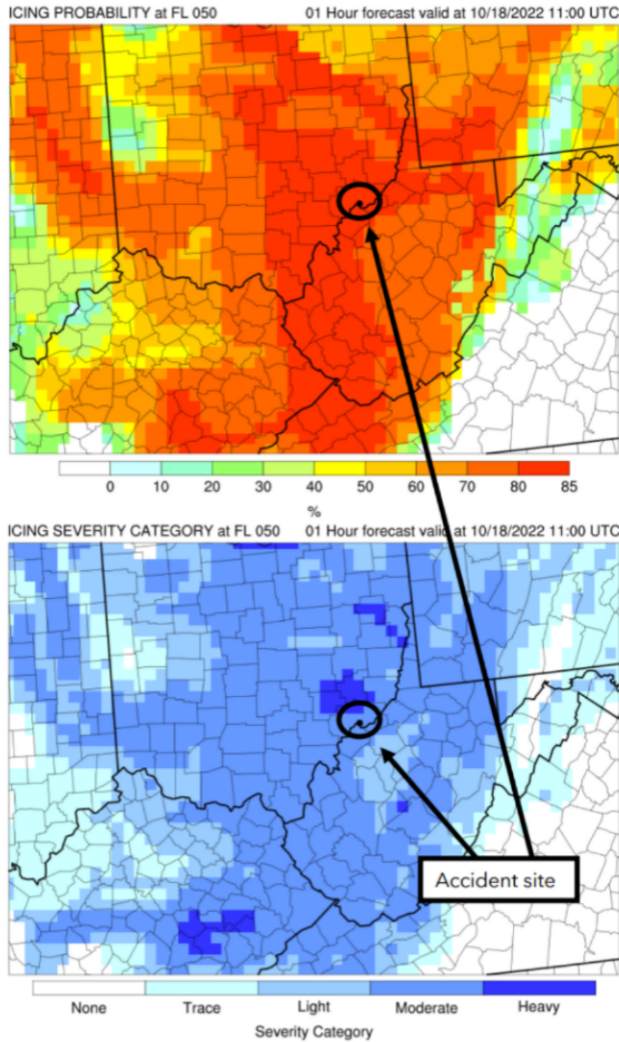
The NWS Current Icing Product (CIP) and Forecast Icing Product (FIP) were intended to supplement other icing advisories such as AIRMETs and SIGMETs. The CIP icing probabilities and severity and 1-hour forecast was valid at 0700 and showed that at 3,000, 4,000, and 5,000 ft, there was a 60 to 85% probability of icing at 3,000 to 5,000 ft surrounding the accident area (see figure 4). Furthermore, the icing intensity near the accident site ranged from “light” to “heavy,” with a 20 to 80% probability of Supercooled Large Droplets (SLD). For additional weather information see the meteorology factual report in the public docket for this investigation.

Figure 4 - Icing probability and severity charts with accident location annotated.
