Aviation Investigation Final Report

Location:	Georgetown, California	Accident Number:	WPR23LA021
Date & Time:	October 20, 2022, 10:10 Local	Registration:	N55DC
Aircraft:	Cessna 140	Aircraft Damage:	Substantial
Defining Event:	Loss of control in flight	Injuries:	1 None
Flight Conducted Under:	Part 91: General aviation - Personal

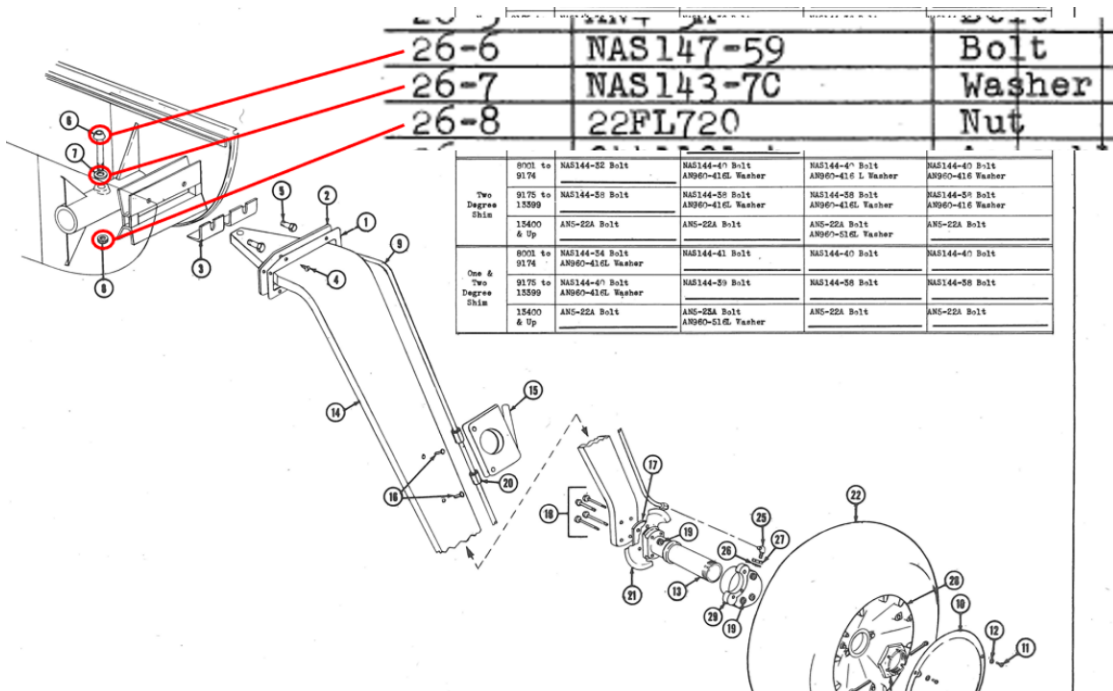
Figure 1: Excerpt of main landing gear drawing from parts manual

According to the airplane parts manual, the main landing gear legs bolt to the fuselage airframe structure with a bolt, washer, and a nut. (See figure 1).

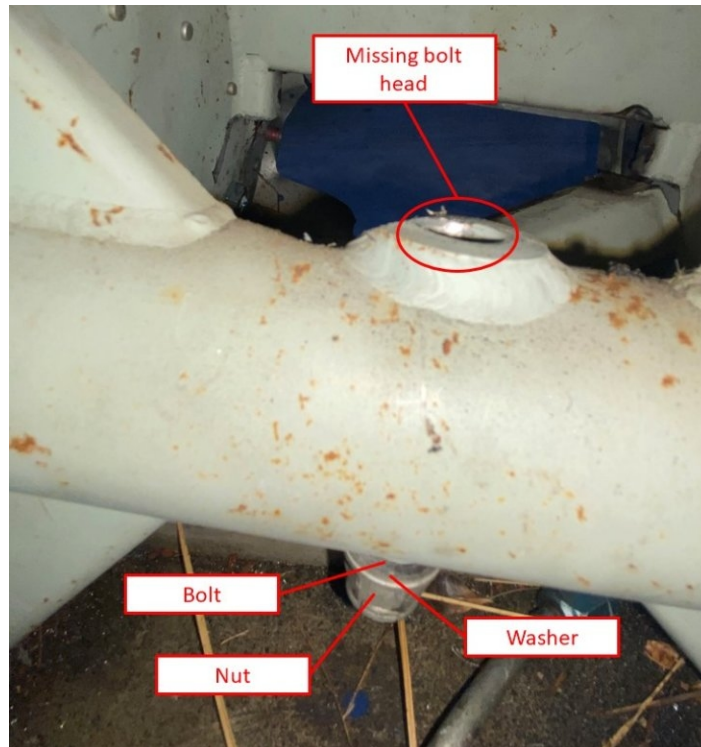
Figure 2: Landing gear leg assembly hardware on accident airplane

Postaccident examination of the landing gear assembly revealed that the right main landing gear leg was normally secured to a support assembly within the airframe by a bolt, washer, and nut. The bolt remained attached with its associated hardware, but the bolthead had fractured in overstress. In addition, there was downward deformation at the lower support of the main landing gear support assembly, likely due to an exceedance of the yield strength of the metal and consistent with overload separation. As the bolt and damaged area of the support assembly are designed to transfer the landing gear loads directly to the airframe, the evidence in this case suggests that the right main landing gear support assembly failed as the result of the pilot's failure to maintain directional control during an attempted go-around, which resulted in runway excursion and a separation of the right main landing gear.

The landing gear bolt remained inside the bolt hole along with its associated hardware, including the nut and washer at the fuselage primary structure. The bolt head separated and was not located. In addition, a portion of the landing gear support assembly was fractured and partially separated.

A National Transportation Safety Board materials laboratory examination revealed that the fracture features of the bolt were consistent with ductile overstress from a shear overload. No evidence of preexisting damage was observed. The forward end of the landing gear support assembly outboard attachment was fractured at 2 locations on the lower support. The upper side of the lower support was deformed downward near the forward attachment location and the outboard flange was fractured, which appeared to coincide with the downward bend at the upper surface. The downward deformation at the forward end of the lower support is consistent with wheel loading in the aft direction, and the deformation suggests the applied load was sufficient to produce stresses that exceeded the yield strength of the material.
