Aviation Investigation Final Report

| Location: | Hanover Township, Pennsylvania | Accident Number: | ERA23FA045 |
| Date & Time: | October 29, 2022, 14:52 Local | Registration: | N964RS |
| Aircraft: | Bearhawk Patrol | Aircraft Damage: | Substantial |

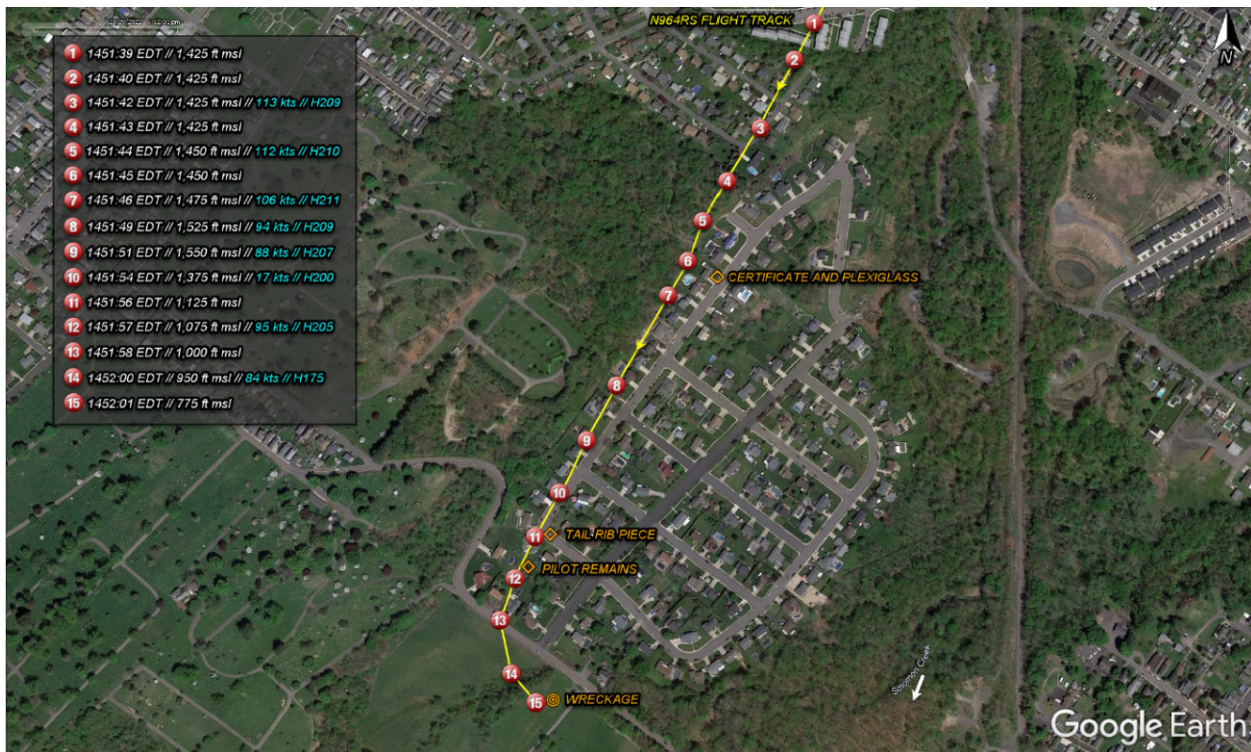
The airplane impacted a grass field about 5.2 nautical miles southwest of WBW. A linear ground scar, consistent with the length of the left wing, extended from the center of the wreckage with the scar oriented toward a magnetic heading of 338°, and the wings came to rest oriented on a magnetic heading of 319°. All major airplane components were located on site; however, paint chips, the airworthiness certificate, and portions of the cockpit ceiling or side window Plexiglas were the first items along the 1,900-ft-long debris path leading to the main wreckage, followed by a portion of a tail rib at 900 ft and the pilot at 530 ft from the main wreckage (see figure 1.)

Figure 1 - Flight path (yellow line) with annotated position, time, altitude, ground speed, and path heading. The locations of recovered debris are also plotted.
