Aviation Investigation Final Report

Location:	Harlan, Kentucky	Accident Number:	ERA23FA048
Date & Time:	November 3, 2022, 10:09 Local	Registration:	N84R
Aircraft:	Beech A36	Aircraft Damage:	Destroyed
Defining Event:	VFR encounter with IMC	Injuries:	1 Fatal
Flight Conducted Under:	Part 91: General aviation - Personal

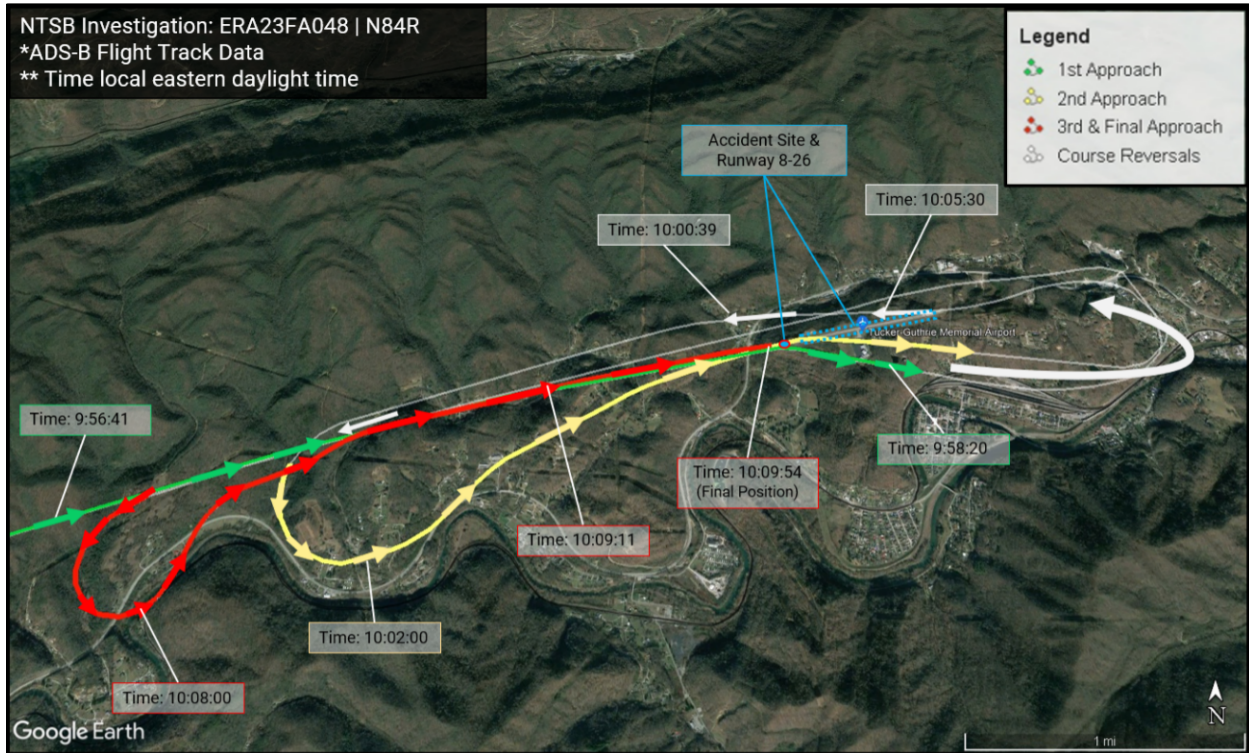
The flight track data revealed that the airplane completed multiple approaches and maneuvers over the airport environment. About 0958, the airplane flew over runway 8 and made a slight right turn followed by a left 180° teardrop turn. This was the first pass over runway 8. About 1000, the airplane flew over runway 26 on an extended centerline before it made another left teardrop 180° turn back toward runway 8. About 1002, the airplane made a second pass over runway 8 before it made a slight right turn again and another left 180° teardrop turn. About 1005, the airplane flew over runway 26 on a longer extended centerline before it made another left 180° teardrop turn to intercept an extended centerline course for runway 8. This was the third and final approach to runway 8.

About 1009, the airplane followed an extended centerline course toward runway 8. The last recorded position was at 1009:54, about 0.1 nautical mile from the runway 8 threshold. Subsequently, the airplane impacted a ravine and steep rock wall about 50 ft below the runway elevation and 375 ft from the runway 8 threshold. Figure 1 displays an overview of the ADS-B flight track.

Figure 1 - ADS-B flight track displaying the three approaches to runway 8 in addition to the 180° left teardrop turns (displayed in white). The green line represents the first approach. The yellow line represents the second approach and the red line represents the third and final approach.

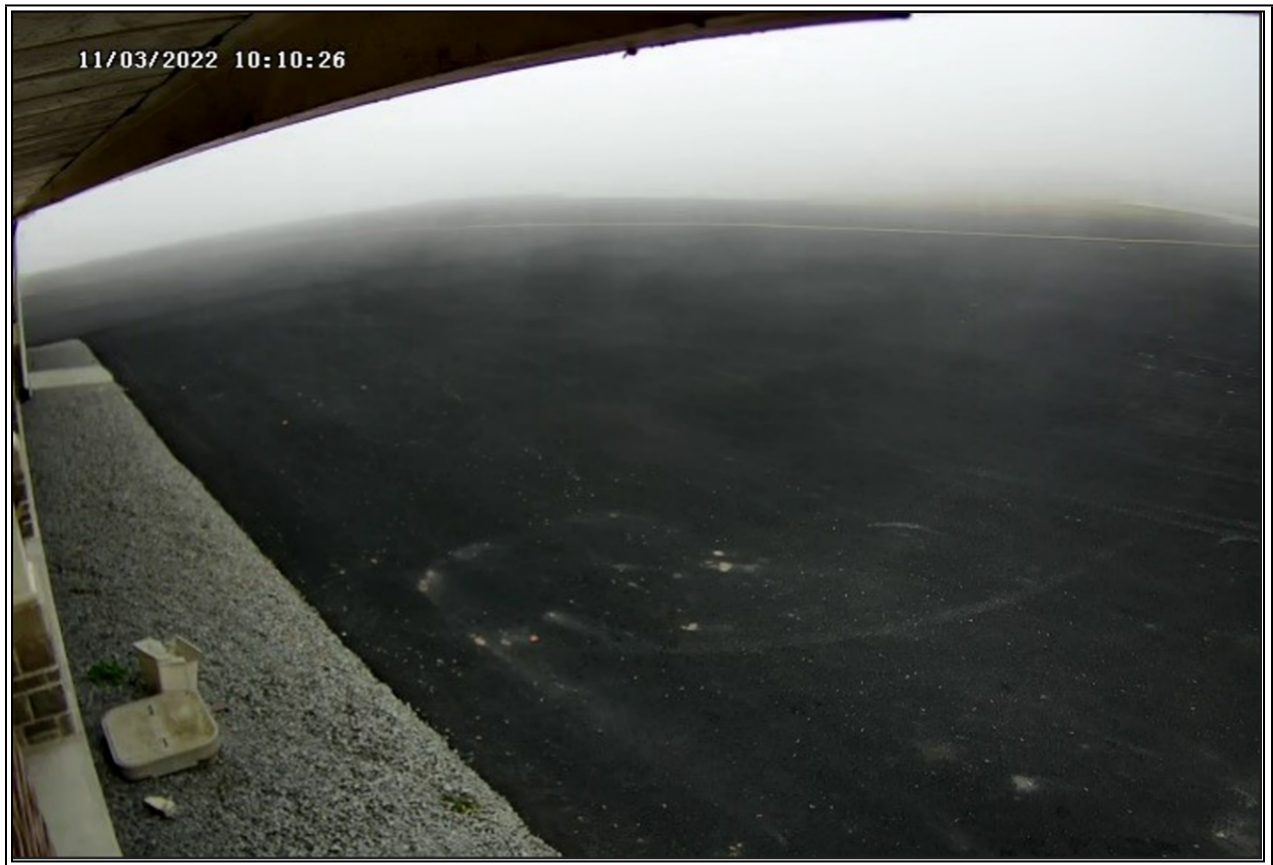
Figure 2 - Surveillance video screenshot at the time of the accident, as viewed from the airport terminal.

The estimated visibility (based on measurements to known objects via aerial imagery) was limited to about 175 ft due to fog and low clouds. An additional image was provided (figure 3), that displayed improved visibility about an hour and a half after the accident.

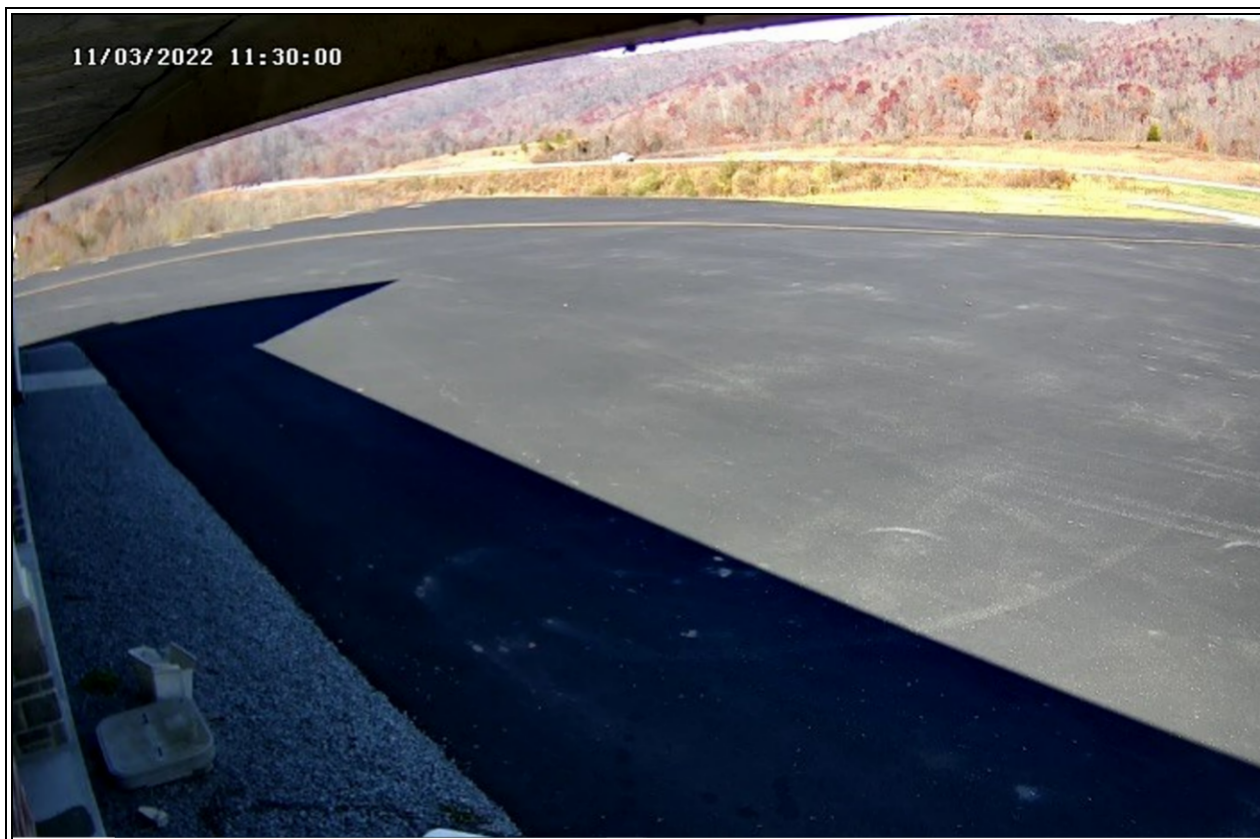
Figure 3 - Surveillance video screenshot taken at 1130 the day of the accident, showing that the fog had burnt off and visibility had improved, as viewed from the airport terminal.

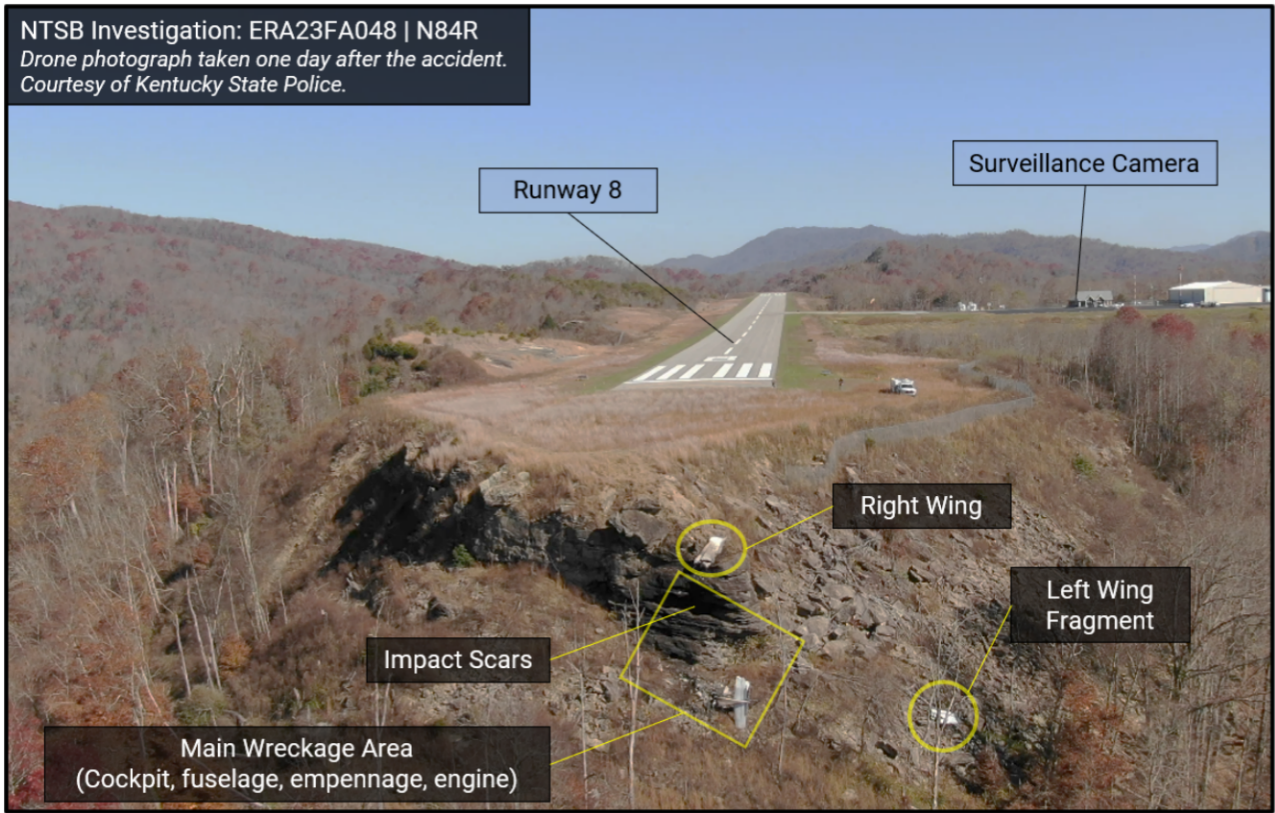
All major portions of the airplane were located; a post-impact fire consumed a majority of the cockpit, fuselage, and portions of the left wing. Figure 4 provides an overview of the airport environment approaching runway 8 and the distribution of wreckage.

Figure 4: Overview of the airport environment and distribution of wreckage
