# Aviation Investigation Final Report

<b>Location:</b>	Harlan, Kentucky	<b>Accident Number:</b>	ERA23FA048
<b>Date &amp; Time:</b>	November 3, 2022, 10:09 Local	<b>Registration:</b>	N84R
<b>Aircraft:</b>	Beech A36	<b>Aircraft Damage:</b>	Destroyed
<b>Defining Event:</b>	VFR encounter with IMC	<b>Injuries:</b>	1 Fatal
<b>Flight Conducted Under:</b>	Part 91: General aviation - Personal

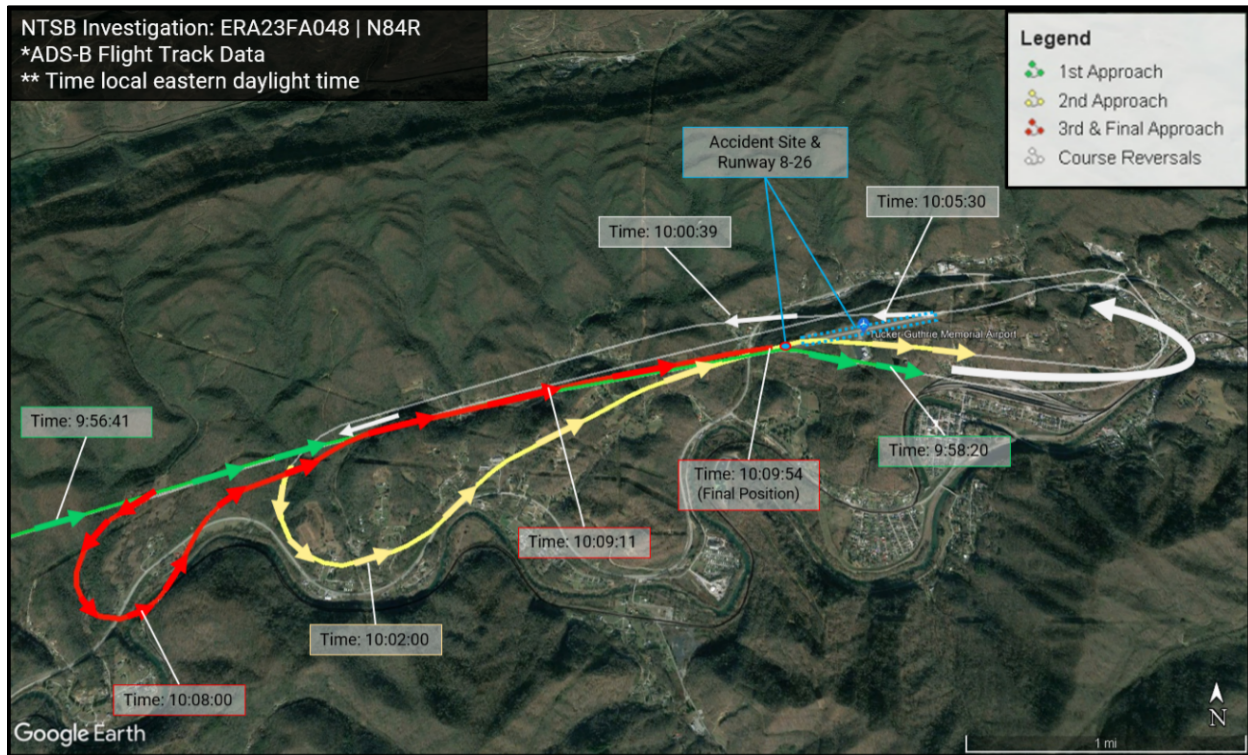
The flight track data revealed that the airplane completed multiple approaches and maneuvers over the airport environment. About 0958, the airplane flew over runway 8 and made a slight right turn followed by a left 180° teardrop turn. This was the first pass over runway 8. About 1000, the airplane flew over runway 26 on an extended centerline before it made another left teardrop 180° turn back toward runway 8. About 1002, the airplane made a second pass over runway 8 before it made a slight right turn again and another left 180° teardrop turn. About 1005, the airplane flew over runway 26 on a longer extended centerline before it made another left 180° teardrop turn to intercept an extended centerline course for runway 8. This was the third and final approach to runway 8.

About 1009, the airplane followed an extended centerline course toward runway 8. The last recorded position was at 1009:54, about 0.1 nautical mile from the runway 8 threshold. Subsequently, the airplane impacted a ravine and steep rock wall about 50 ft below the runway elevation and 375 ft from the runway 8 threshold. Figure 1 displays an overview of the ADS-B flight track.

Figure 1 - ADS-B flight track displaying the three approaches to runway 8 in addition to the 180° left teardrop turns (displayed in white). The green line represents the first approach. The yellow line represents the second approach and the red line represents the third and final approach.

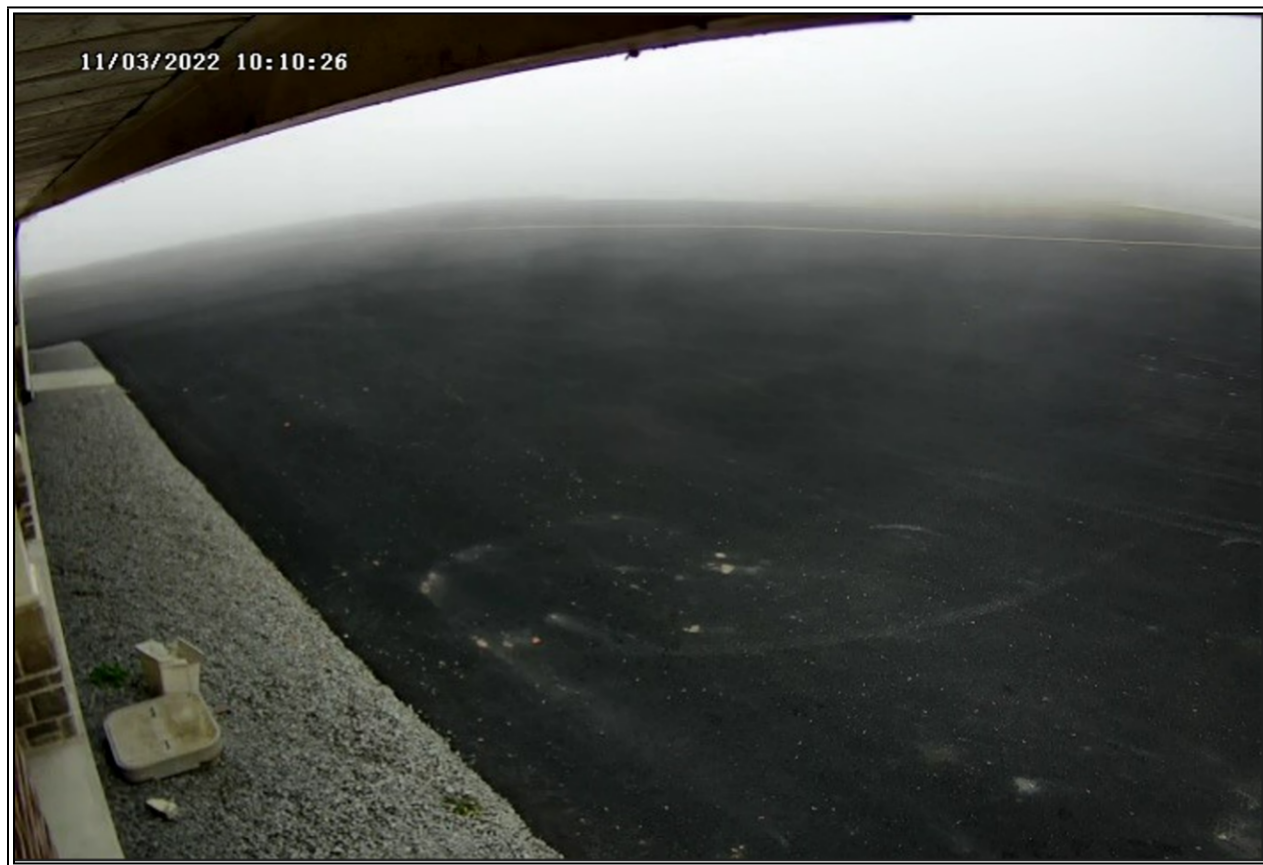
Figure 2 - Surveillance video screenshot at the time of the accident, as viewed from the airport terminal.

The estimated visibility (based on measurements to known objects via aerial imagery) was limited to about 175 ft due to fog and low clouds. An additional image was provided (figure 3), that displayed improved visibility about an hour and a half after the accident.

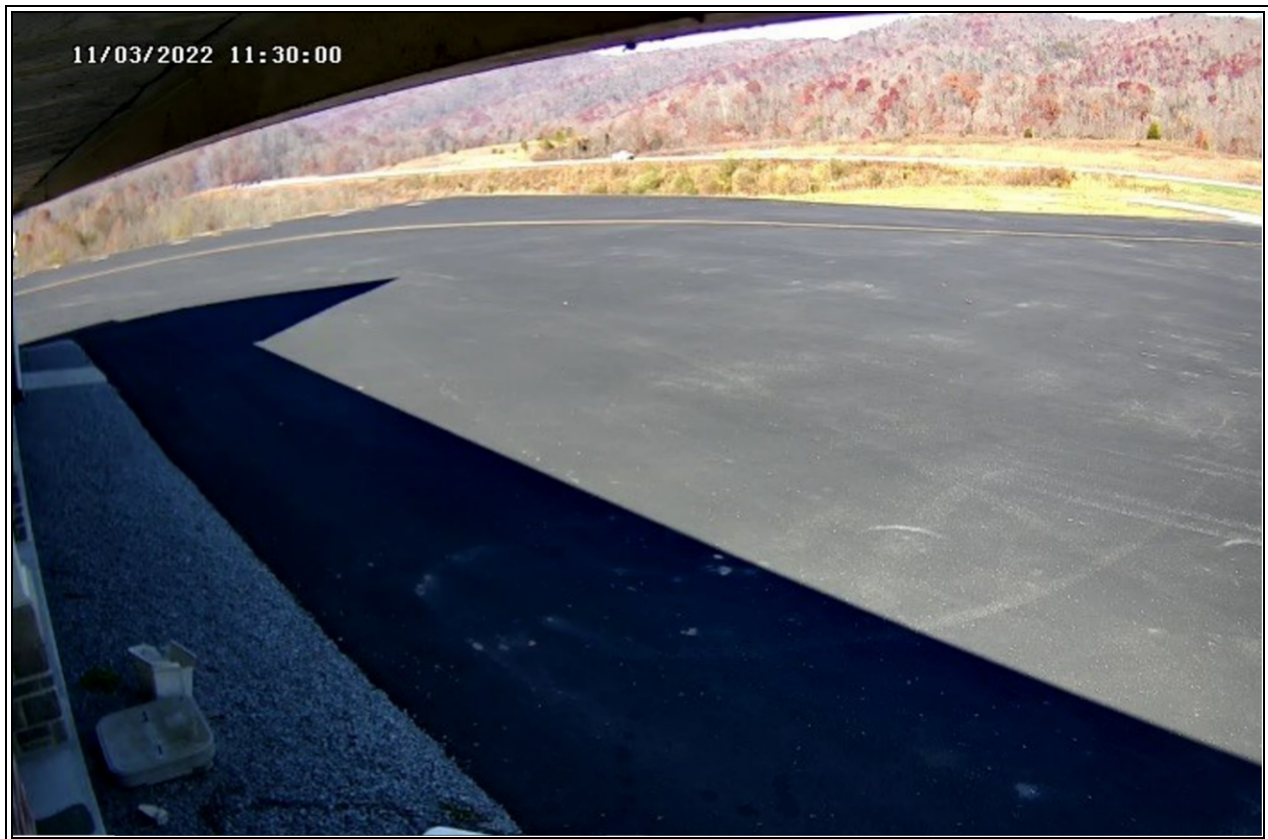
*Figure 3 - Surveillance video screenshot taken at 1130 the day of the accident, showing that the fog had burnt off and visibility had improved, as viewed from the airport terminal.*

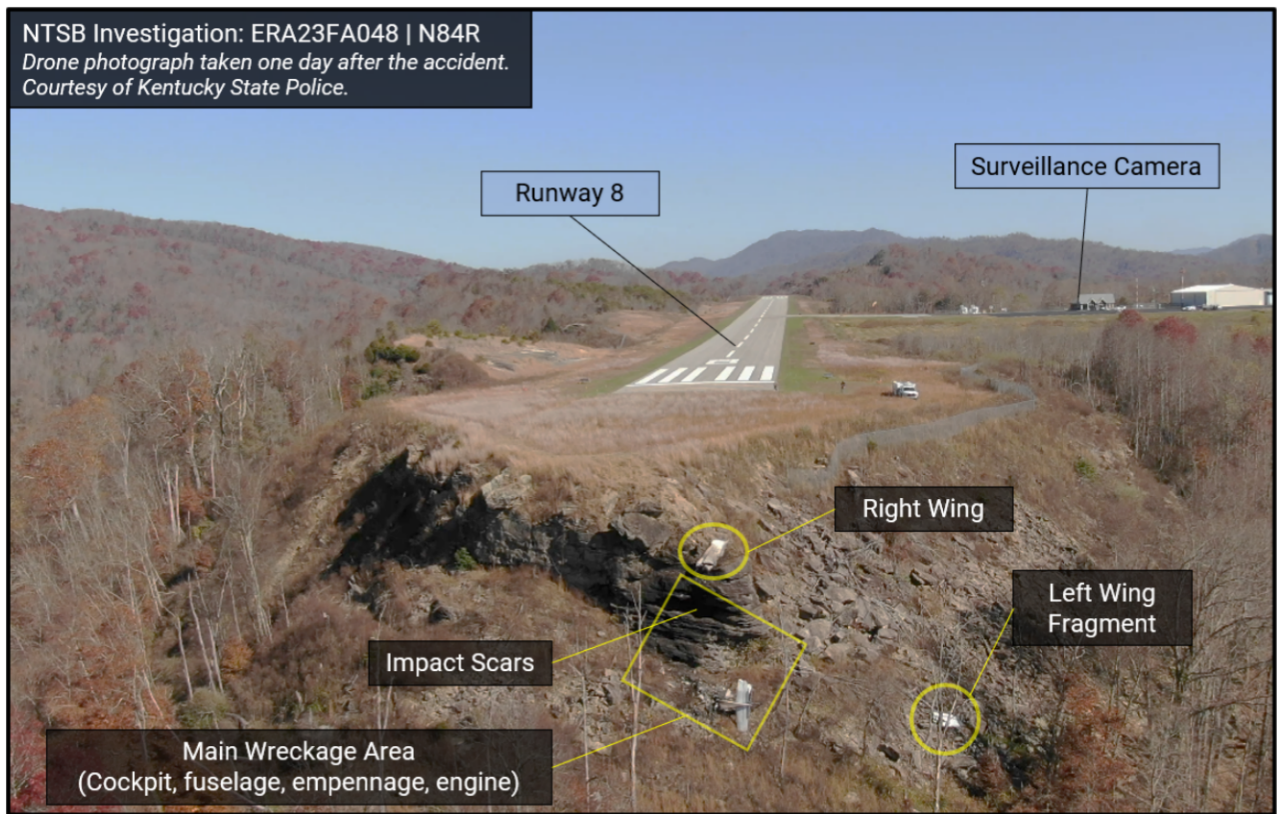
All major portions of the airplane were located; a post-impact fire consumed a majority of the cockpit, fuselage, and portions of the left wing. Figure 4 provides an overview of the airport environment approaching runway 8 and the distribution of wreckage.

Figure 4: Overview of the airport environment and distribution of wreckage
