Aviation Investigation Final Report

Location:	Slidell, Louisiana	Accident Number:	CEN23LA028
Date & Time:	November 6, 2022, 21:45 Local	Registration:	N809DM
Aircraft:	Beech E-90	Aircraft Damage:	Destroyed
Defining Event:	Loss of control in flight	Injuries:	1 Serious
Flight Conducted Under:	Part 91: General aviation - Positioning

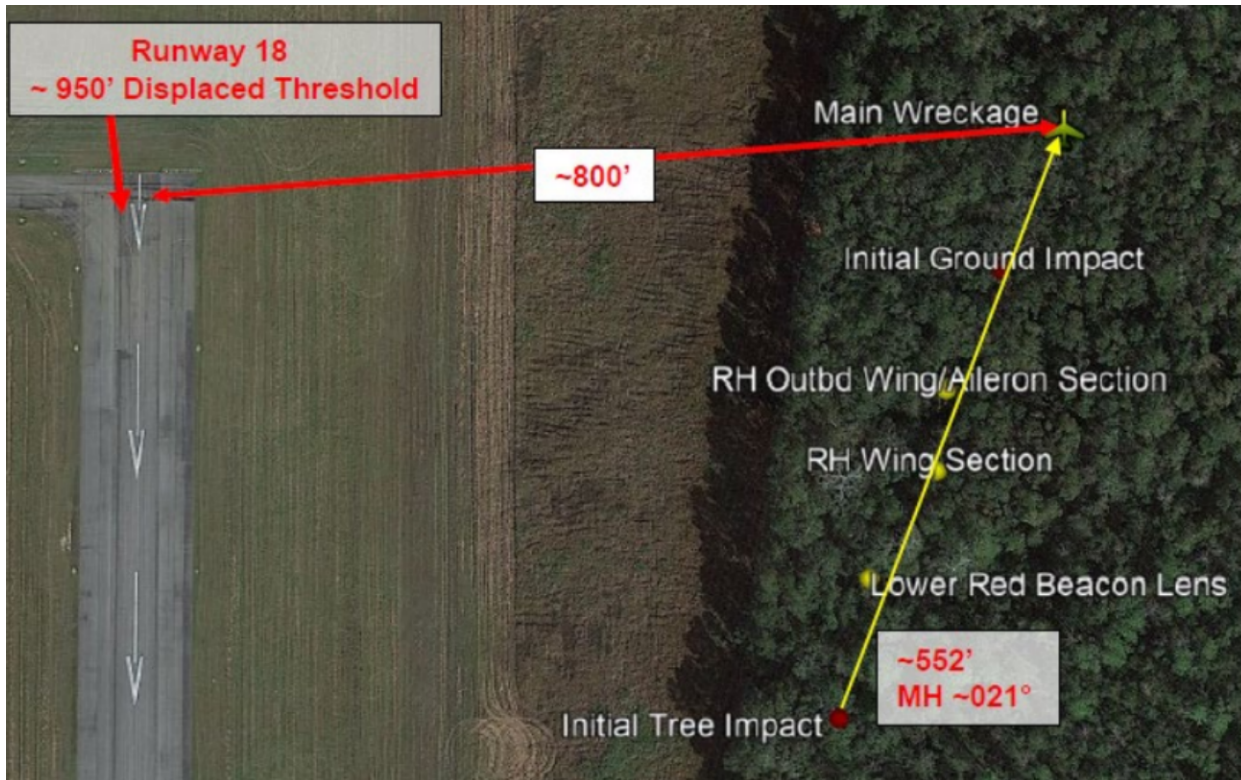
Figure 1. Wreckage Diagram, Courtesy of Textron Aviation

The airplane initially impacted trees with the right wing (see Figure 1). The main wreckage came to rest upright and was consumed by a post-impact fire. The postaccident examination of the airplane revealed no preimpact anomalies that would have precluded normal operation.
