Aviation Investigation Preliminary Report

| Location: | Snohomish, WA | Accident Number: | WPR23FA034 |
| Date & Time: | November 18, 2022, Local | Registration: | N2069B |
| Aircraft: | TEXTRON AVIATION INC 208B | Injuries: | 4 Fatal |

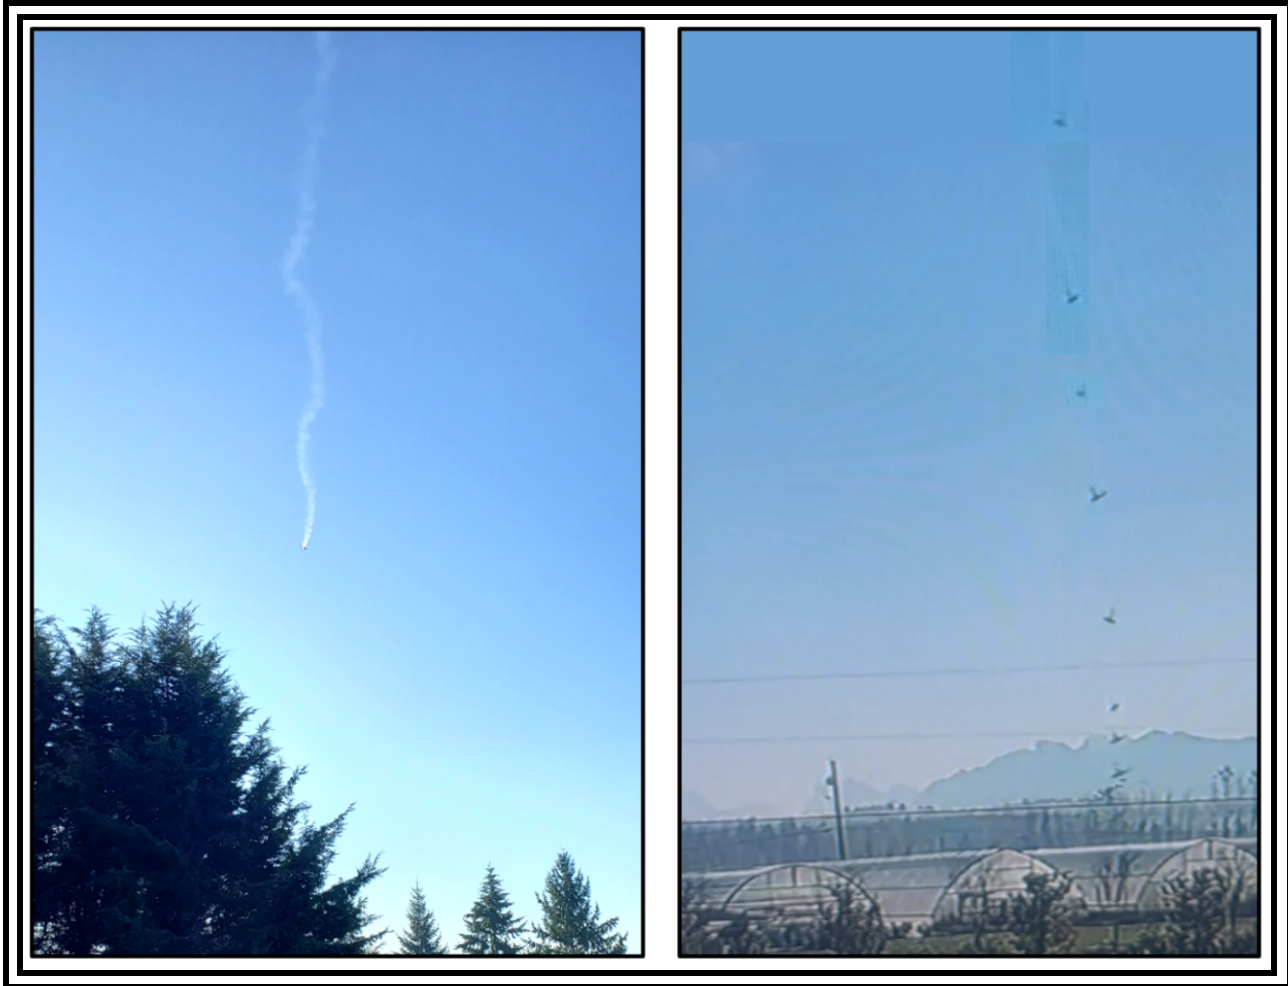
The purpose of the accident flight was to complete that test card from the day prior, which was baseline testing of the airplane’s aft CG stall characteristics. Witnesses reported that they observed the airplane break-up inflight and watched pieces floating down. The airplane then descended in a nose-low near-vertical corkscrew maneuver toward the ground (see Figure 1 below). Several witnesses reported seeing a white plume of smoke when they observed the airplane break into pieces. A security camera recorded a low-quality image of the airplane rotating about its longitudinal axis in nose-low attitude (see Figure 1 below).

Figure 1: Picture from Witness (left) and Excerpts of Video Still Images

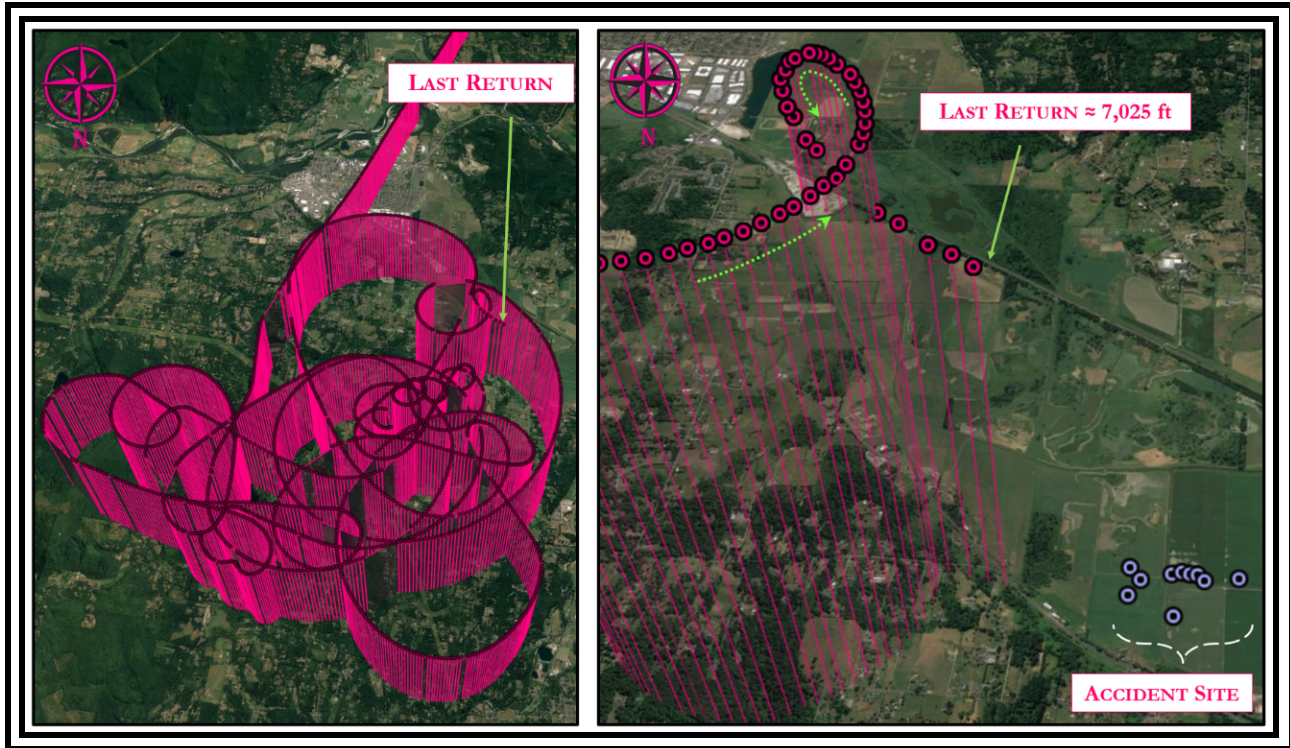
A review of the preliminary radar track data indicated that after departing Renton, Washington around 0925, the airplane continued to the north. The airplane continued in a gradual climb to about 9,500 ft mean sea level (msl) and began a series of turns/maneuvers. The airplane proceeded for about 45 minutes varying in altitude between about 6,500 ft to 10,275 ft msl. At 1017 the track data indicated the airplane was climbing to an altitude of 9,700 ft msl and turning to the left.

The radar data further shows that the track made a near 360° turn and then at 1019:06, there was a sharp 180° left-turn. The track continued west until the last recorded hit at 1019:18. During the last 12 seconds the track indicated that the airplane's descent rate exceeded 14,000 ft-per-minute (fpm) and gradually lessened to 8,700 fpm at the last hit. The main wreckage was located about 2,145 ft east of the last recorded track data.

The right-seat pilot that flew on the day prior to the accident reviewed that track data. He thought that just prior to the accident, they were likely at the second to last maneuver on the card which specified: 96 kts indicated airspeed; flaps in landing configuration; 930 ft-lbs of torque; propeller rpm fully forward; and accelerated 30° bank to the left.

Figure 2: Radar Data of Maneuvers During Flight (left) and Last Turns

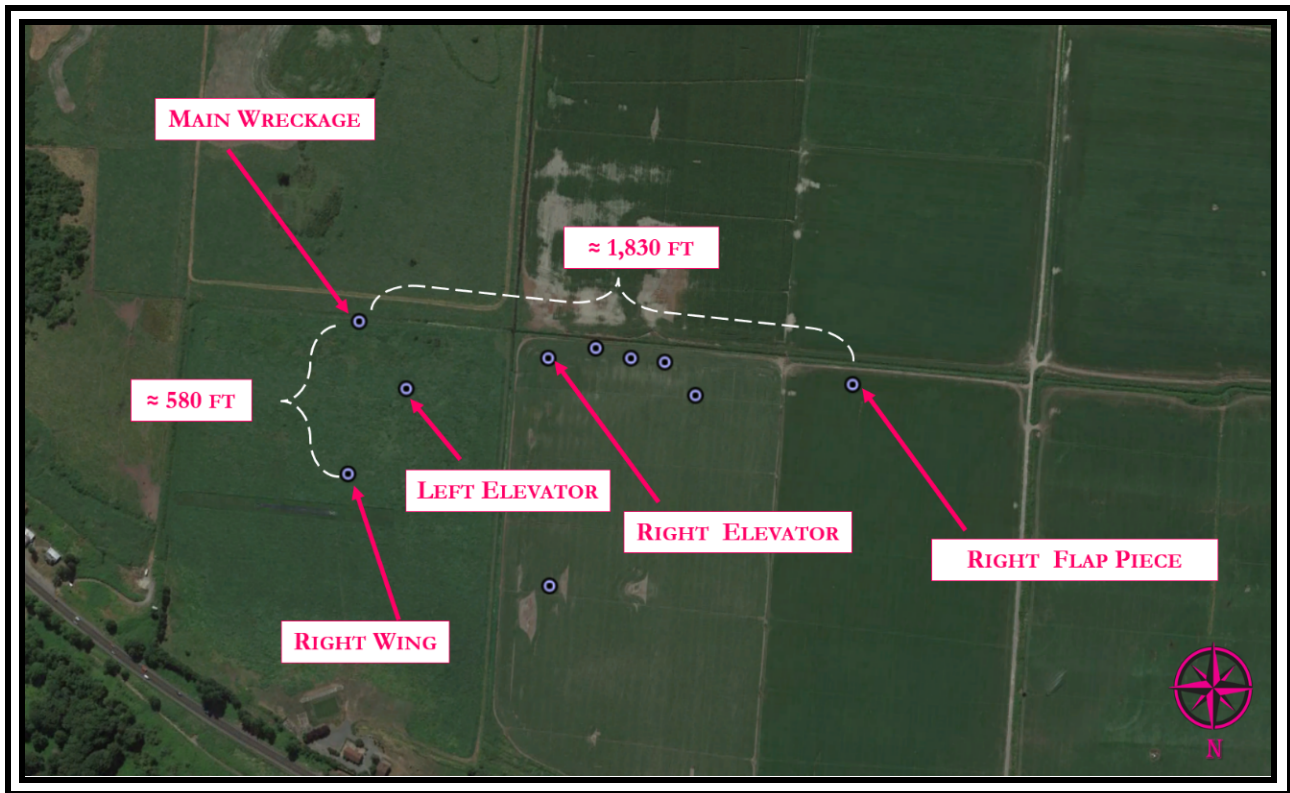
The wreckage was distributed over an approximate 1,830 ft distance on a median magnetic bearing of about 270°. The main wreckage and right wing were located at the beginning of the debris field and about 580 ft apart (see below Figure3). The main wreckage, consisting of the engine, cockpit (and cargo pod), cabin, vertical stabilizer, and rudder, was partially consumed by fire. The right-wing strut separated from the fuselage attachment point, but remained attached to the wing; the right flap was separated into numerous pieces and scattered among the debris field. The left-wing separated from the fuselage although was located adjacent to the main wreckage; the flap remained attached and was found in the retracted position.

Figure 3: Wreckage Debris Field
