Aviation Investigation Final Report

Location:	Snohomish, Washington	Accident Number:	WPR23FA034
Date & Time:	November 18, 2022, 10:19 Local	Registration:	N2069B
Aircraft:	TEXTRON AVIATION INC 208B	Aircraft Damage:	Substantial
Defining Event:	Aircraft structural failure	Injuries:	4 Fatal
Flight Conducted Under:	Part 91: General aviation - Flight test

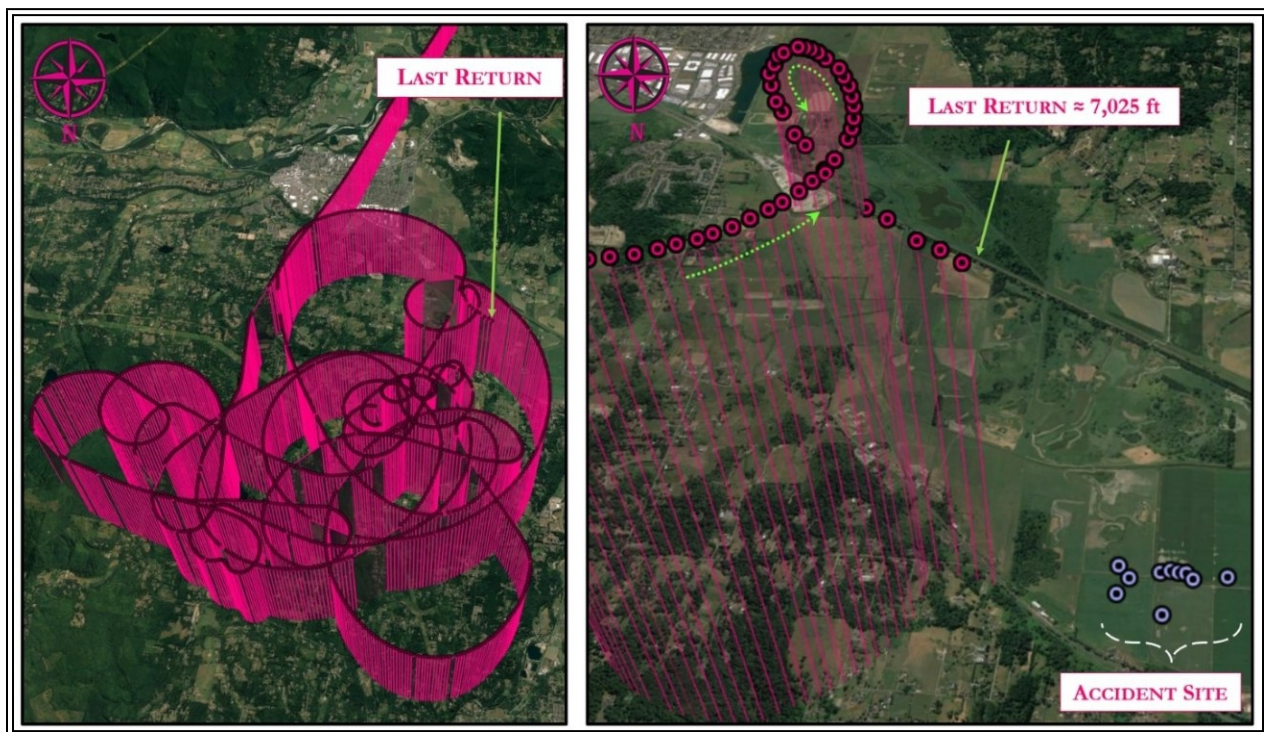
At 1019:05, the ADS-B data indicated a sudden and tight course reversal from east to west, corresponding with the minimum airspeed and a dramatic increase in the descent rate. The computed roll angle stayed consistent at about 30° left until the course reversal. The ADS-B data stopped at 1019:17 about 7,025 ft msl with a recorded descent rate of 8,700 fpm (see Figure 1 below). The location of the wreckage, witness statements, and video footage were all consistent with the airplane breaking apart inflight shortly thereafter. The main wreckage was located about 2,145 ft east of the last recorded return.

Figure 1: Radar data of maneuvers during flight (left) and last turn (right)

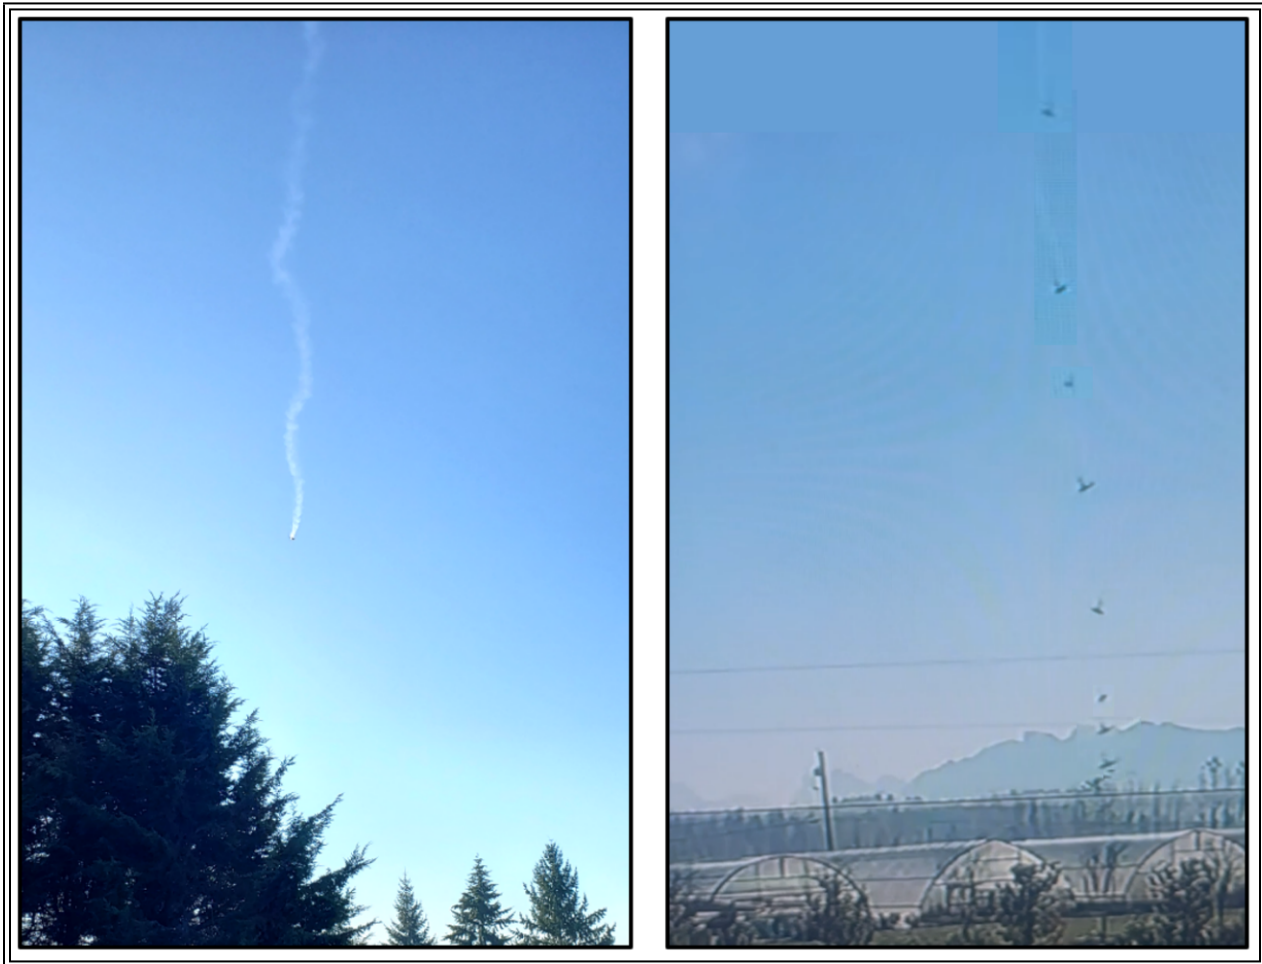
Witnesses reported that they observed the airplane break up in flight and watched pieces floating down. The airplane then descended in a nose-low, near-vertical corkscrew maneuver toward the ground. Several witnesses reported seeing a white plume of smoke when they observed the airplane break into pieces. A security camera recorded a low-quality image of the airplane rotating about its longitudinal axis in nose-low attitude (see figure 2 below).

Figure 2: Picture from witness (left) and excerpts of video still images (right)

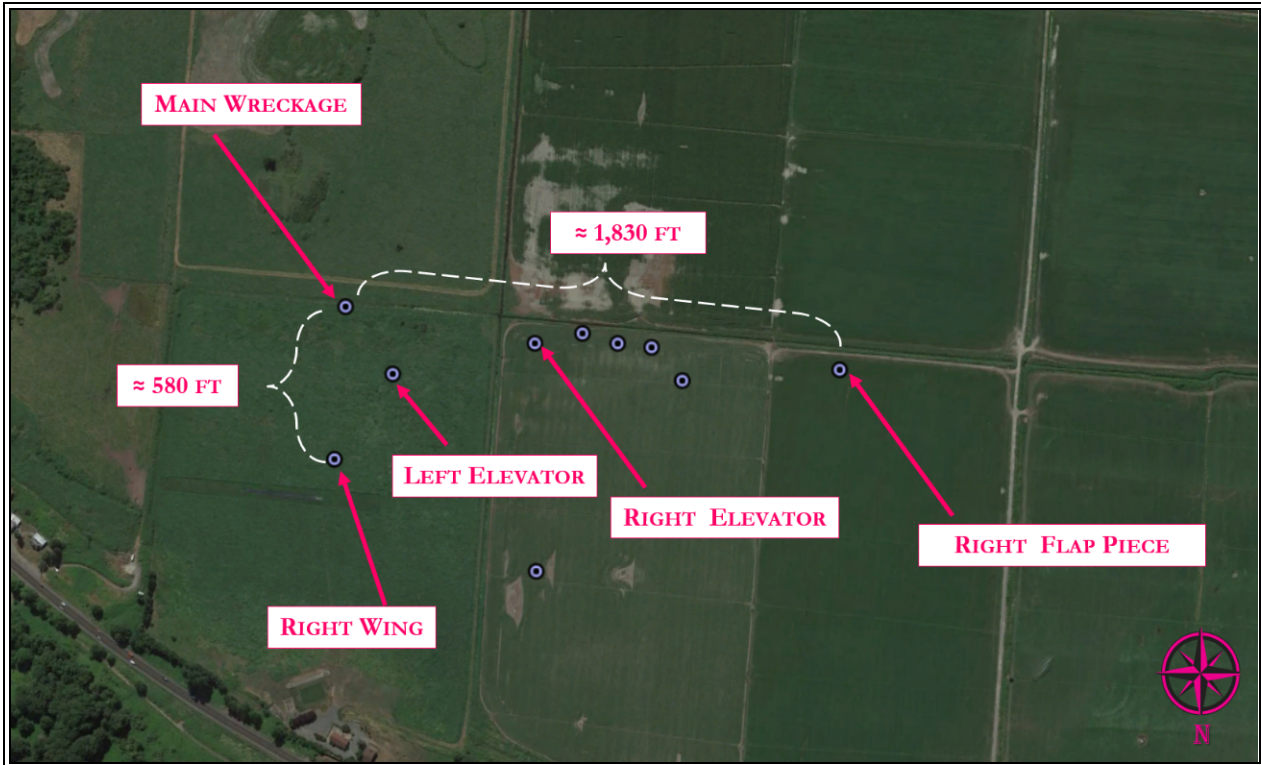
The wreckage was distributed over about 1,830 ft on a median magnetic heading of about 270°. The main wreckage and right wing were located at the beginning of the debris field and about 580 ft apart (see Figure 3 below). The main wreckage, consisting of the engine, cockpit (and cargo pod), cabin, vertical stabilizer, and rudder, was partially consumed by fire. The right wing strut separated from the fuselage attachment point, but remained attached to the wing; the right flap was separated into numerous pieces and scattered among the debris field. The left wing separated from the fuselage and was located adjacent to the main wreckage; the flap remained attached and was found in the retracted position.

Figure 3: Wreckage debris field

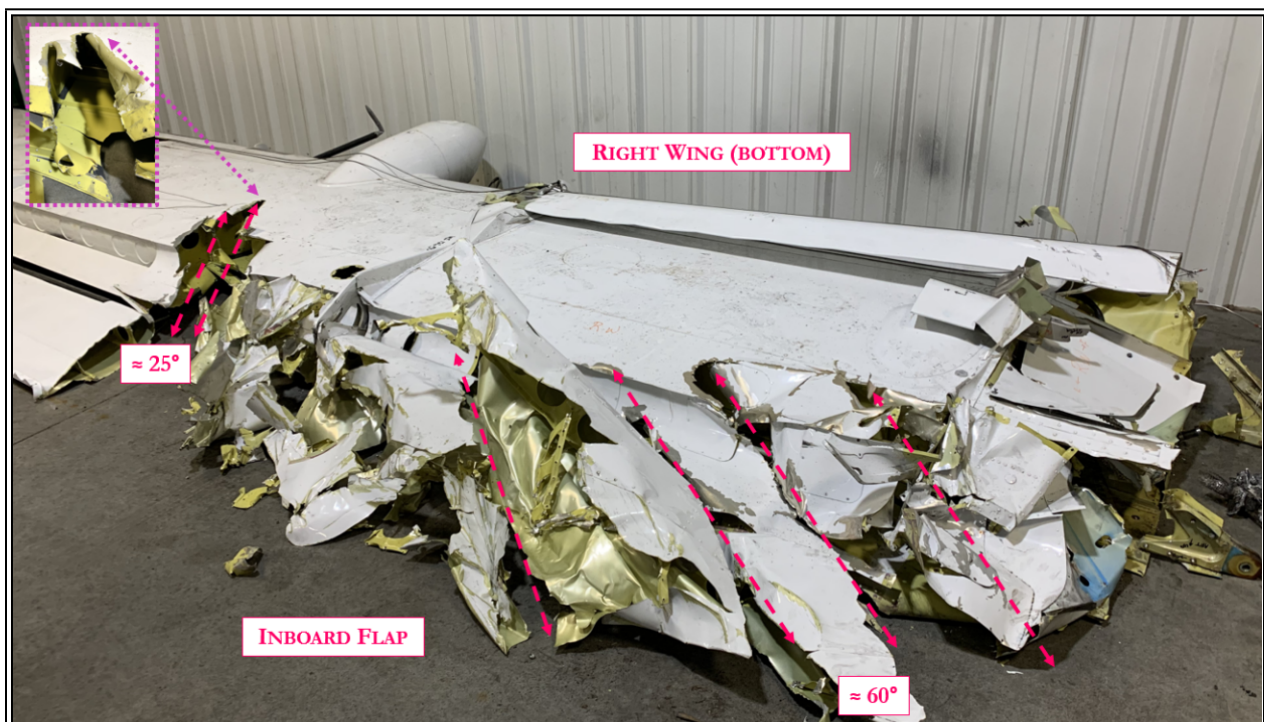
The right wing was recovered mostly intact from root to tip, with the right aileron and trim tab intact. The upper wing skin exhibited diagonal buckling, and the right flap was found in several pieces, with the largest section being mostly undamaged. The outboard flap section was mechanically cut and exhibited upward-curved edges. Significant crushing and mechanical cuts were noted on the flap and wing, with evidence of black paint transfer on the cut edges consistent with contacting the propeller (see Figure 4 below).

Figure 4: Bottom of the right wing showing cuts

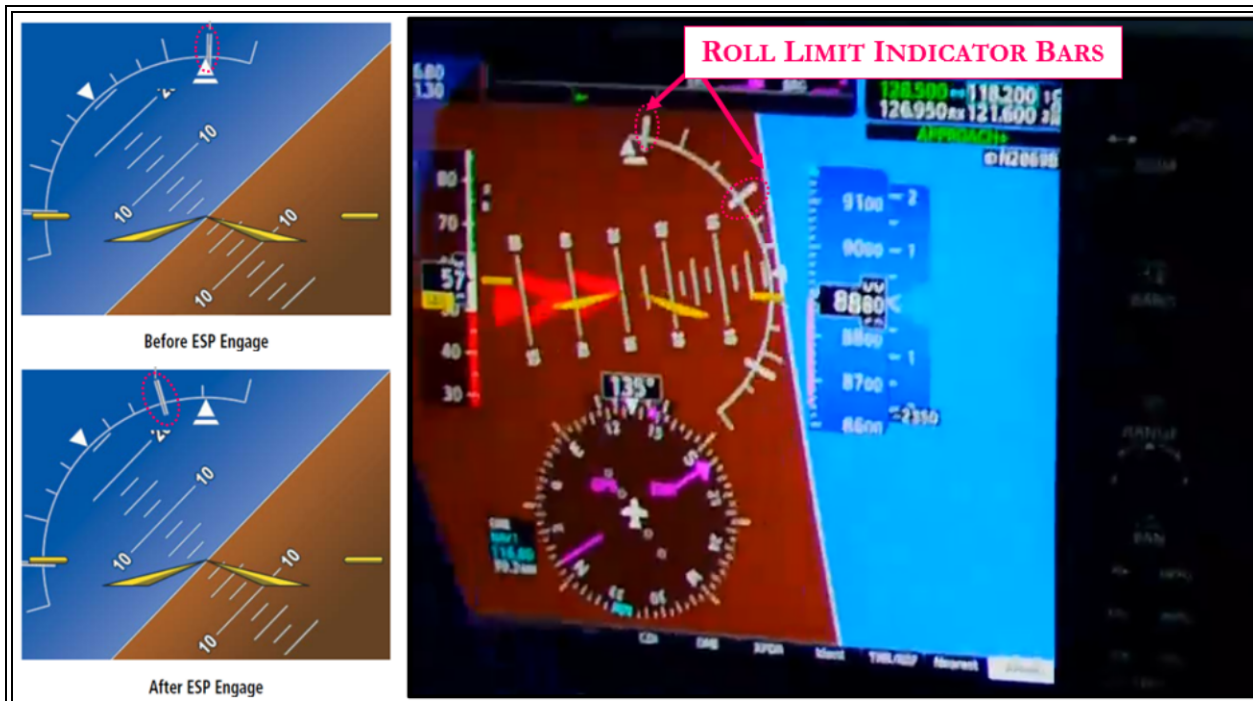
Maneuver 5.6L began at 96 KIAS and 30° bank to the left. The pilot stated, “Stall warning at 72... buffet at 59...” At a recorded time of 1514:51, when the pilot was performing the stall, the airplane rolled left and passed the 45° threshold, which was seen to activate the ESP (the Roll Limit Indicator bars moving from 45° to 30°). The airplane continued to roll past 75° (at which point the ESP system would have disengaged) and per recorded flight data, reached a maximum roll of about -83° before returning to wings level (see Figure 5 below).

Figure 5: Image of the PFD during the stall
