# Aviation Investigation Final Report

<b>Location:</b>	Charlotte, North Carolina	<b>Accident Number:</b>	ERA23FA070
<b>Date &amp; Time:</b>	November 22, 2022, 11:57 Local	<b>Registration:</b>	N7094J
<b>Aircraft:</b>	ROBINSON HELICOPTER R44	<b>Aircraft Damage:</b>	Substantial
<b>Defining Event:</b>	Sys/Comp malf/fail (non-power)	<b>Injuries:</b>	2 Fatal
<b>Flight Conducted Under:</b>	Part 91: General aviation - Aerial observation

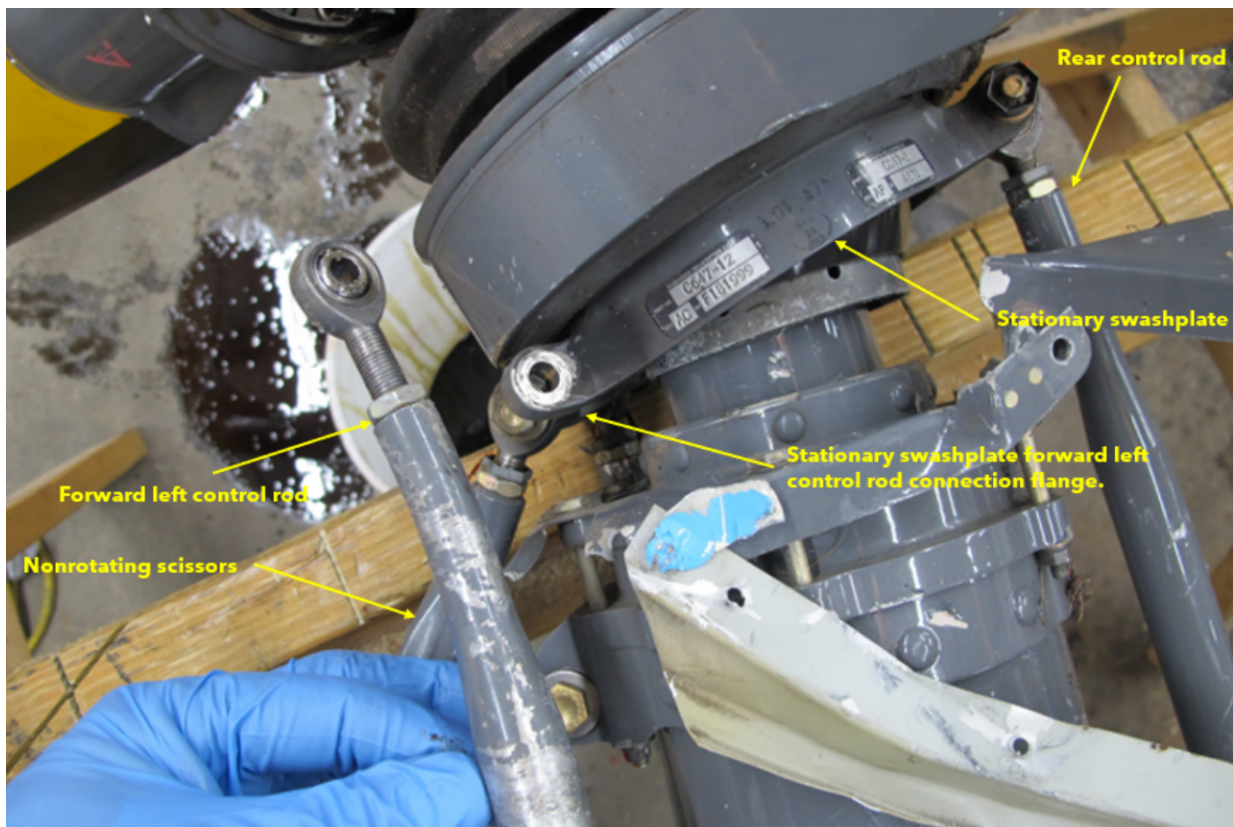
The inadequate inspections of the forward left control rod end attachment hardware to the stationary swashplate by the pilot and by maintenance personnel, resulting in an eventual loosening and backing out of the hardware and subsequent loss of helicopter control.

Cyclic and collective control continuity was established from the cockpit aft to the stationary swashplate through multiple breaks in the control tubes. All bell cranks and control tube rod end connections were present except for the upper, forward left control rod to the swashplate flange. The forward left control rod end connection to the stationary swashplate flange was not connected (figure 1) and the fastening hardware was missing (threaded bolt, nut, palnut, two washers, and two hat-shaped spacers). The rotating swashplate had witness marks on the forward rotating face and the underside in line with the forward left control tube rod end. The control tube rod end had witness marks on its outer diameter, the palnut fastener was not present, and the rod end was extended (unscrewed) 3/4-inch from the control rod. The upper forward portion of the rotor mast fairing and control rod had damage consistent with the control rod repeatedly impacting the interior of the fairing.

Figure 1 - Photo of the upper controls showing the disconnected forward left control rod from the stationary swashplate

Although the attachment hardware for the forward left control rod end connection to the stationary swashplate flange was not located after the accident, the swashplate forward left lug and the associated rod end were examined. Bolt thread contact marks were observed on

the end fitting bearing outer race, bolt thread wear marks were observed in the swashplate lug bore hole, and rubbing contact damage was observed on the contact face of the swashplate lug. Also, witness marks found on the lug and rod end were consistent with one of the two hat-shaped spacers being installed backwards.
