Aviation Investigation Final Report

Location:	San Diego, California	Accident Number:	WPR23LA045
Date & Time:	November 22, 2022, 17:57 Local	Registration:	N160AQ (A1); 166583 (A2)
Aircraft:	Sikorsky UH-60A (A1); Sikorsky MH-60R (A2)	Aircraft Damage:	Substantial (A1); Substantial (A2)
Defining Event:	Collision during takeoff/land	Injuries:	2 None (A1); 3 None (A2)
Flight Conducted Under:	Part 91: General aviation - Instructional (A1); Armed Forces (A2)

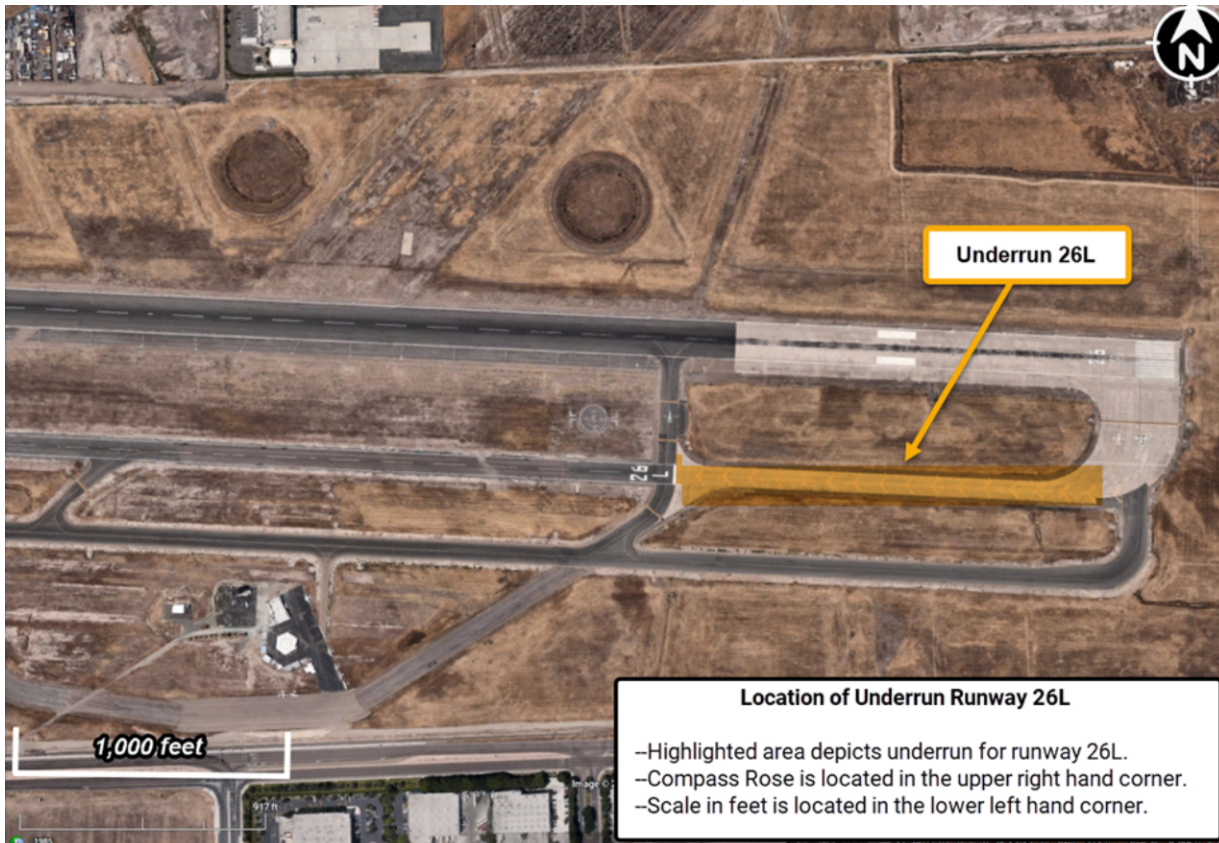
According to the pilot-in-command (PIC) of the UH-60A (Copter 129), he and a second pilot were conducting night vision goggle training. ADS-B data showed that Copter 129 departed Gillespie Field Airport (SEE) San Diego, California, about 1741 and proceeded to Brown Field Municipal Airport (SDM) San Diego, California. A review of the audio recording between the controller and Copter 129 revealed the initial contact and arrival to SDM was uneventful. About 1748, the controller asked Copter 129 if they could accept the underrun of runway 26L for landing at their own risk, and the pilot of Copter 129 accepted the underrun (Figure 1).

Figure 1. Google Earth image of SDM, showing the underrun runway 26L.

During postaccident interviews, ATCT personnel explained that the underrun was a non-movement portion of runway 26L, about 1,800 to 2,000 ft long, that was neither maintained by the airport nor lighted. The underrun was used for helicopter operations by civilian and military helicopters without written procedures. According to the air traffic manager, runway 26L was not approved for UH-60 helicopters to touch down on the runway because of the weight restriction. A review of airport data revealed the weight bearing capacity for runway 26L was 12,500 pounds.
