Aviation Investigation Final Report

Location:	Gaithersburg, Maryland	Accident Number:	ERA23LA071
Date & Time:	November 27, 2022, 17:29 Local	Registration:	N201RF
Aircraft:	Mooney M20J	Aircraft Damage:	Substantial
Defining Event:	Collision during takeoff/land	Injuries:	2 Serious
Flight Conducted Under:	Part 91: General aviation - Personal

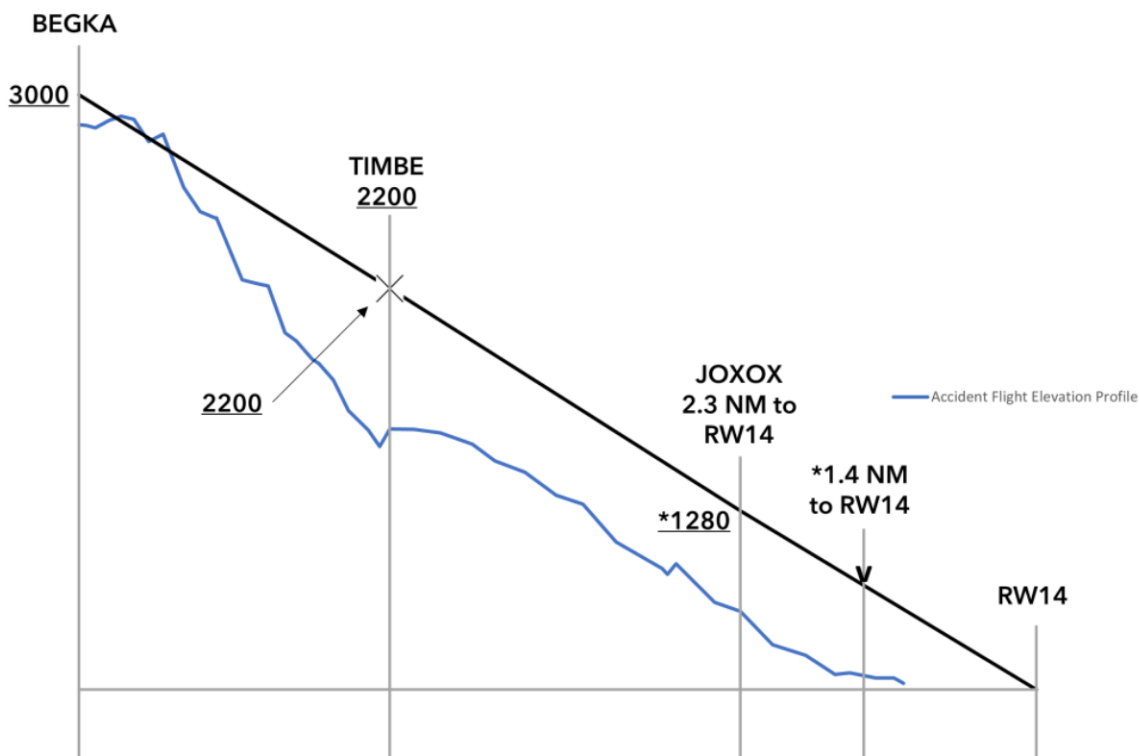
Figure 1. RNAV RWY14 GPS approach profile with the airplane’s altitude depicted in blue

Flight track data revealed that the airplane was consistently below published minimum altitudes throughout the approach and was 500 ft below the minimum altitude prescribed at the final approach fix. The pilot continued the descent below the lowest minimums prescribed by the approach procedure, and about 1.25 miles from the runway and left of the runway centerline, the airplane impacted and became suspended in a power line tower at an elevation about 600 ft mean sea level (msl) and 100 ft above ground level. The airport was located at an elevation of 539 ft msl.

The controller instructed the accident pilot to proceed direct to BEGKA and cleared him for the RNAV (GPS) RWY 14 approach. The minimum altitude at BEGKA, 11.3 nautical miles (nm) from the runway, was 3,000 ft mean sea level (msl). The airplane crossed BEGKA about 2,775 ft GPS altitude as it aligned with the final approach course and continued its descent. The minimum altitude at the final approach fix (TIMBE), 5.2 nm from the runway, was 2,200 ft msl; the airplane crossed TIMBE at 1,500 ft msl. The minimum altitude at JOXOX waypoint, about 2.3 nm from the runway, was 1,280 ft msl; the airplane crossed JOXOX at 750 ft. The final point on the approach procedure, the visual descent point (VDP), was located 1.4 nm from the runway 14 threshold. The airplane crossed the VDP at 587 ft. (See Figure 1.)

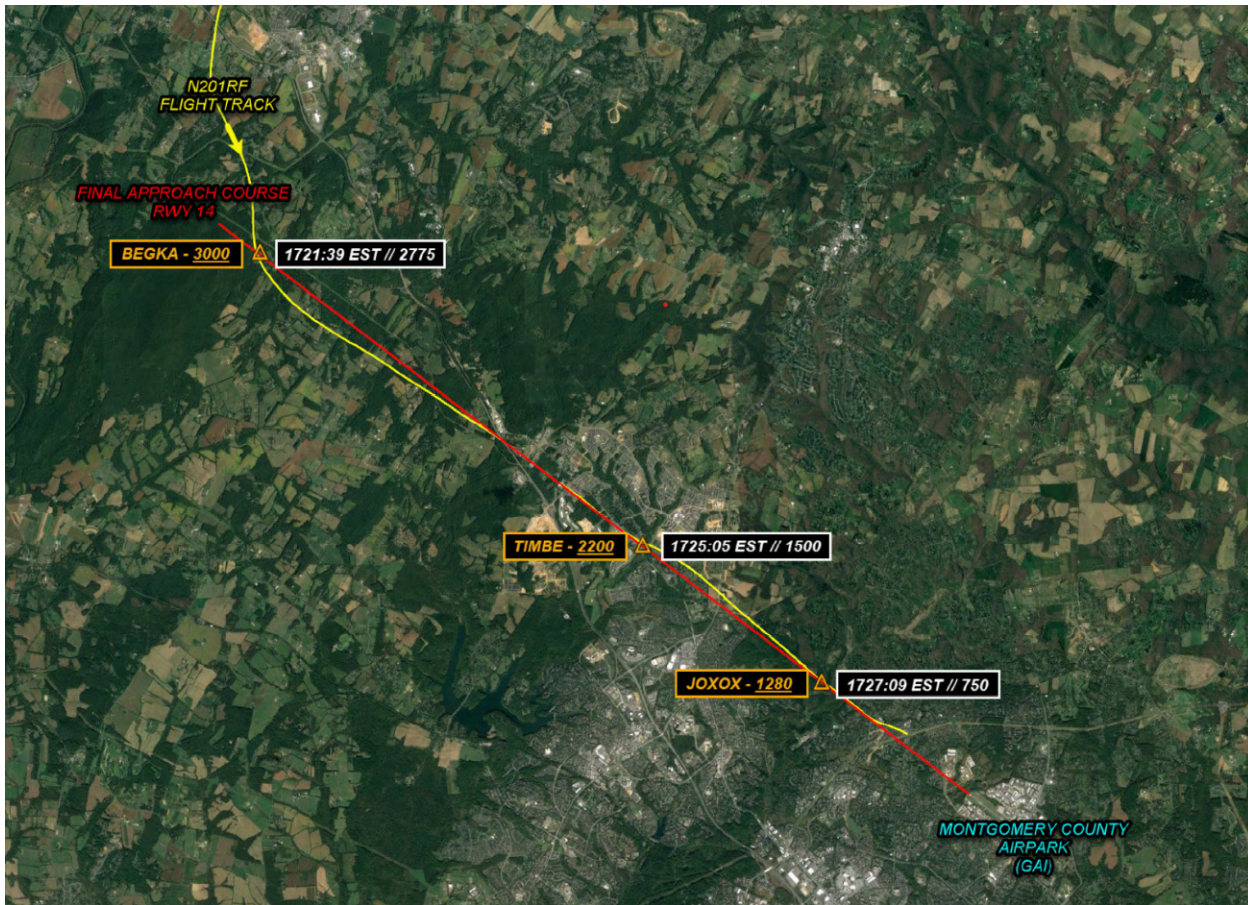
Figure 2. ADS-B flight track information

About 1.25 miles from the runway and left of the runway centerline, the airplane impacted and became suspended in a power line tower at an elevation about 600 ft msl and 100 ft above ground level. Between JOXOX and the collision with the tower, the airplane descended as low as 475 ft. The published field elevation at GAI was 539 ft msl.

Figure 2 shows flight track information in relation to the runway 14 final approach course, with minimum altitudes for each segment of the approach shown in orange, and the airplane’s altitude at those locations shown in white.

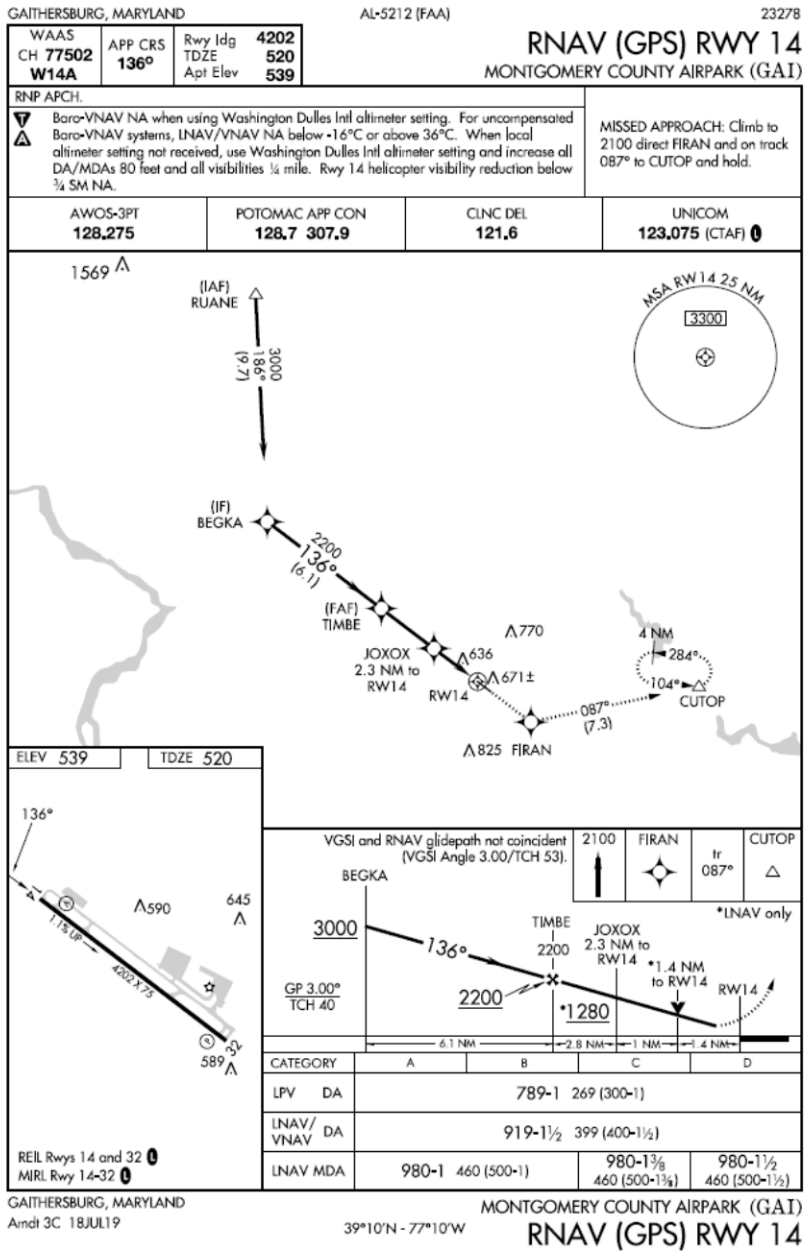
Figure 3. RNAV (GPS) RWY 14 Approach Procedure

The lowest altitude allowed by the approach procedure was 789 ft msl, or 269 ft agl. However, this altitude was for an approach category that provided both lateral and vertical course guidance, and the pilot stated that he was not receiving vertical guidance. Whether the lack of vertical guidance was the result of the pilot’s mis-programming of the approach procedure or because he was referring to his VFR-only GPS for guidance was not determined. The lowest altitude allowed for an approach with only lateral guidance was 980 ft msl, or 460 ft agl.

The RNAV (GPS) Runway 14 approach procedure at GAI provided three categories of instrument approaches; localizer performance with vertical guidance (LPV), with a decision altitude of 789 ft msl (269 ft agl); lateral navigation/vertical navigation (LNAV/VNAV), with a decision altitude (DA) of 919 ft msl (399 ft agl); and lateral navigation (LNAV), with a minimum descent altitude (MDA) of 980 ft msl (460 ft agl).
