Aviation Investigation Final Report

Location:	Venice, Florida	Accident Number:	ERA23FA079
Date & Time:	December 3, 2022, 19:38 Local	Registration:	N4676F
Aircraft:	Piper PA28	Aircraft Damage:	Substantial
Defining Event:	Loss of control in flight	Injuries:	3 Fatal
Flight Conducted Under:	Part 91: General aviation - Personal

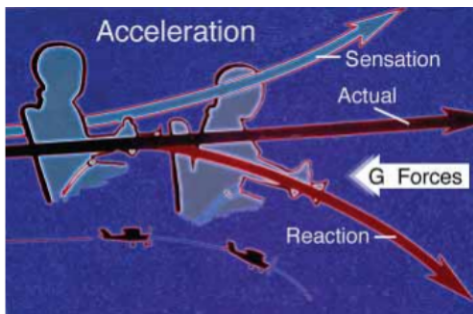
Figure 1 - Illustration paired with paragraph above in AM-400-03/1 (FAA).

The Head-Up Illusion involves a sudden forward linear acceleration during level flight where the pilot perceives the illusion that the nose of the airplane is pitching up. The pilot’s response to this illusion would be to push the yoke or the stick forward to pitch the nose of the aircraft down. A night takeoff from a well-lit airport into a totally dark sky (black hole) or a catapult take-off from an aircraft carrier can also lead to this illusion, and could result in a crash.
