# Aviation Investigation Final Report

<b>Location:</b>	Gulf of Mexico, Gulf of America	<b>Accident Number:</b>	CEN23LA064
<b>Date &amp; Time:</b>	December 15, 2022, 08:15 Local	<b>Registration:</b>	N414RL
<b>Aircraft:</b>	Bell 206-L4	<b>Aircraft Damage:</b>	Substantial
<b>Defining Event:</b>	Dynamic rollover	<b>Injuries:</b>	3 Minor
<b>Flight Conducted Under:</b>	Part 135: Air taxi & commuter - Scheduled

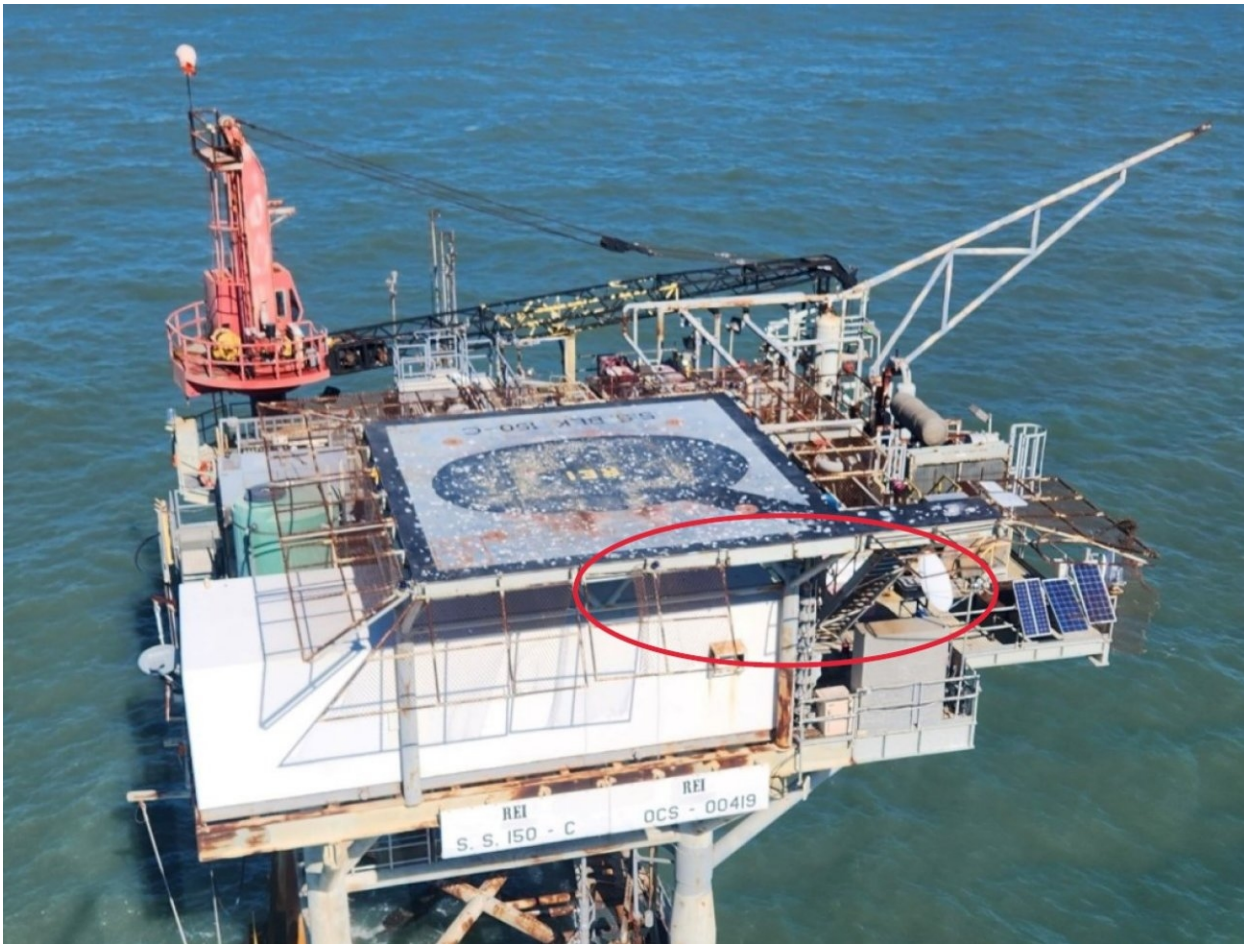
Photos of the helideck revealed the metal safety skirting was damaged and partially separated.

It is likely that the pilot's improper takeoff technique allowed the helicopter to drift toward the helideck light, then when the skid contacted the light, that acted as a pivot point and resulted in dynamic rollover.

Photos of the helideck revealed that a blue light and the metal safety skirting were found damaged and partially separated, as seen in Figure 1.

*Figure 1. Aerial view of the platform and helideck (courtesy of the helicopter operator). The damaged light and skirting are circled in red at the bottom right side of the helideck near the stairway.*
