Aviation Investigation Final Report

Location:	Gulf of Mexico, Gulf of Mexico	Accident Number:	CEN23LA064
Date & Time:	December 15, 2022, 08:15 Local	Registration:	N414RL
Aircraft:	Bell 206-L4	Aircraft Damage:	Substantial
Defining Event:	Dynamic rollover	Injuries:	3 Minor
Flight Conducted Under:	Part 135: Air taxi & commuter - Scheduled

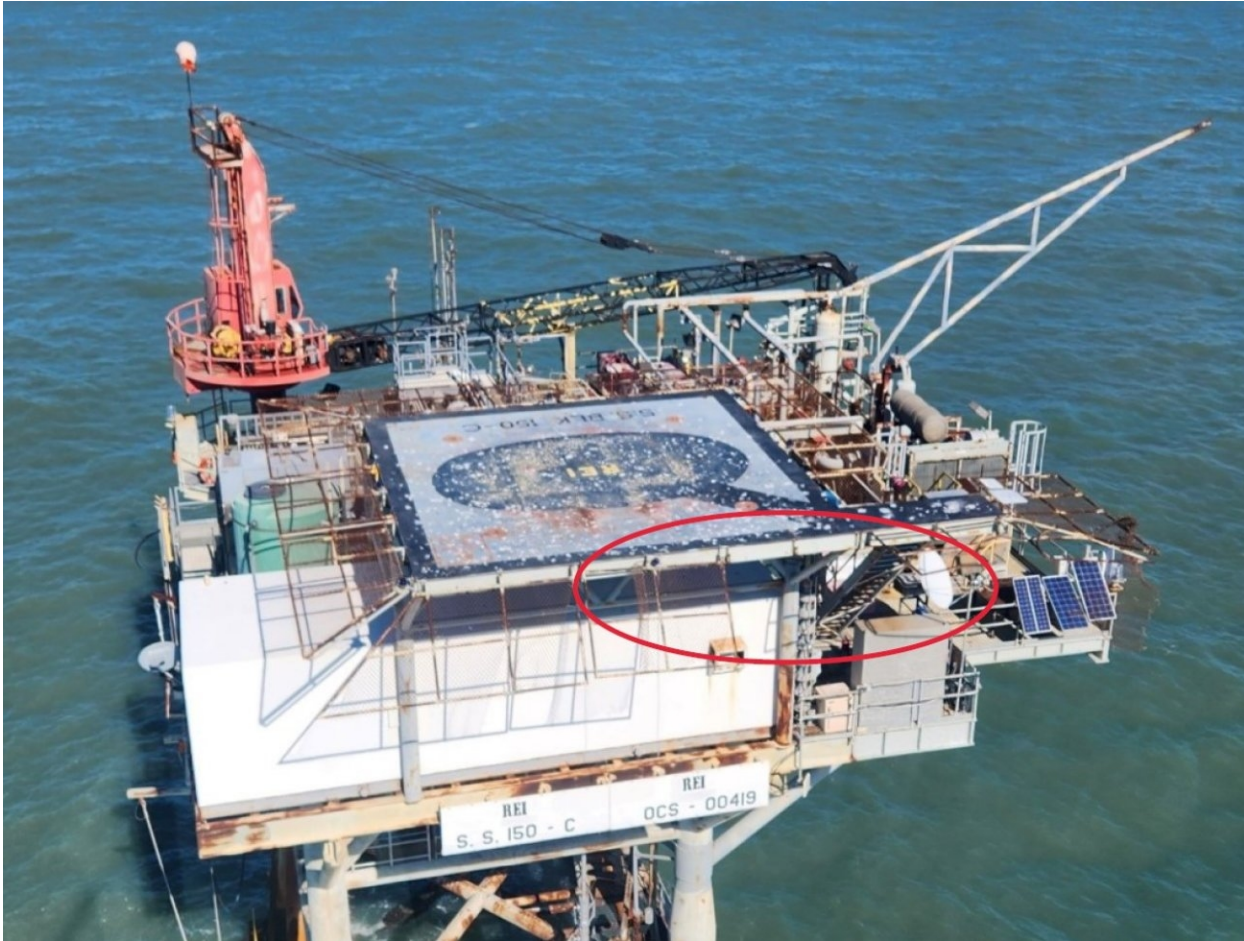
Photos of the helideck revealed the metal safety skirting was damaged and partially separated.

It is likely that the pilot's improper takeoff technique allowed the helicopter to drift toward the helideck light, then when the skid contacted the light, that acted as a pivot point and resulted in dynamic rollover.

The pilot's improper takeoff technique that allowed the helicopter skid to drift into a helideck light, resulting in a dynamic rollover.

Photos of the helideck revealed that a blue light and the metal safety skirting were found damaged and partially separated, as seen in Figure 1.

Figure 1. Aerial view of the platform and helideck (courtesy of the helicopter operator). The damaged light and skirting are circled in red at the bottom right side of the helideck near the stairway.
