# Aviation Investigation Final Report

<b>Location:</b>	Kaupo, Hawaii	<b>Accident Number:</b>	ANC23FA008
<b>Date &amp; Time:</b>	December 15, 2022, 21:14 Local	<b>Registration:</b>	N13GZ
<b>Aircraft:</b>	RAYTHEON AIRCRAFT COMPANY C90A	<b>Aircraft Damage:</b>	Substantial
<b>Defining Event:</b>	Inflight upset	<b>Injuries:</b>	3 Fatal
<b>Flight Conducted Under:</b>	Part 91: General aviation - Positioning

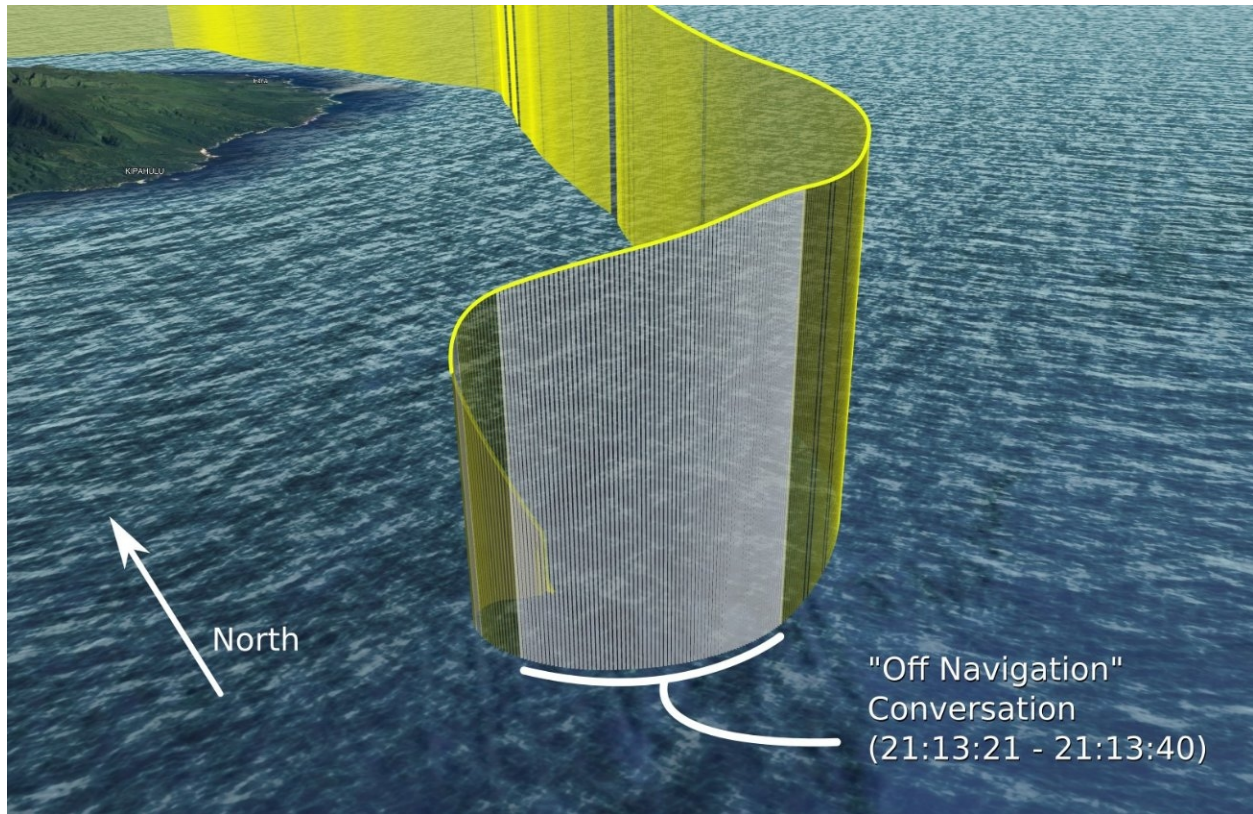
At 2113:40, the pilot replied: "Uhh, 13GZ is off navigation here... we're gonna... we're gonna give it a try." The vertical speed indicator was pegged at -3,500 fpm (see Figure 2).

*Figure 2. Google Earth image of a portion of the flight track.*

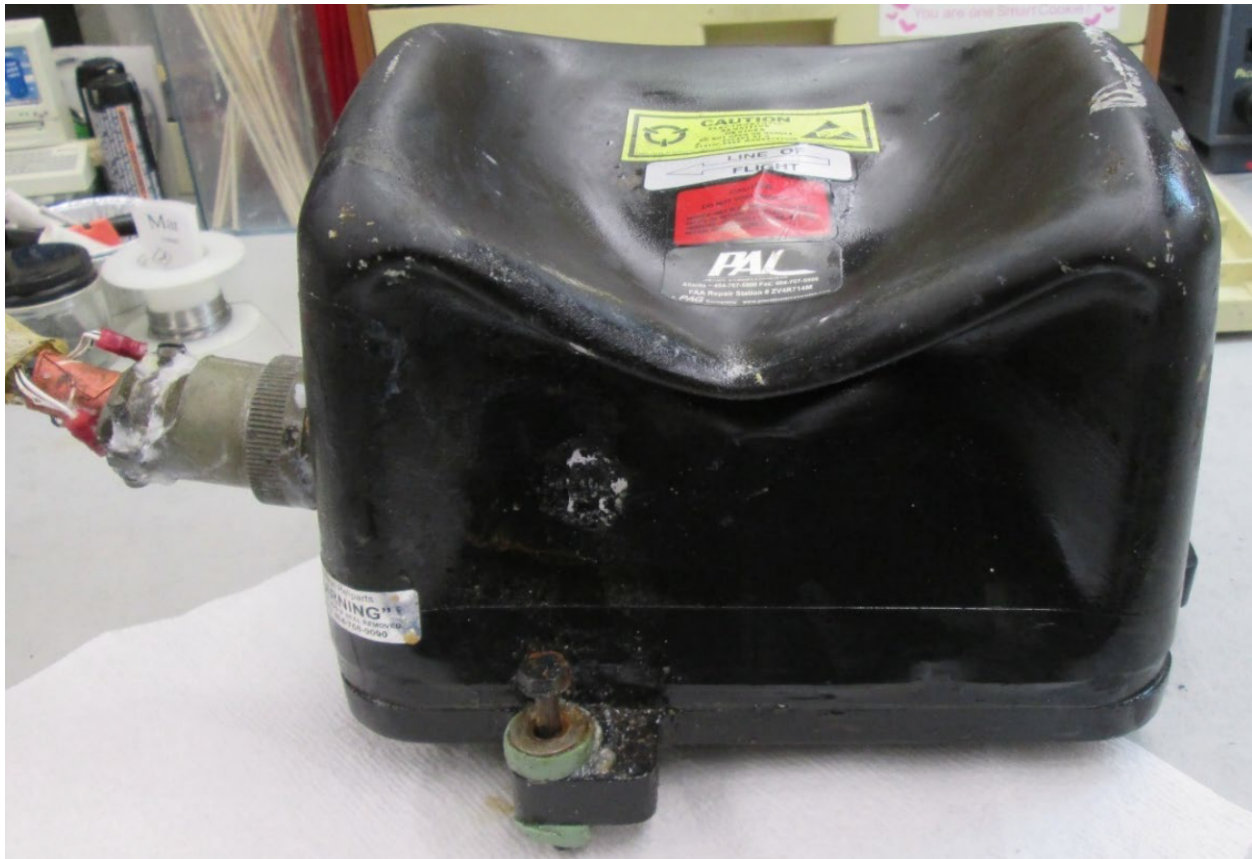
A postaccident examination of the vertical gyro was performed. The unit was crushed inward on the top and 2 sides (see Figure 6).

*Figure 6. View of inward crushing on the vertical gyro housing.*

The crushing of the case is consistent with excessive external water pressure. There were salt deposits on the electrical connector. The airframe electrical connector was removed. The pins were straight. The sockets on the aircraft side of the connector were present and none

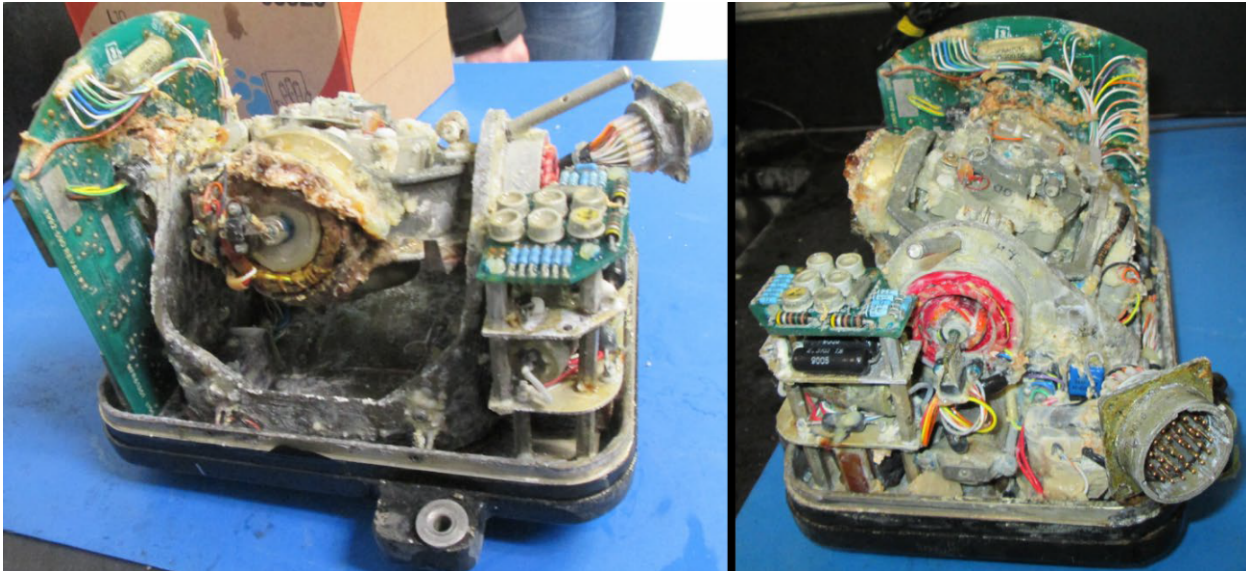
appeared to be recessed. The preservation sealing tape around the base of the unit was removed. Water was present and was drained from the unit. The cover was removed. The interior of the unit was covered in marine growth and deposits. The unit was washed with de-ionized water and some of the marine growth was removed (see Figure 7).

*Figure 7. Corrosion and marine growth inside the vertical gyro.*

The slip ring was damaged, and the damage appeared to correspond to the crushed cover. Several components on the unit were observed to be crushed. The S1 switch was broken, and the damage appears to correspond to the crushed cover. Damage to wire wound resistor (R61) on terminal board 7 (TB7) was observed. The resistance across the resistor was measured at 83.5 ohms as found. One of the wires between the resistor and the board was cut to isolate the resistor. The resistance across the resistor was re-measured at 83.4 ohms. (Note that the R61 resistor has a nominal value of 82 ohms.)

Continuity checks were performed on the electrical connector of the unit. Operation of the unit was not possible due to deposits on the unit. The area where the R61 resistor was located showed some corrosion deposits but no thermal damage. No other anomalies were observed during the examination.

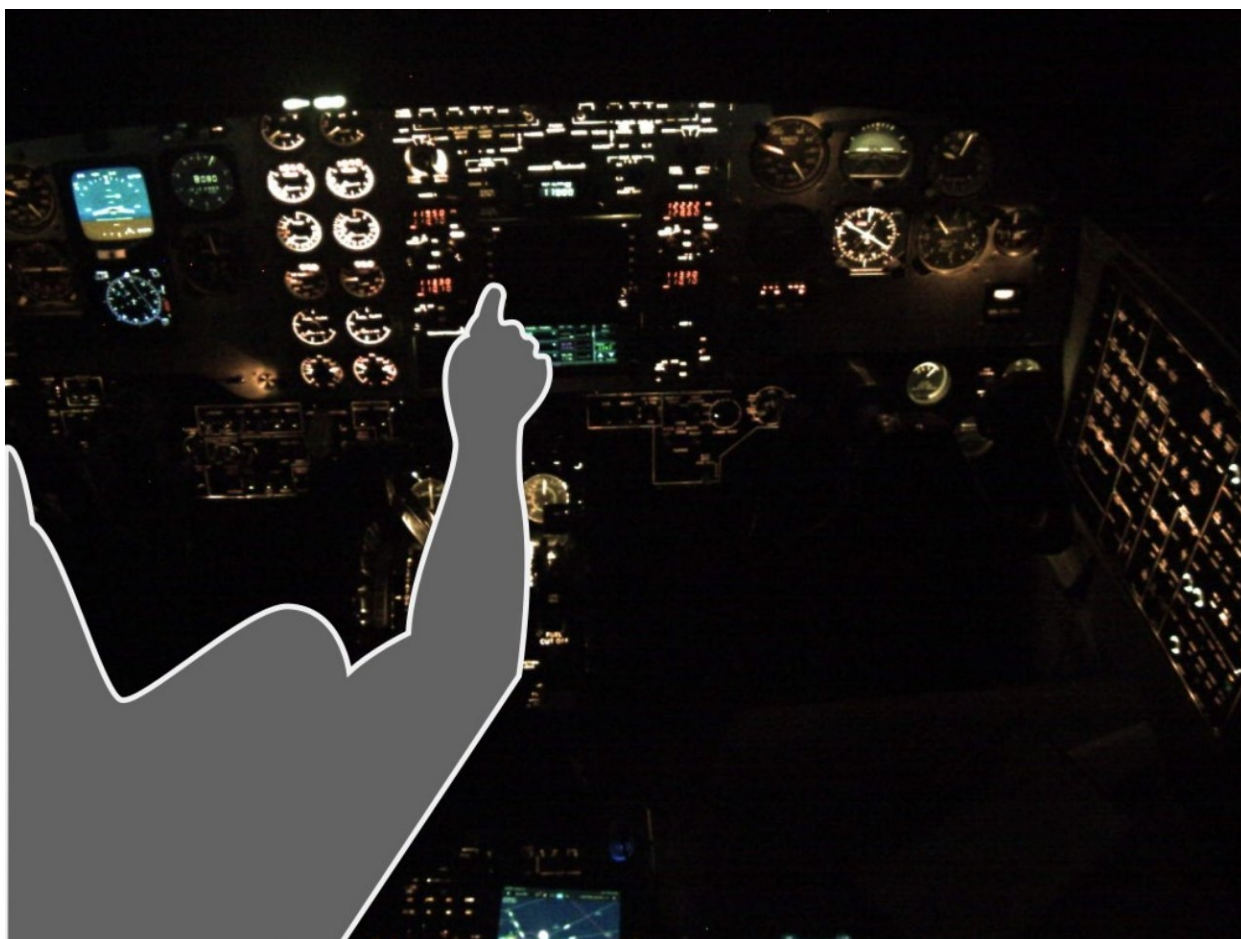
for examination and download. The Appareo Vision 1000 records about the two hours of image, audio, and parametric data, and is equipped with an internal memory module. The camera was mounted in a position that captured the entire instrumentation for both the left seat and right seat, as well as the center pedestal and overhead panel (see Figure 8). During the accident flight, the Appareo video recording captured, in part: the pilot utilizing a cell phone to listen to music after takeoff; the Collins MFD being inoperative for the duration of the flight; and the Electronic Flight Instrument System, which included the EADI on the captain's side (or left side), going black or inoperative approximately 13 minutes into the flight (see Figure 9). Additionally, the Appareo system captured audible sounds including the autopilot disconnect, master caution, altitude alert tones, and the sound of a loud metallic bang.

*Figure 8. Appareo image of accident flight.*

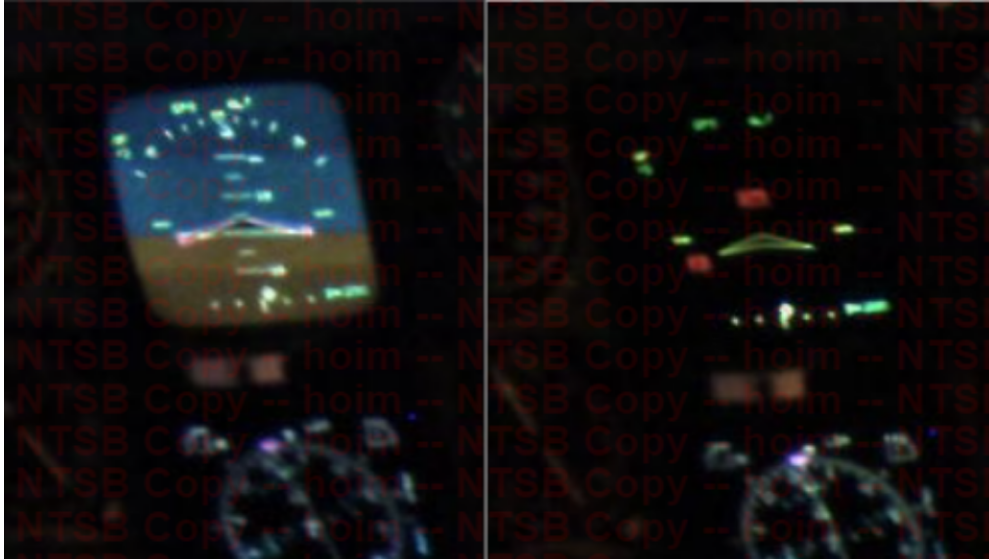
The Appareo Vision 1000 cockpit video recording of the accident indicated that the autopilot and the attitude indicator failed at the same time. The only component common to both systems is the vertical gyro. The vertical reference gyro provides 3-wire synchro pitch and roll attitude data to the autopilot and to the attitude indicator.

Figure 9. Appareo image of the Electronic Attitude Director Indicator, before and after the failure.

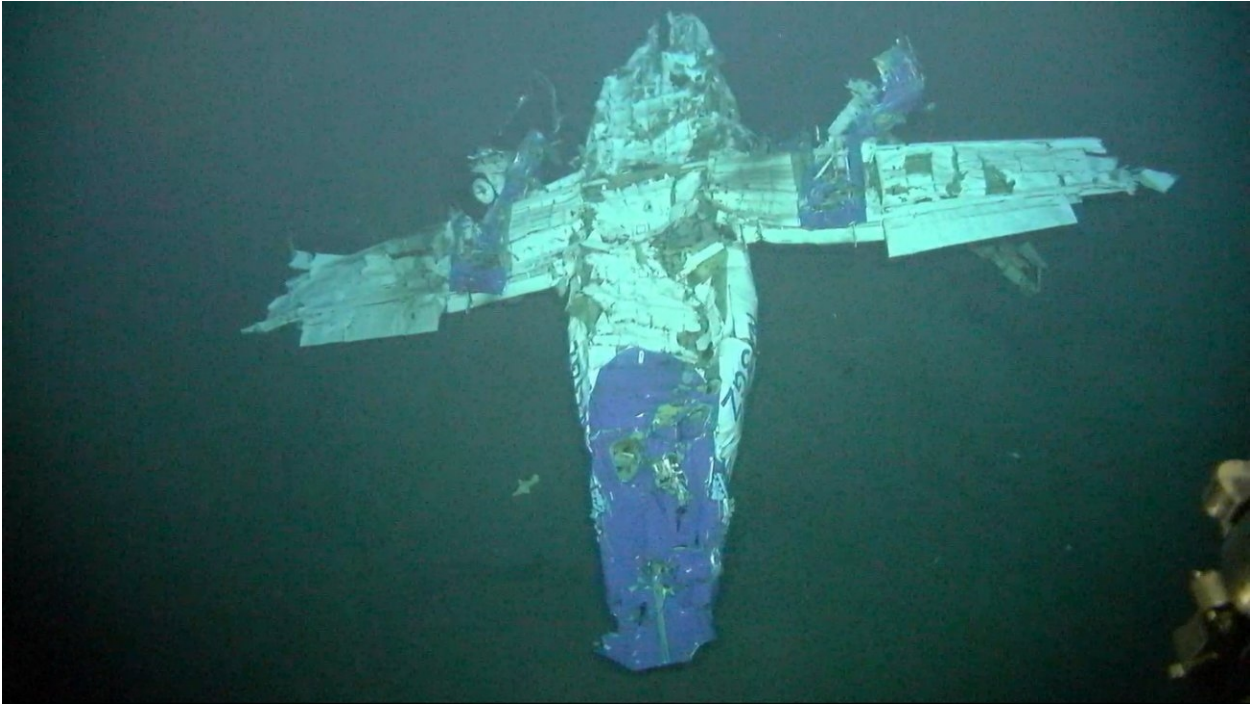
The postaccident examination revealed that the wreckage displayed vertical crush damage consistent with impact at a high rate of descent. The fuselage, from the nose to tail section, was impact damaged and compressed upward. The empennage separated from the fuselage in flight and was not recovered. The left and right wings were mostly intact but damaged from the wing roots out to beyond the end of the outboard flaps; neither wing tip was recovered. The lower surface of the wings had significant upward hydraulic compression damage. All wing separations exhibited signatures consistent with tension overload.

*Figure 14. View of N13GZ on the seabed. (Courtesy of Ocean Infinity)*
